SC 20/S-201 Augusta Street

Road Safety Audit

Greenville, South Carolina

Stantec Consulting Services Inc.

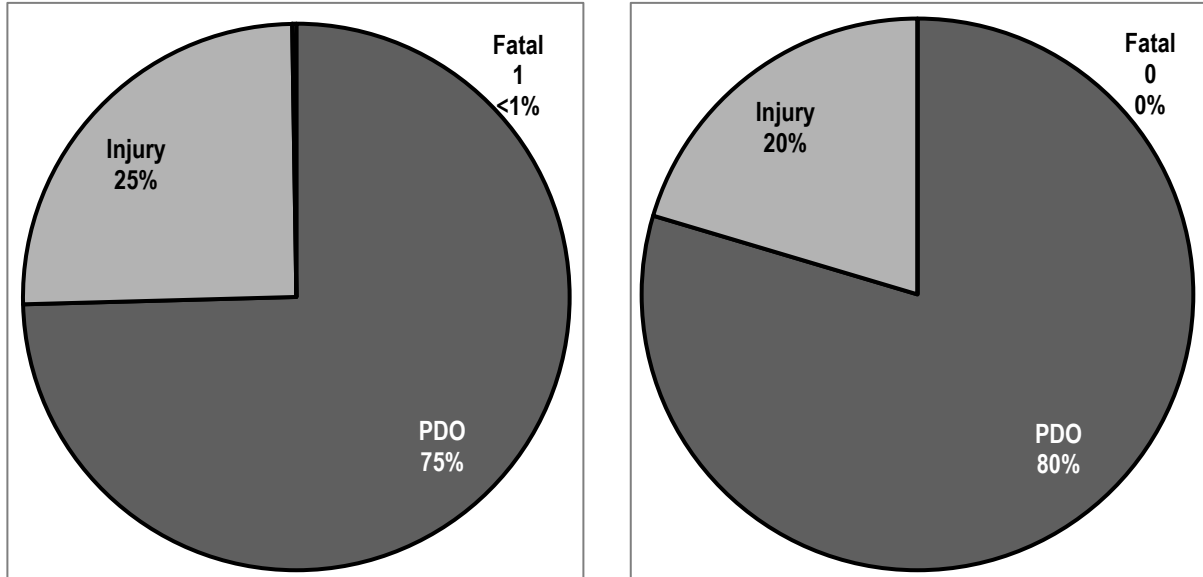
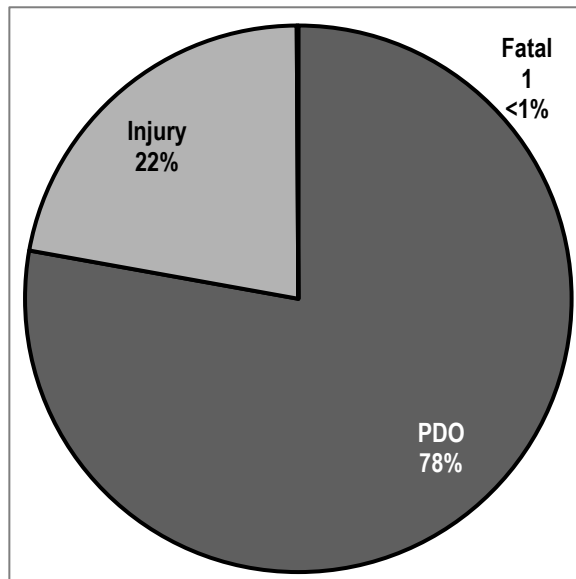
Figure 3 - Crashes by Severity (2016-2020)

Crash data presented in **Figure 3** indicates crashes categorized by severity. Crash severity is broken down into three different types, property damage only (PDO), injury, and fatal.

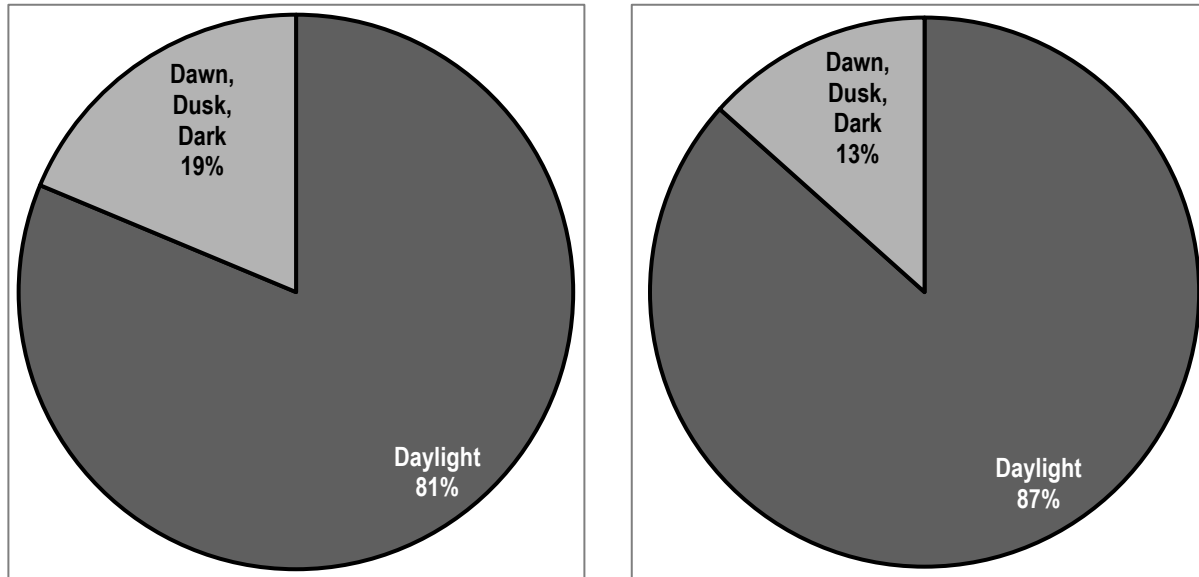
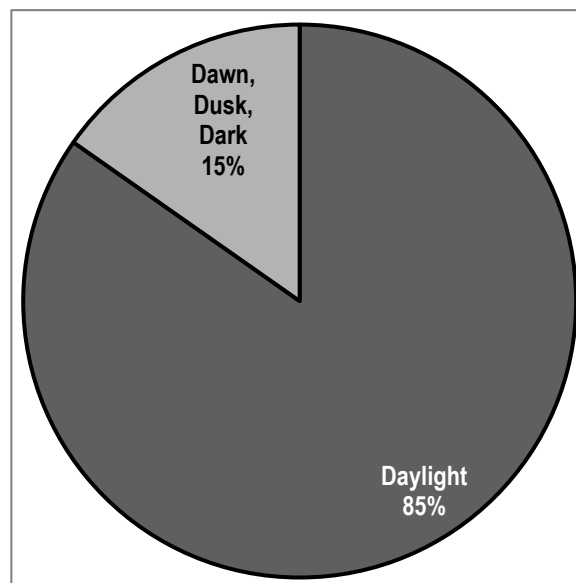
Figure 4 - Crashes by Light Condition (2016-2020)

Crash data presented in **Figure 4** separates crashes out by light conditions. The rates below roughly correspond to typical light condition crash patterns experienced in other parts of South Carolina.

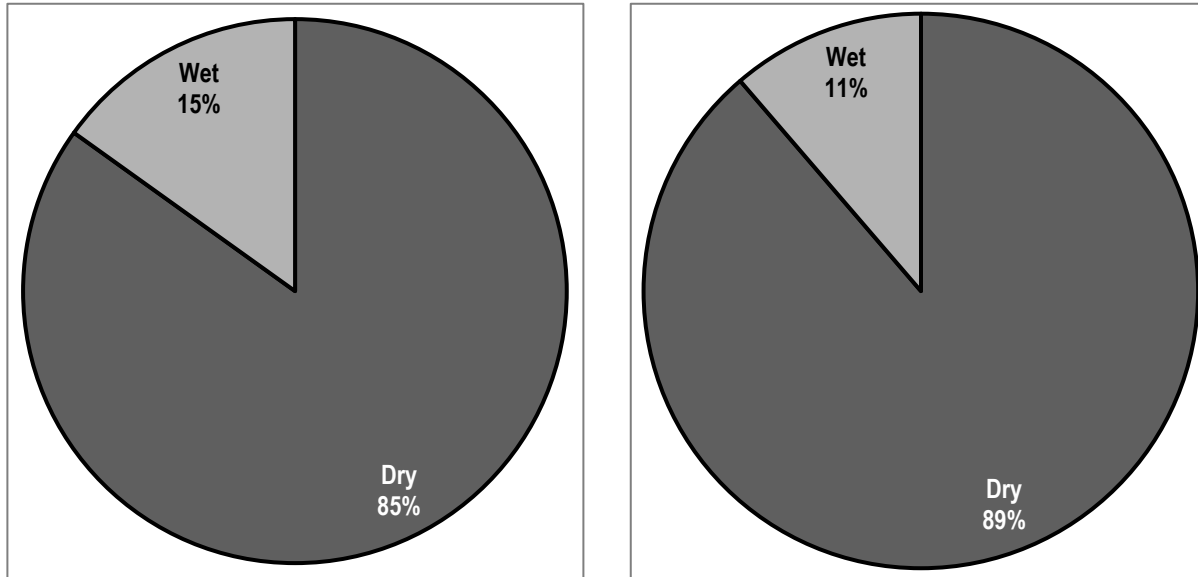
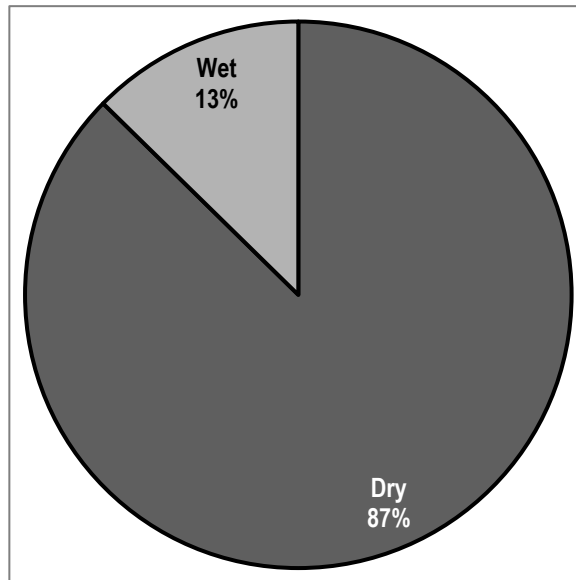
Figure 5 - Crashes by Pavement Condition (2016-2020)

Crash data in **Figure 5** indicates the pavement condition. This statistic is potentially important as wet pavement has a lower coefficient of friction and as such, may result in an increased number of collisions. The results from the collision analysis indicates no significant change when comparing the residential to commercial sections or when compared to roadways with similar characteristics in South Carolina.

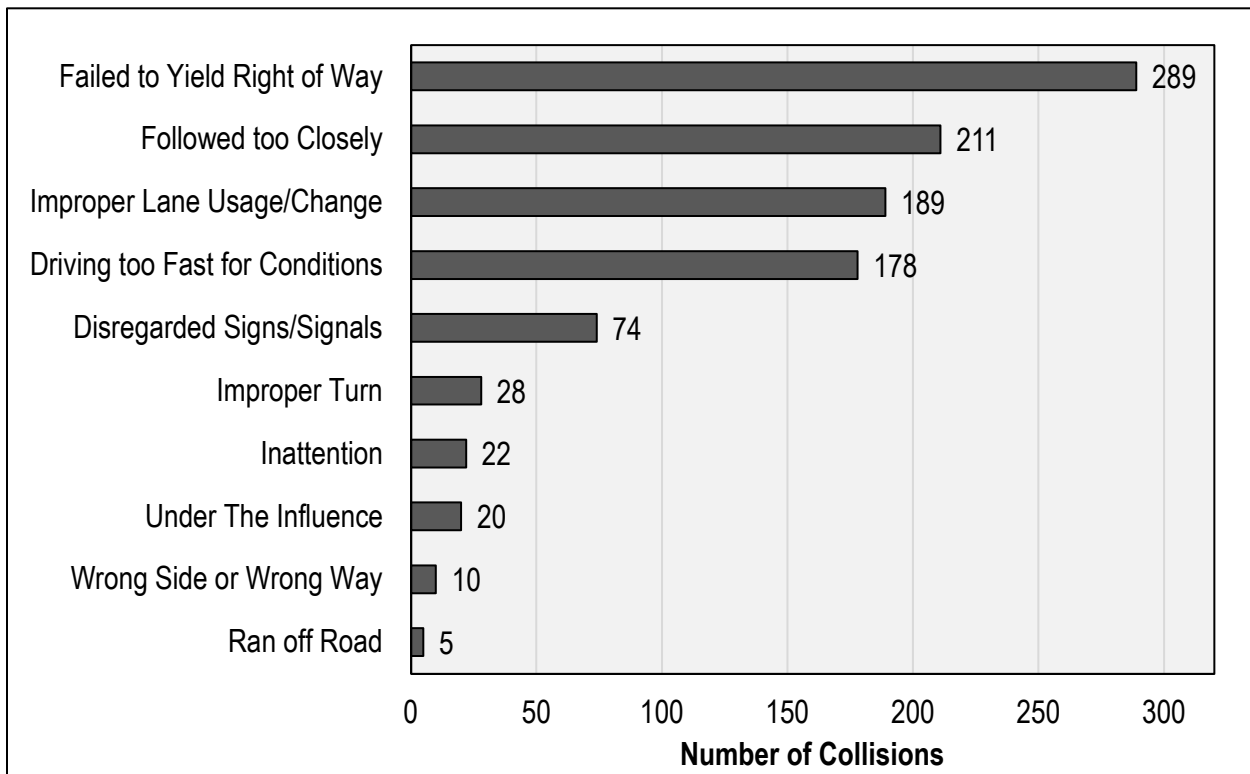
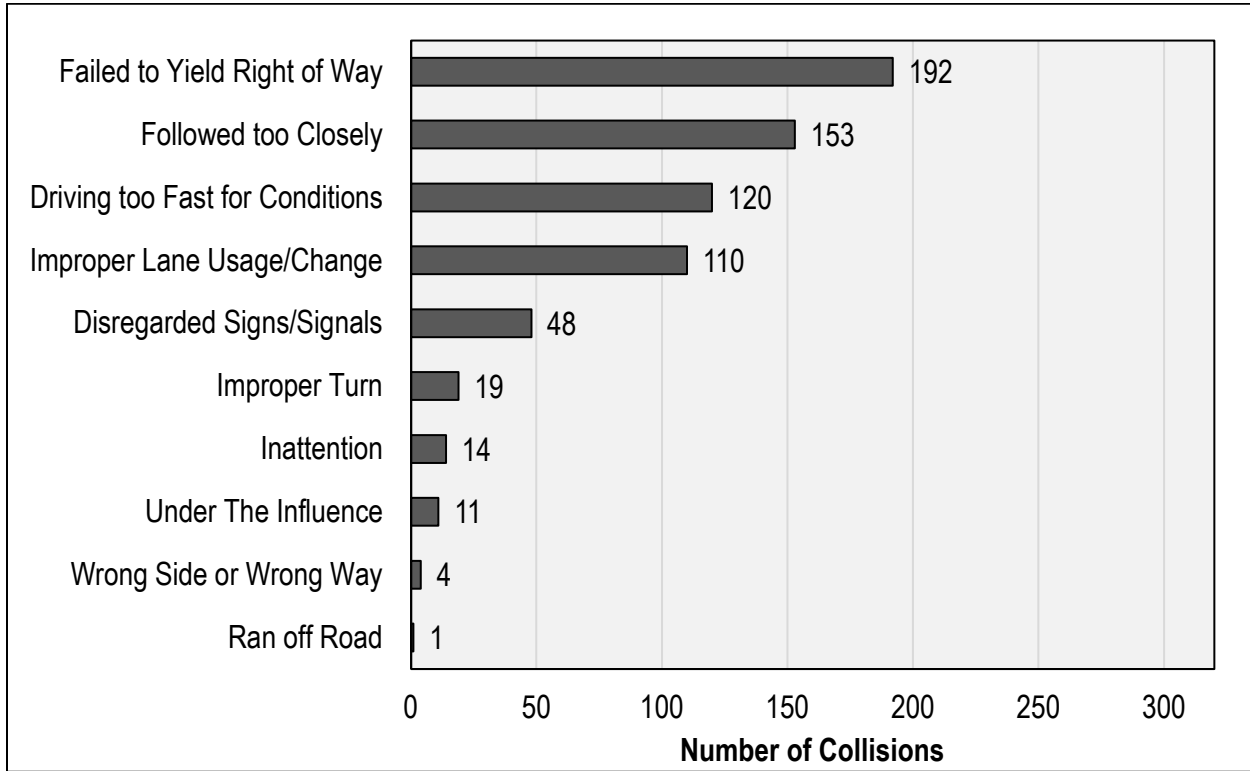
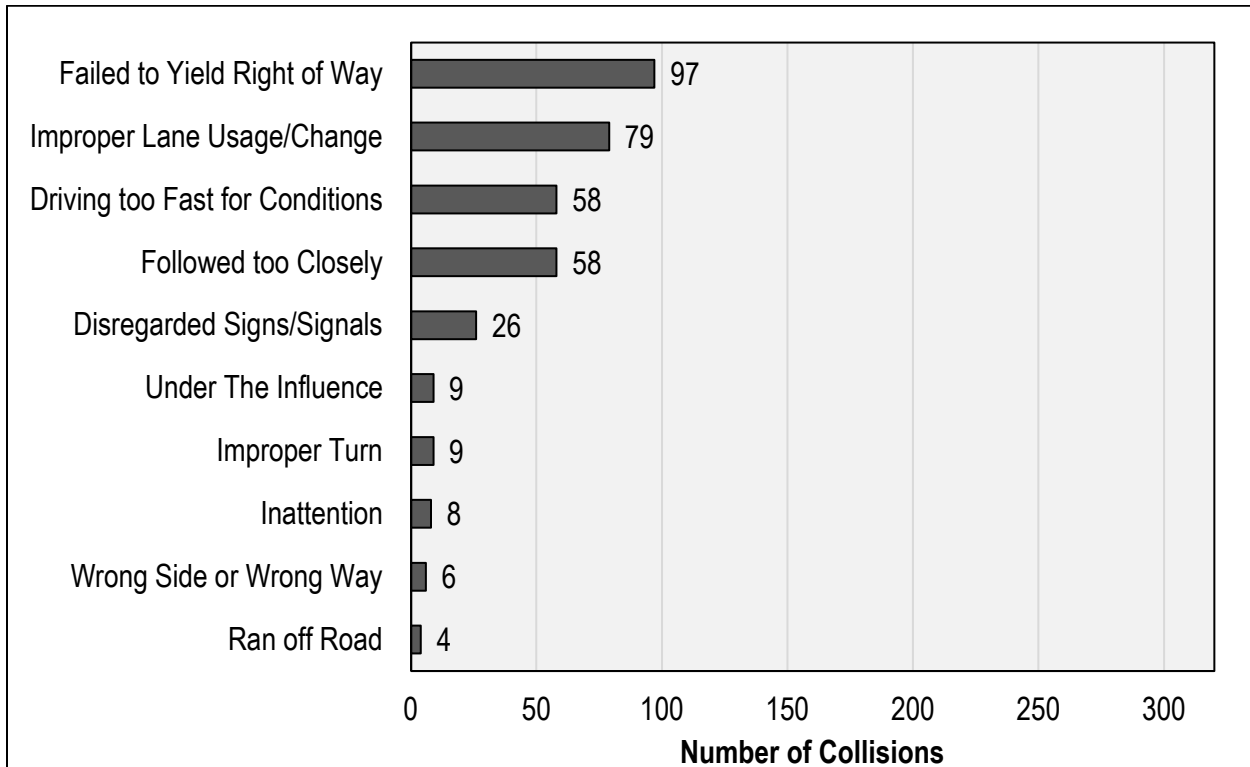
The statistic displayed below in **Figure 6-8** indicates the manner in which the collision was most likely caused. The most common causes along the August Street corridor are similar to other roadways throughout the state. For each figure, the top ten, known probable causes are shown (causes such as “unknown”, “other improper action”, etc. are not shown as they do not provide definitive information about the probable cause of the collision).

Figure 6 - Probable Cause (2016-2020)

Figure 7 - Probable Cause - Commercial Section (2016-2020)

Figure 8 - Probable Cause - Residential Section (2016-2020)

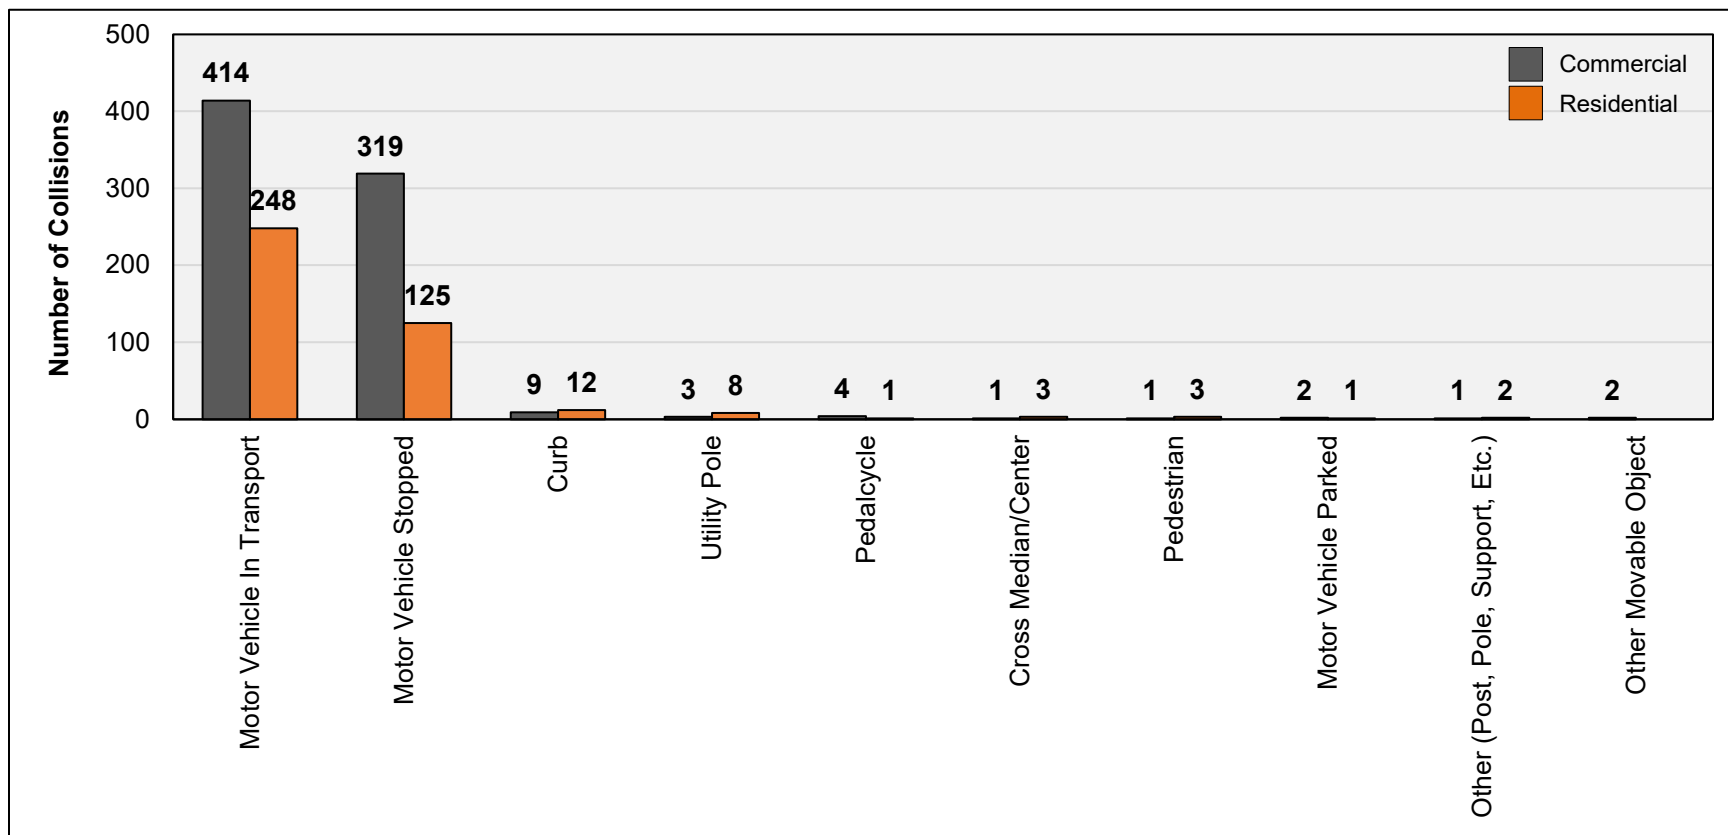
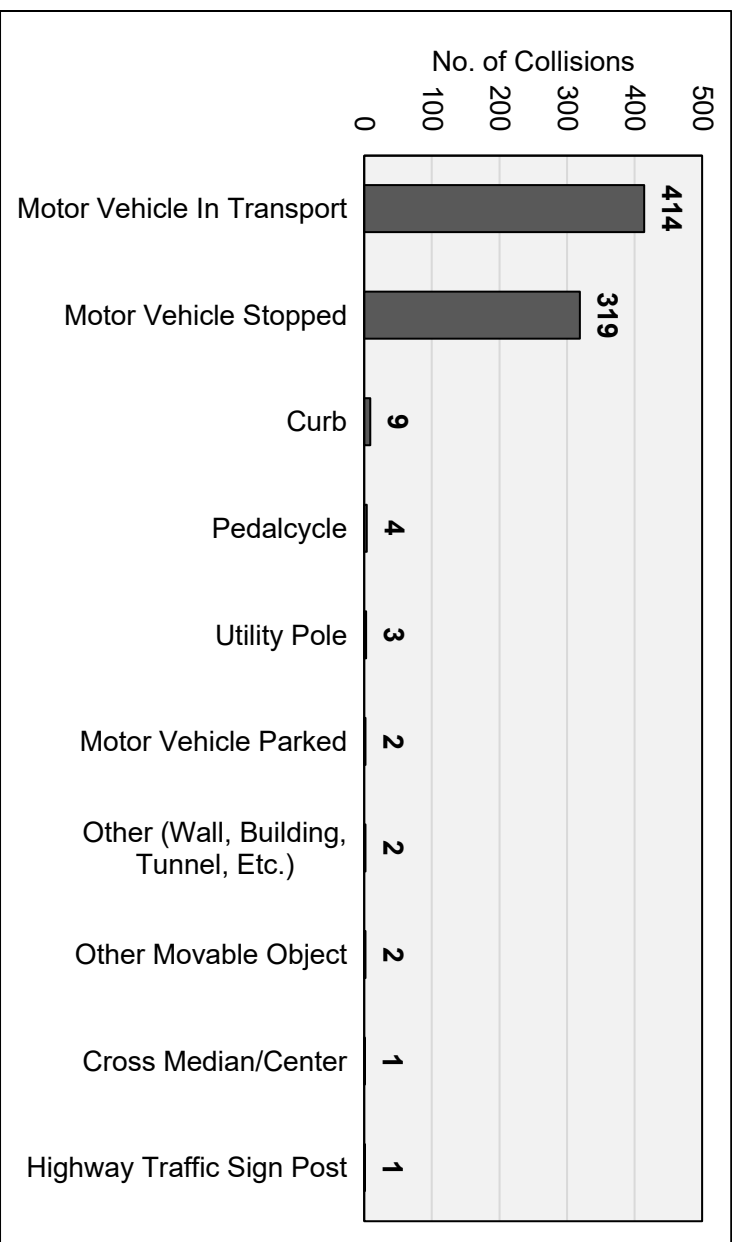
The first harmful event statistics indicates the cause of the collision. As shown in **Figures 9-11** the first harmful event is most often the result of a vehicle vs vehicle crash, which is coded as motor vehicle in transport or motor vehicle stopped on the police report form. For each figure, the top ten events are shown.

Figure 9 - First Harmful Event – Combined (2016-2020)

Figure 10 - First Harmful Event - Commercial (2016-2020)

Figure 11 - First Harmful Event - Residential (2016-2020)

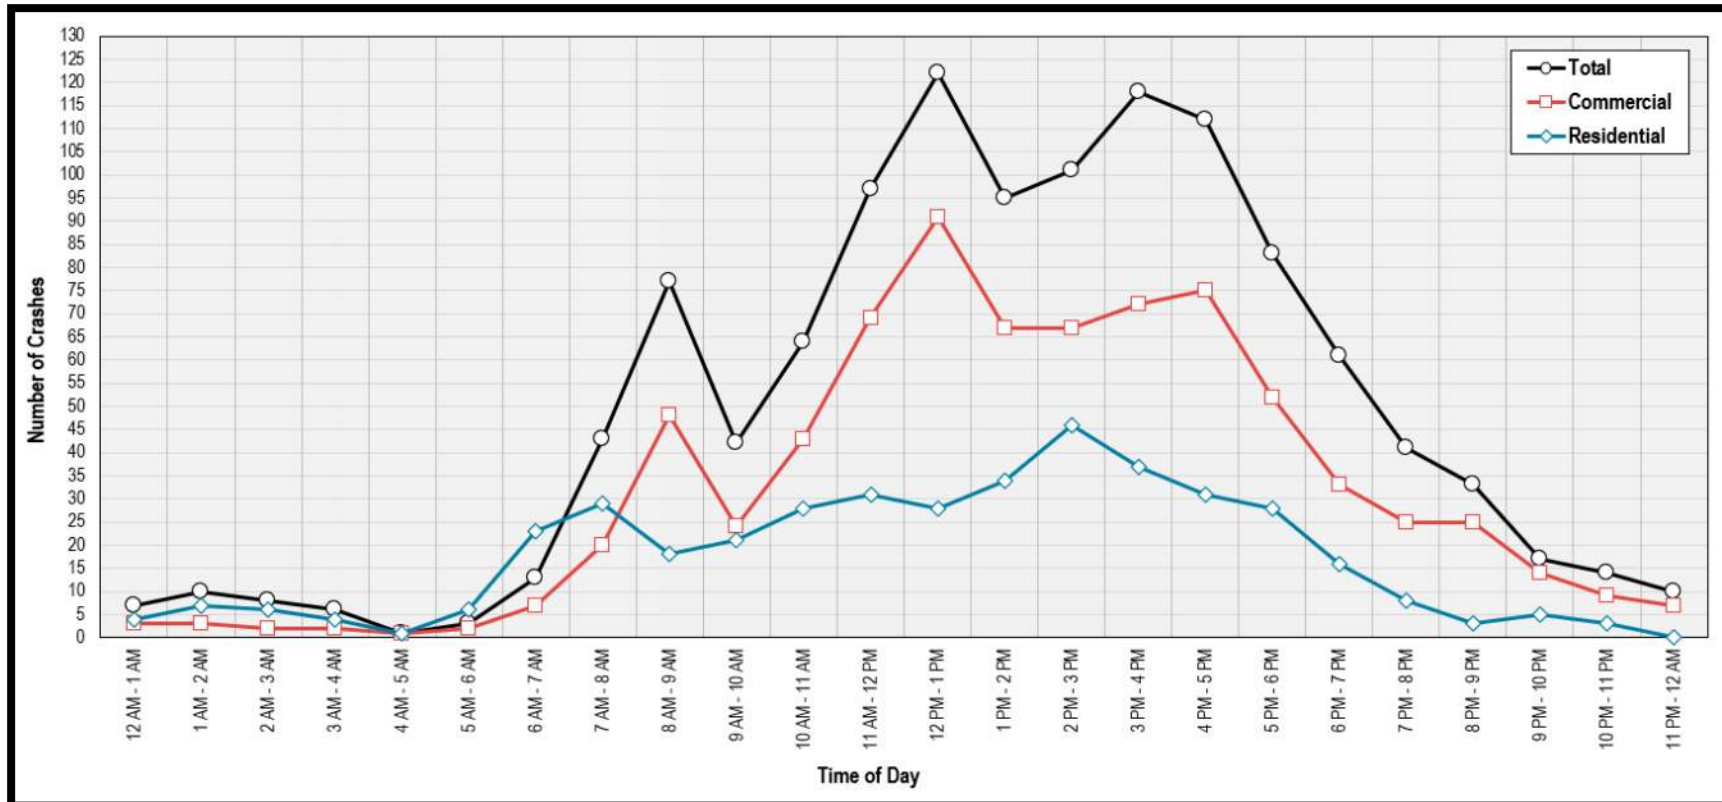
Figure 12 - Crashes by Time of Day (2016-2020)

Figure 12 below shows crash data by time of day and indicates a peak collision time period between Noon and 4PM which is counter to what is typically seen. Most often, as a result of an increase in traffic congestions, crashes will peak in the PM peak hour. One possible reason for this difference may be the type of roadway user groups who access Augusta Street in the AM and PM peak compared with the lunch and school release hour. There are many curb cuts along the corridor and these access points are more likely to be utilized by lunch and school release traffic than commuter traffic in the afternoon, who are more likely to pass through the corridor without entering or exiting the roadway.

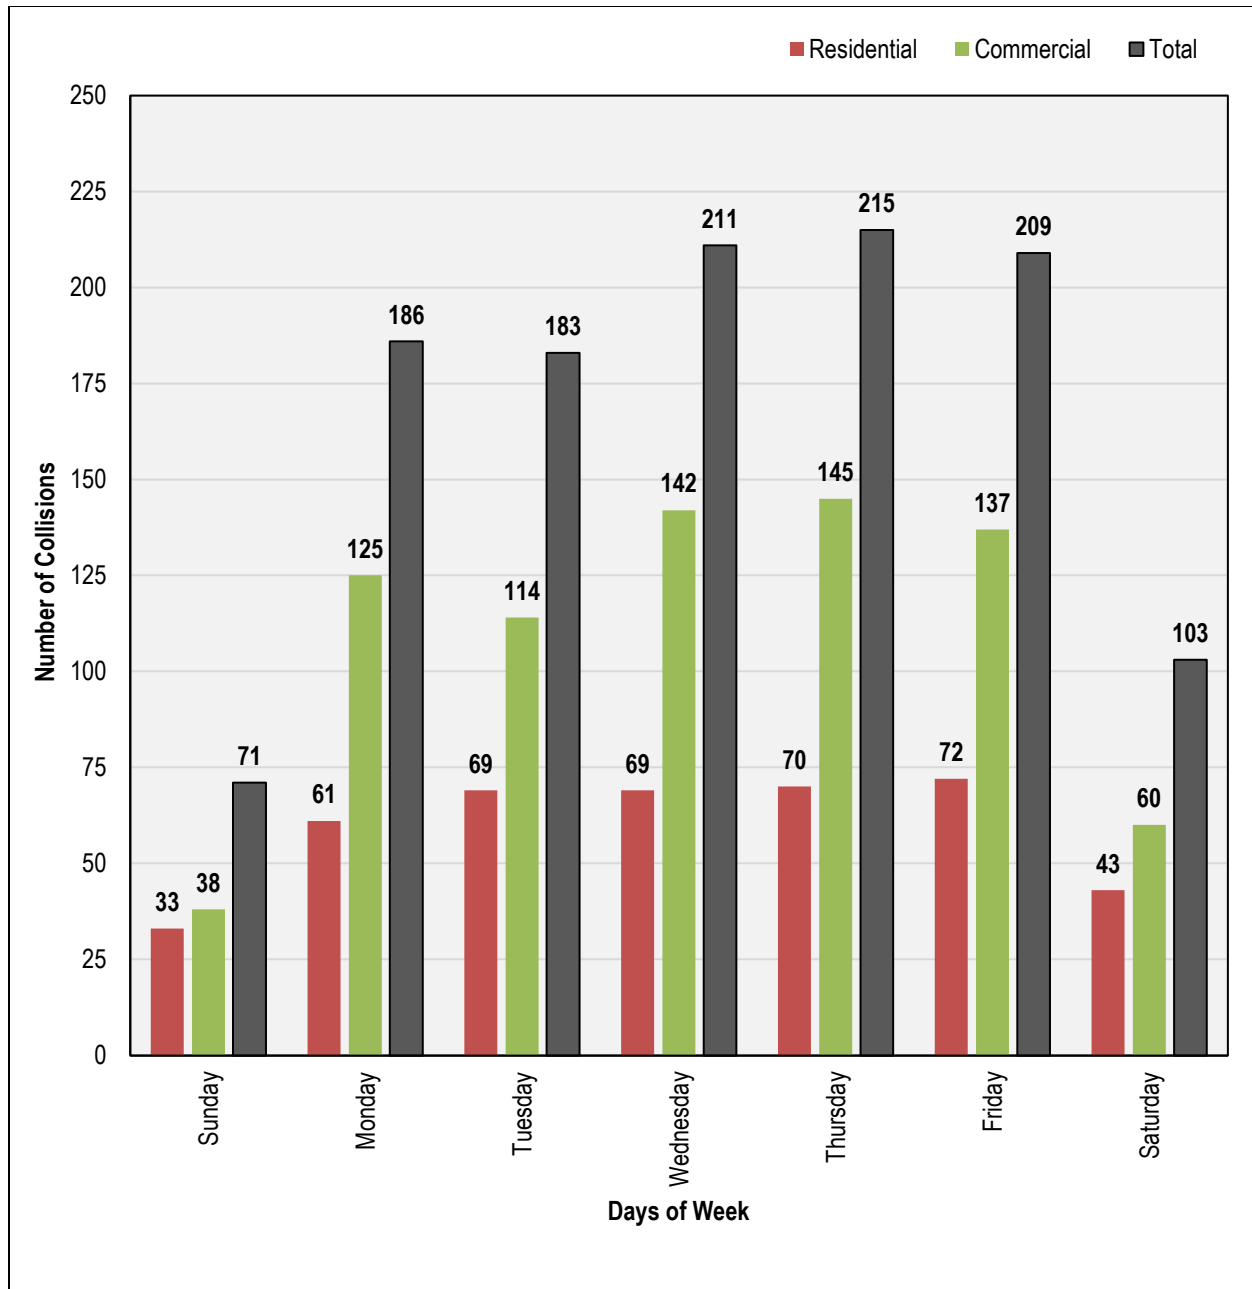
Figure 13 - Crashes by Day of the Week (2016-2020)

Figure 13 below shows crash data by day of the week indicates, as is typical, a majority of collisions occur during the weekdays. While most roadways experience fewer collisions on the weekend, the drop of 50% for the weekend compared with the weekday peaks is larger than what is typically experienced. This large drop in collision may indicate that the Augusta Street corridor has a greater share of commuter traffic than other roadways with similar characteristics.

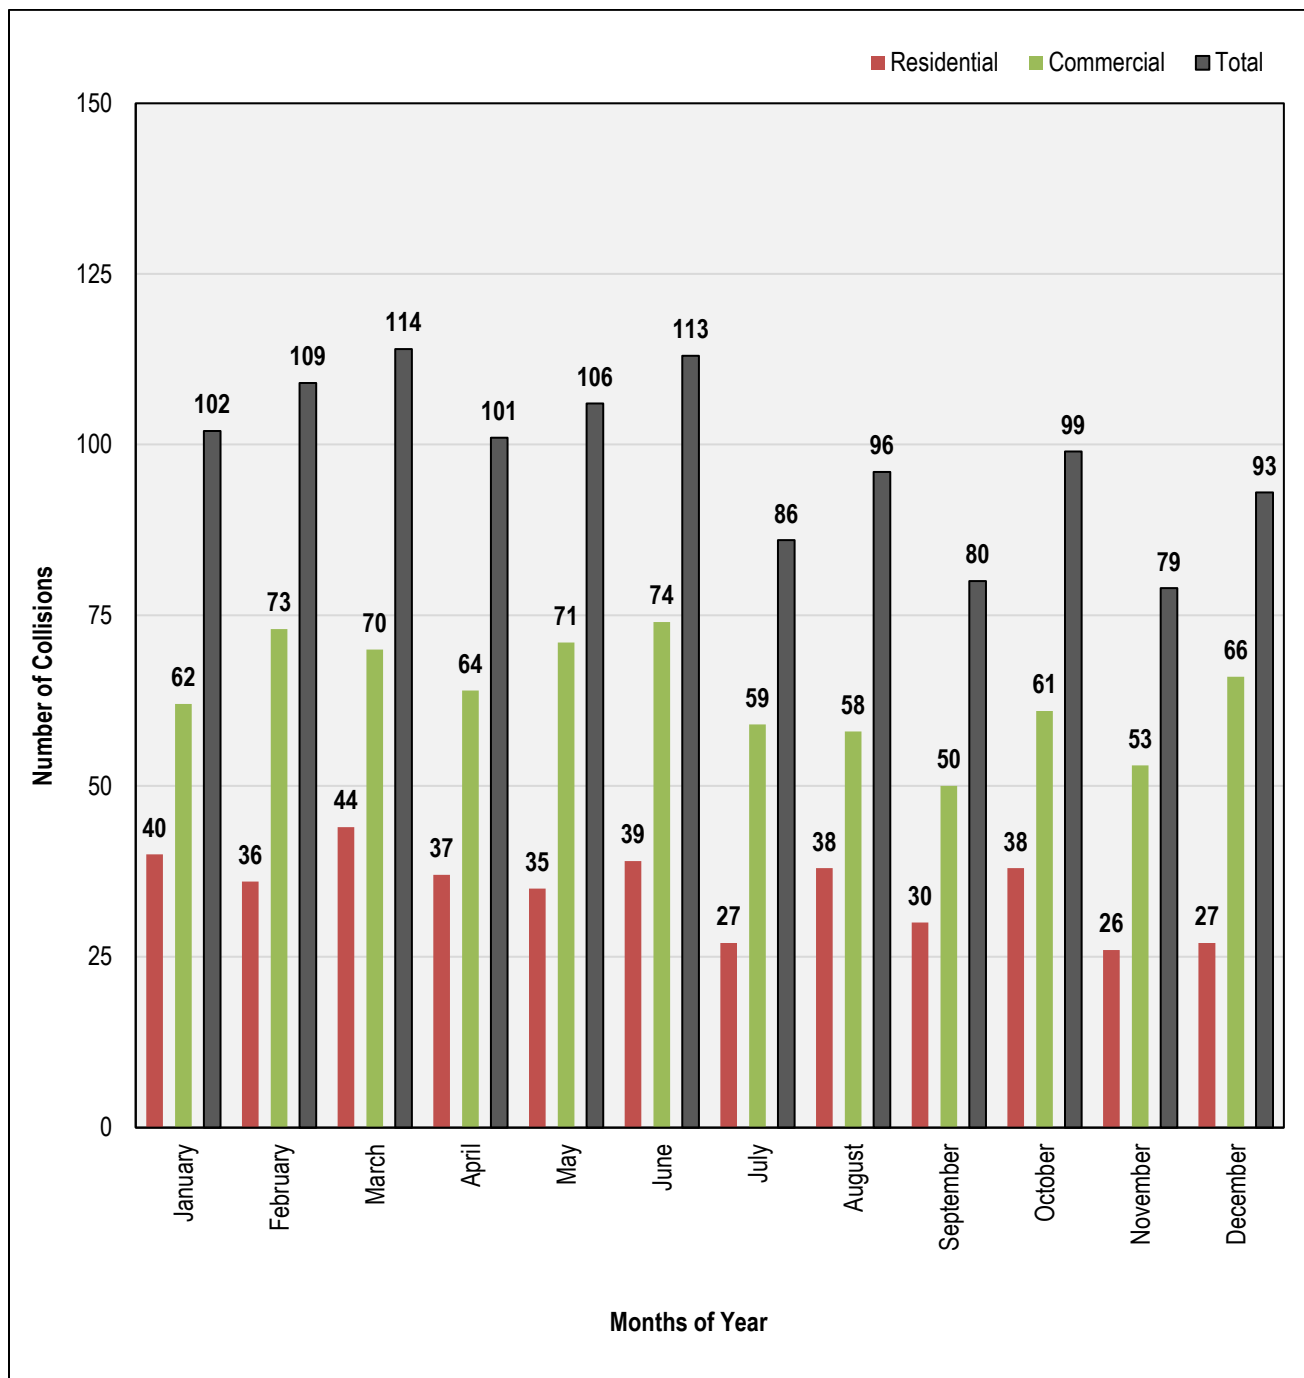
Figure 14 - Crashes by Month of Year (2016-2020)

Figure 14 below illustrates crash data by months of the year and indicates that the fewest collisions occur in the fall of each year. This is counter to typical crash patterns experienced on roadways similar characteristics to Augusta Street.

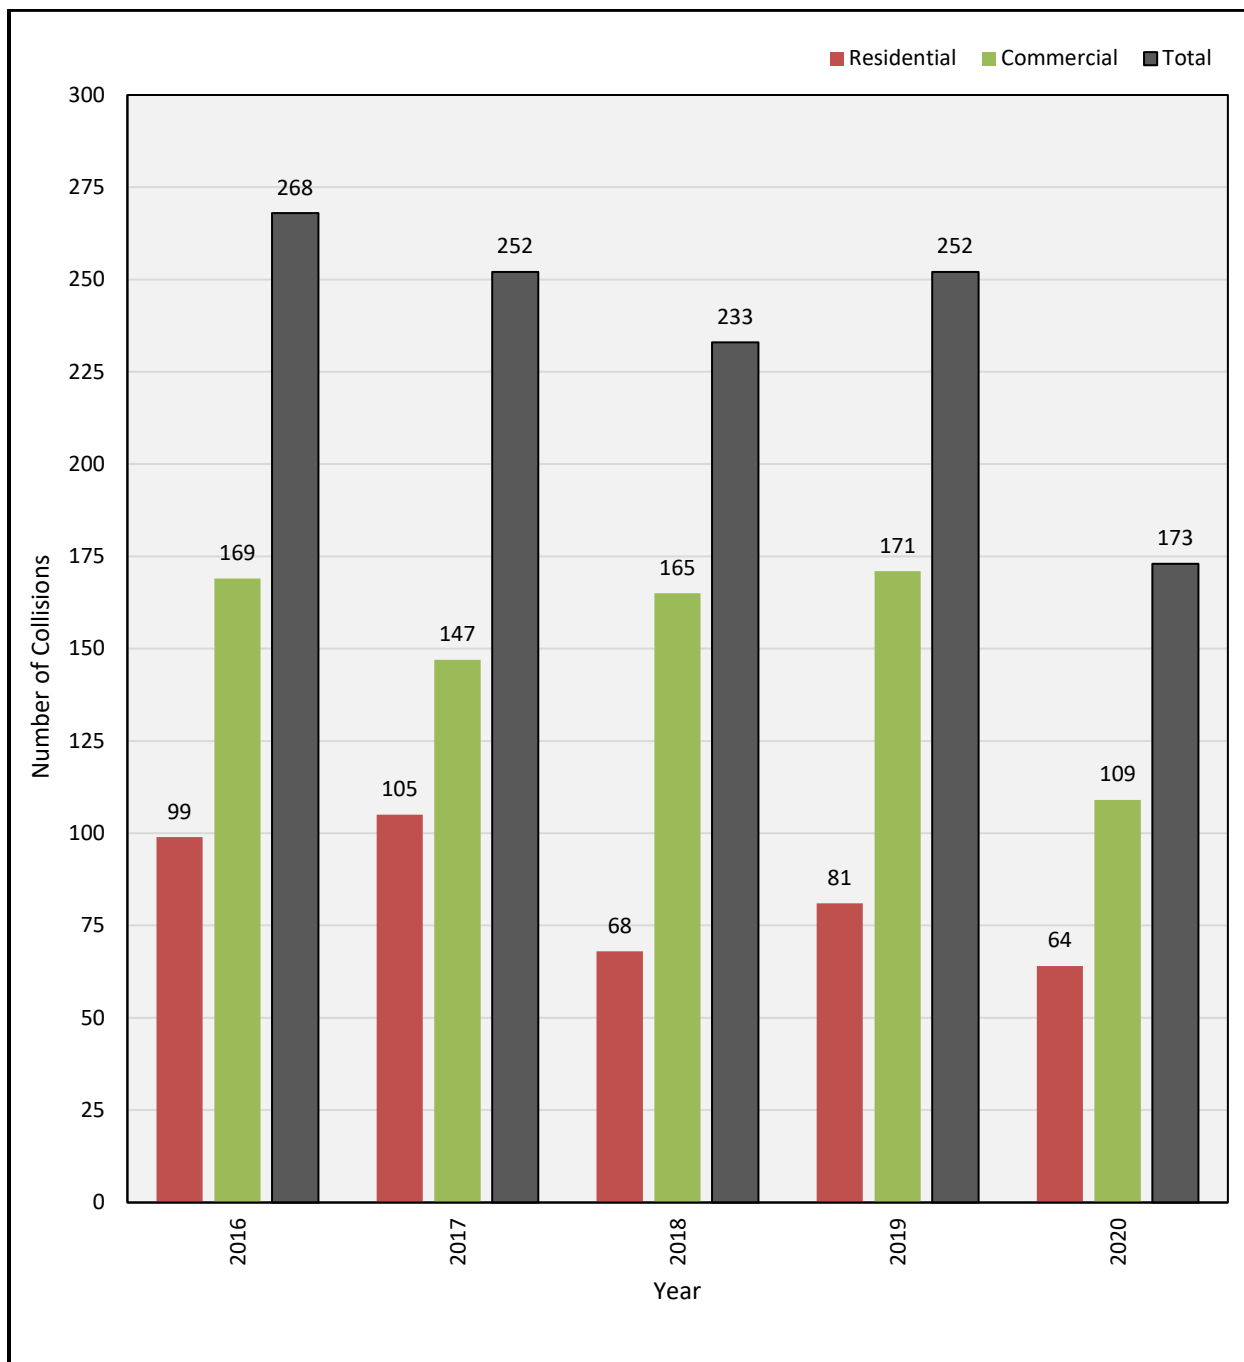
Figure 15 - Crashes by Year (2016-2020)

As shown in **Figure 15** below, the crash data from the last five years do not vary more than 15%, with the one exception of 2020. It is assumed that 2020 experienced significantly fewer crashes as a result of the COVID-19 pandemic.

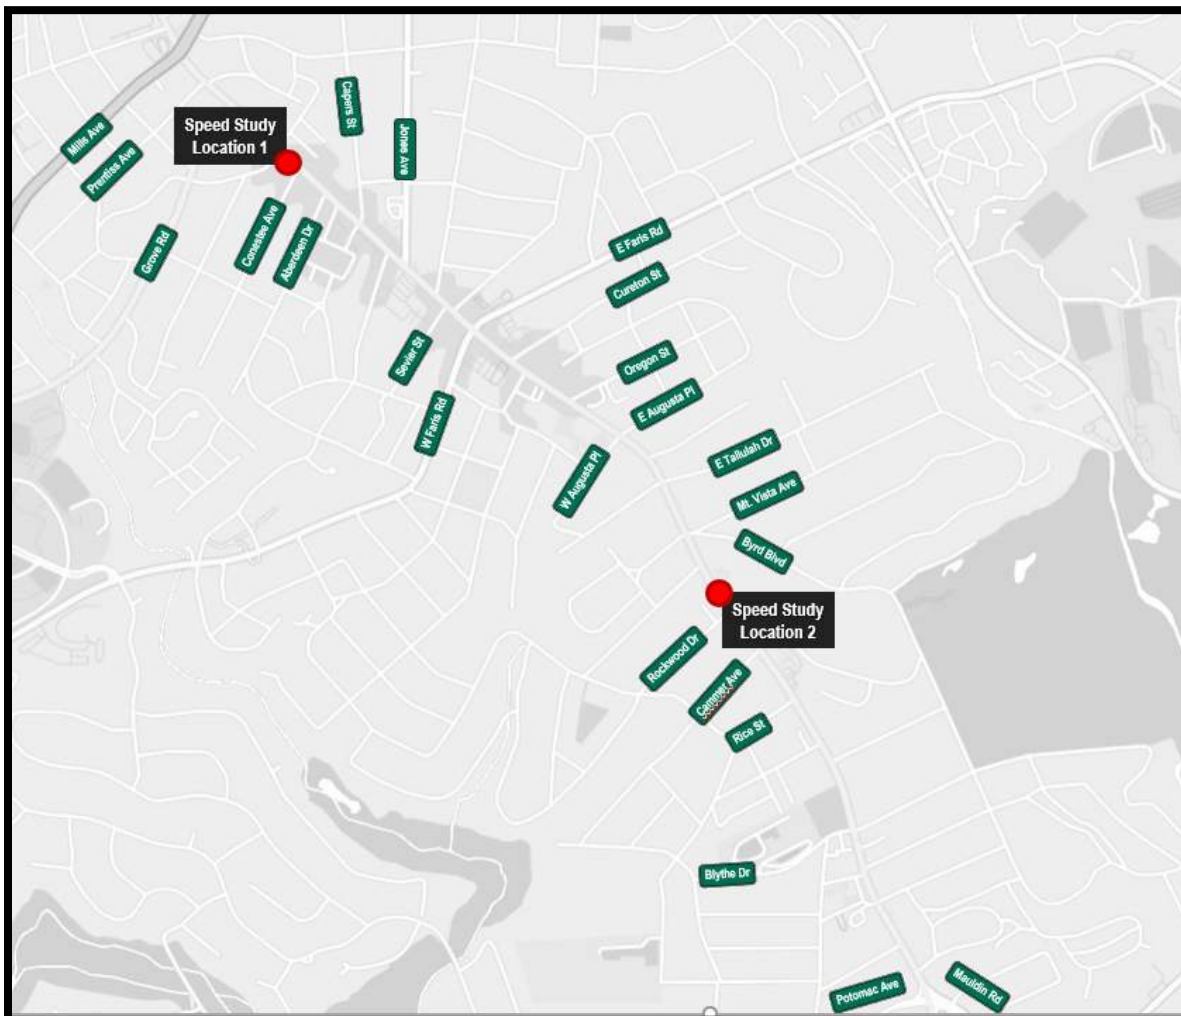
Figure 18 - Augusta Street Speed Study Locations

A speed study was conducted at two locations along the project corridor. As shown in **Figure 18** below, Location #1 readings were taken on Augusta Street between Cateechee Avenue and Conestee Avenue. Location #2 readings were taken between Rockwood Drive and Phillips Lane. The speed limits varied from 30 MPH at Location 1 (commercial area) to 35 MPH at Location 2 (residential area). Results of the speed study are shown in **Table 1** below.

Results of the speed study indicate that, while the commercial sector of the corridor has a lower speed limit of 30 mph, average speeds and 85th percentile speeds are essentially unchanged when compared with the residential sector. The 85th percentile speed is a metric often used to determine the appropriate driving speed and/or speed limit and is defined as speed at or below which 85 percent of all vehicles are observed to travel under free-flowing conditions at a particular point. The result of the speed study indicates that, although the roadway cross-section differs through the corridor, travel speeds do not significantly vary between sectors.

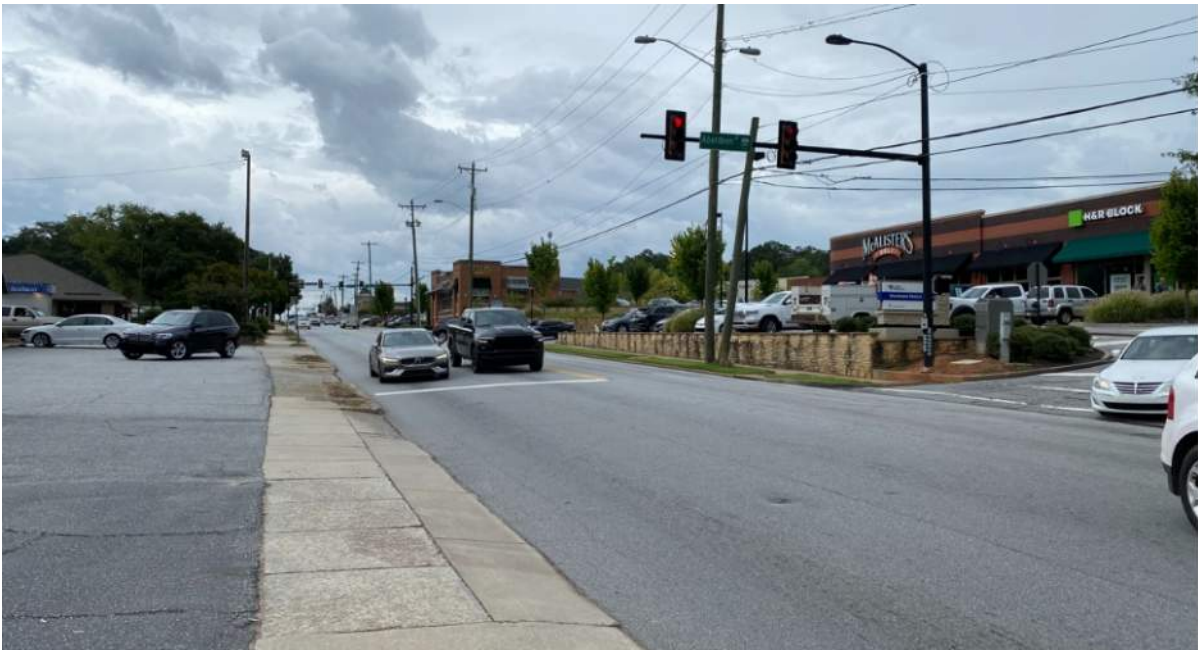
Augusta Street Commercial Section

From 2016 – 2020, Augusta Street experienced 401 right angle and 198 sideswipe crashes. Many of these collisions are related to ingress and egress of the numerous driveways located throughout the corridor. In fact, many commercial parcels have more than one access point, with several locations having a curb cut present along the entire property. Because of the abundance of driveways along the corridor, there is increased opportunity for conflict between entering and exiting vehicles.

For the commercial section consider locations where a TWLTL or median could be instituted to reduce potential conflicts caused by multiple access points and allow for the development of a dedicated left turn lane. These scenarios should undergo a capacity analysis to gauge the overall impacts to traffic patterns.

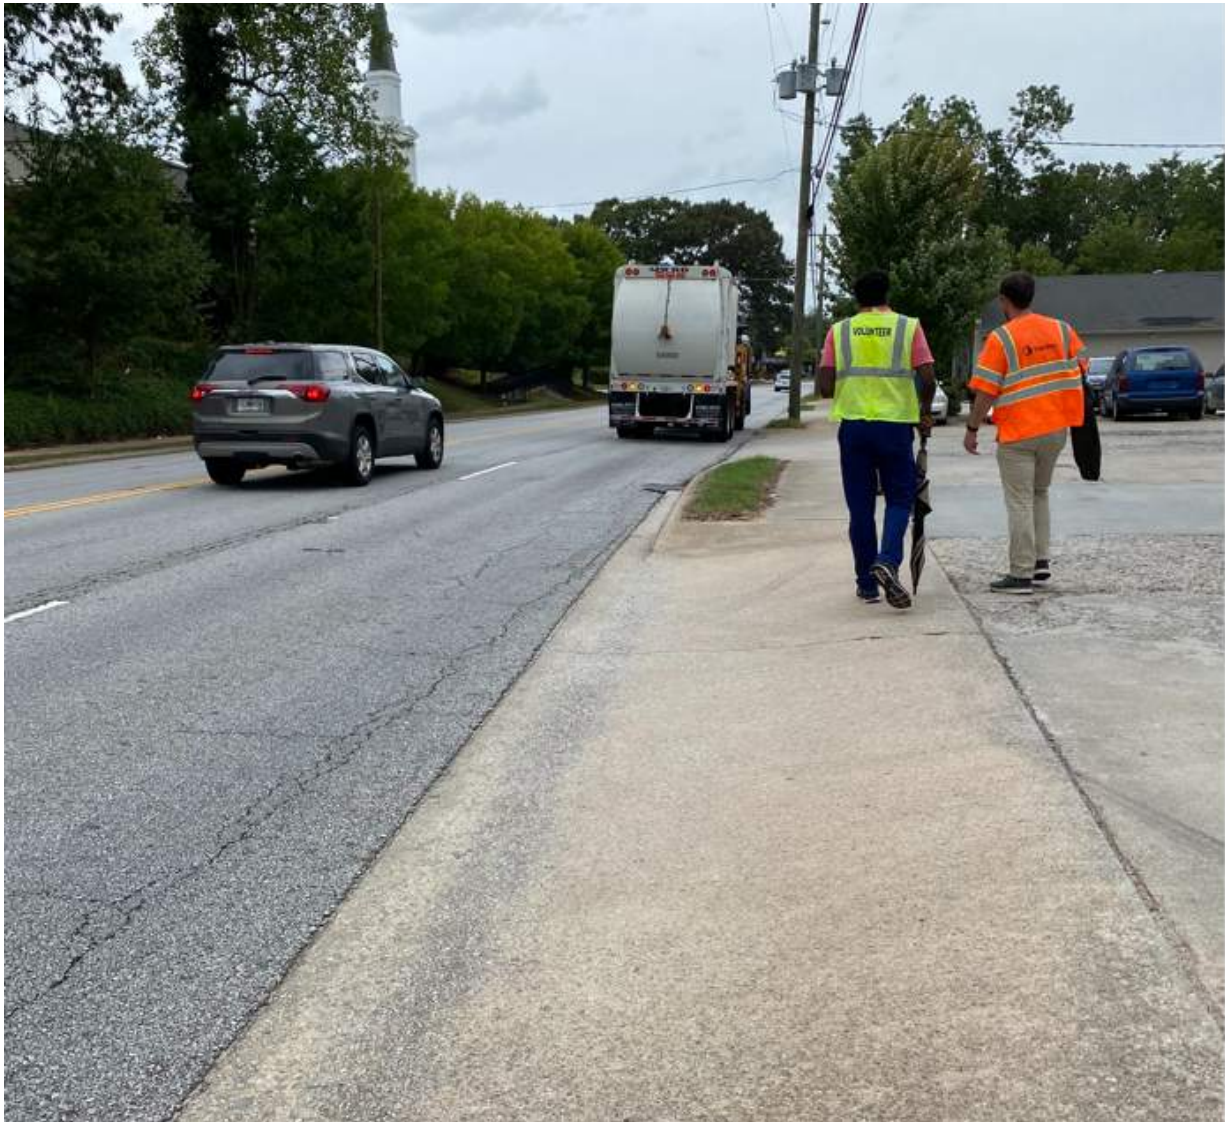
The issue of access management is currently being mitigated by the City of Greenville Planning and Zoning process as multiple, unnecessary access points are no longer allowed after a property undergoes redevelopment. While this process is likely to continue promoting access management along the corridor, it should be considered a passive solution as it does not apply to a parcel unless it is undergoing redevelopment.

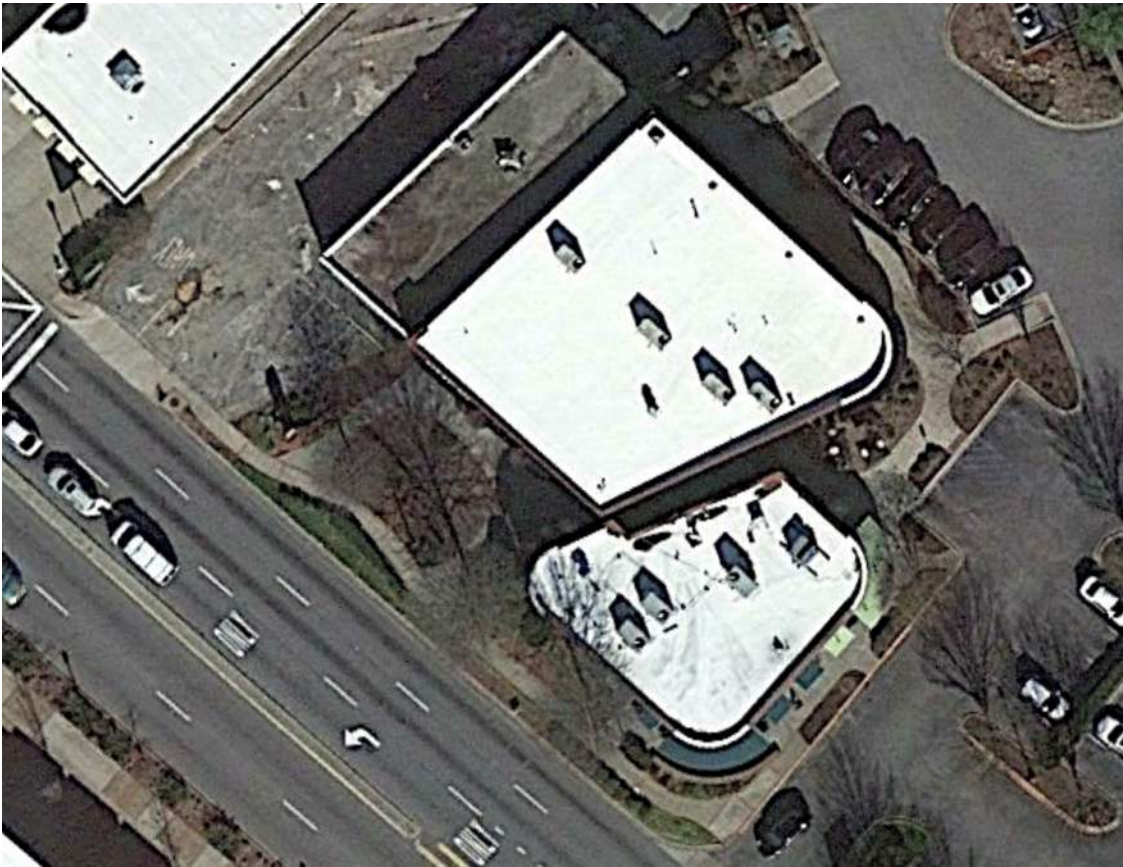
Redeveloped Parcel

Augusta Street has active pedestrian traffic and sidewalk present along both sides of the street for the entirety of the corridor. Along the residential section, a 2–3-foot grass buffer is present, giving some additional lateral offset to the travel lane. Due to the conversion of the gutter pan into the standard roadway surface, vehicular traffic is generally less than 5 feet from pedestrian facility, which may cause unease with some pedestrians. Each of the 12 signalized intersections contain at least one marked crosswalk to cross Augusta Street. Riverside Drive/Old Augusta Road currently utilizes a Leading Pedestrian Interval (LPI) for pedestrian walk movement as intersection experiences high pedestrian volumes during school hours. As part of the City of Greenville's planning and zoning process, all newly re-developed parcels contain improvement lateral offset and sidewalks.

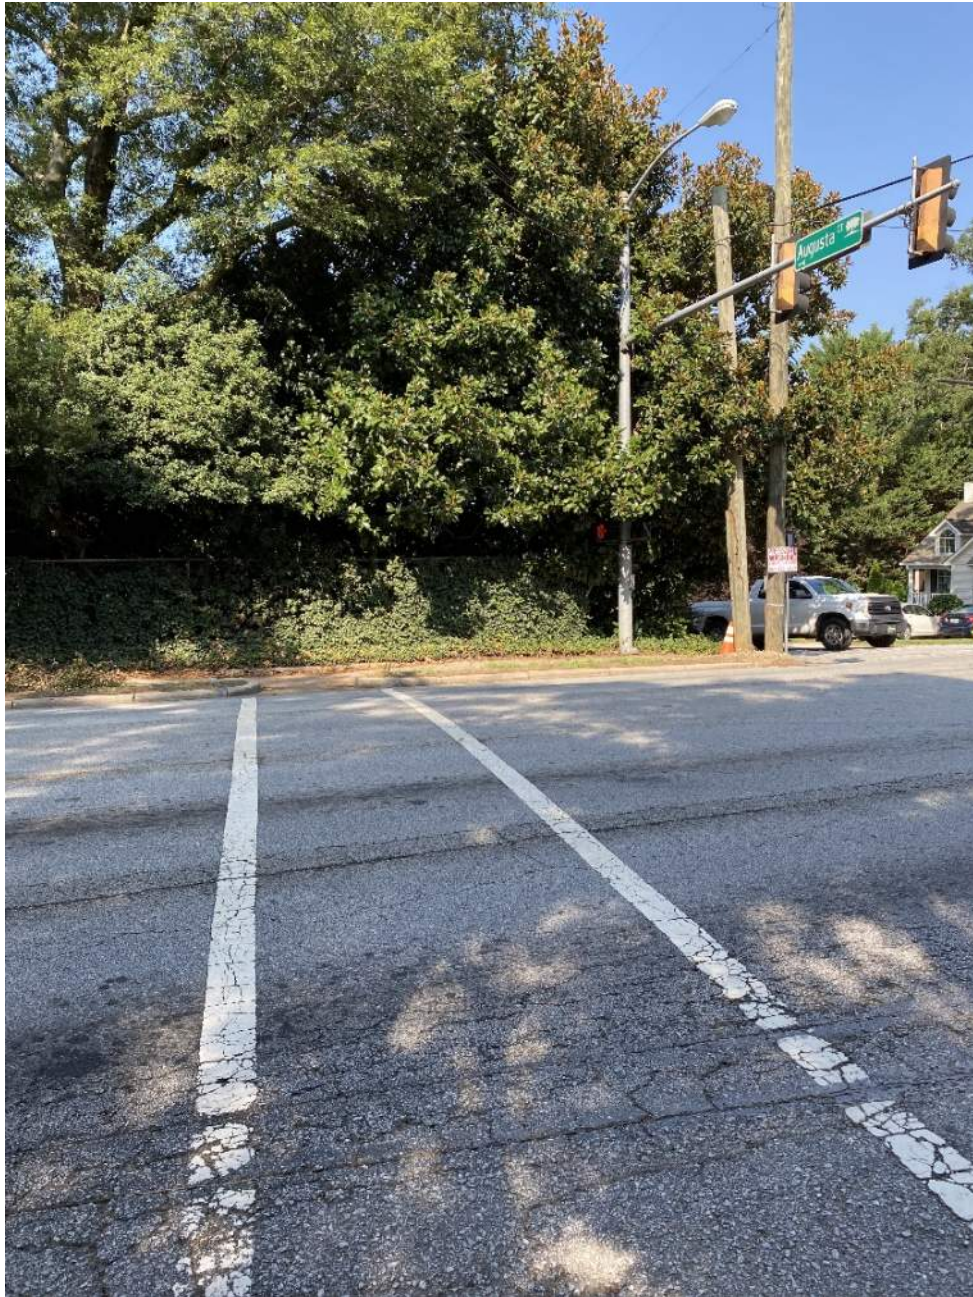
Signalized Crosswalk at Augusta Court

- During field review, it was noted that some pedestrian crossings seem to have inadequate flashing don't walk (FDW) times. It is recommended to review Pedestrian Clearance Interval for all pedestrian crossings to ensure enough crossing time when walking 3.5 ft/second.
- To enhance pedestrian safety, consider implementing Leading Pedestrian Intervals (LPIs) for the signalized pedestrian crossings. LPIs give pedestrians the opportunity to enter a signalized intersection 3–7 seconds before vehicles are given green indications. With this head start, pedestrians can better establish their presence in the crosswalk before vehicles begin entering the intersection. A traffic analysis study is needed to verify LPIs will not materially affect congestion and delays.

- While all crossings have a dedicated pedestrian signal head, many only have one pedestrian button on each corner and it is unclear as to which pedestrian movement the button will call. Additionally, some pedestrian pedestals do not meet MUTCD or ADA standards for placement. Consider updating locations of pedestrian signal pedestals to have a lateral offset from the marked crosswalk of no more than 10' to ensure ADA compliance.
- Consider updating pedestrian signal heads, push buttons and signs to newest standards recommended by MUTCD and SCDOT.
