SC 20/S-201 Augusta Street

Road Safety Audit

Greenville, South Carolina

Stantec Consulting Services Inc.

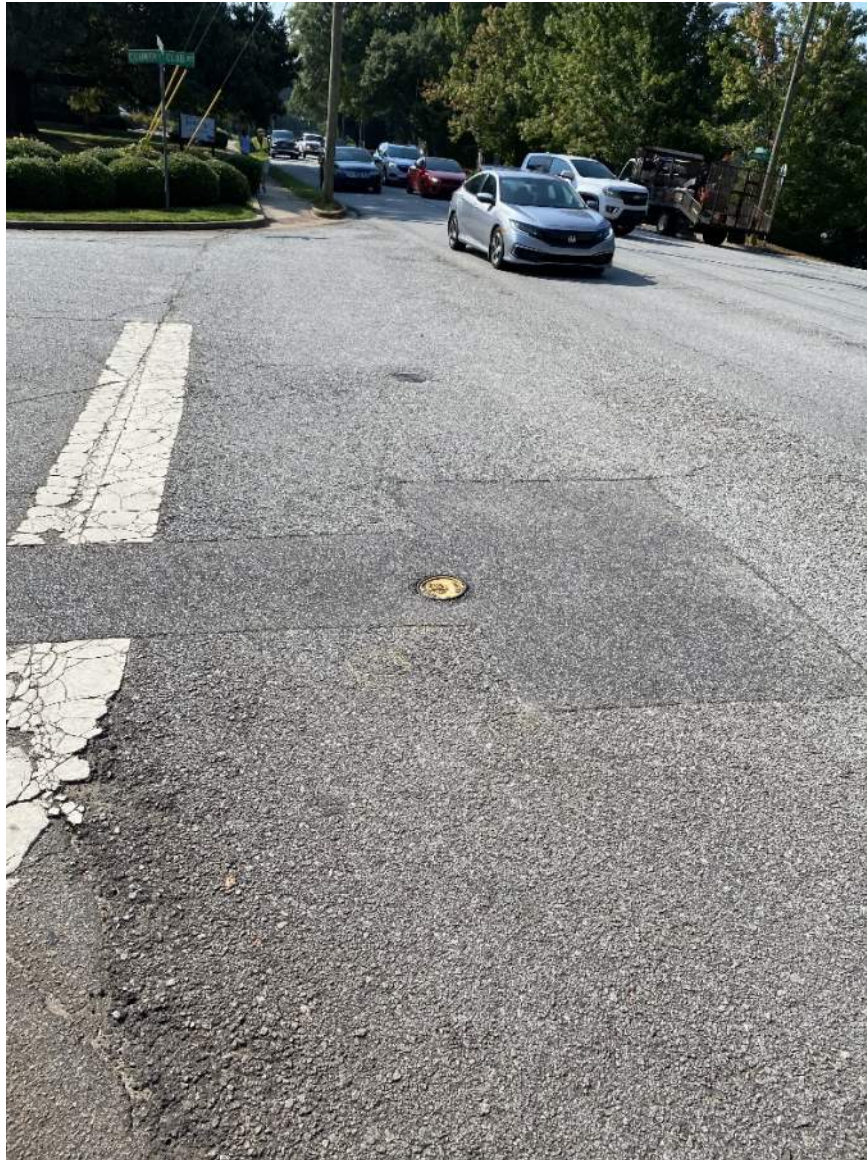
Crosswalk markings are missing for side street crosswalks in the residential section of the Augusta Street Corridor.

Missing crosswalk at County Club Drive.

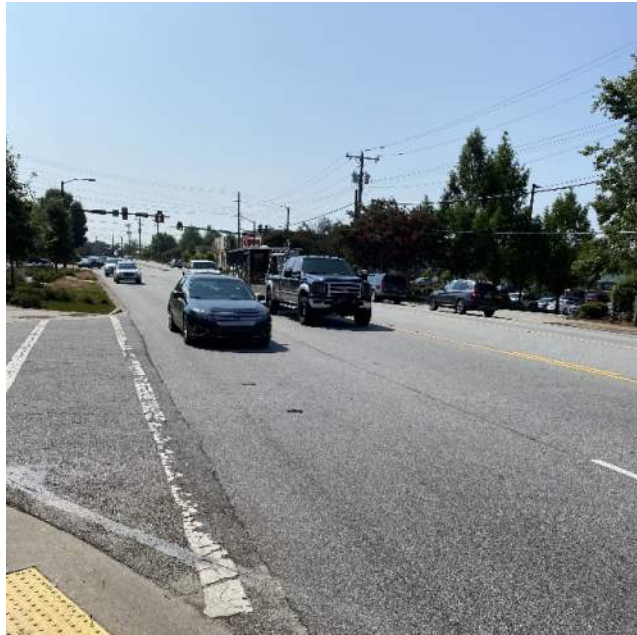
Pavement markings and raised pavement markers (RPM) in several sections are worn out.

Existing pavement markings worn out

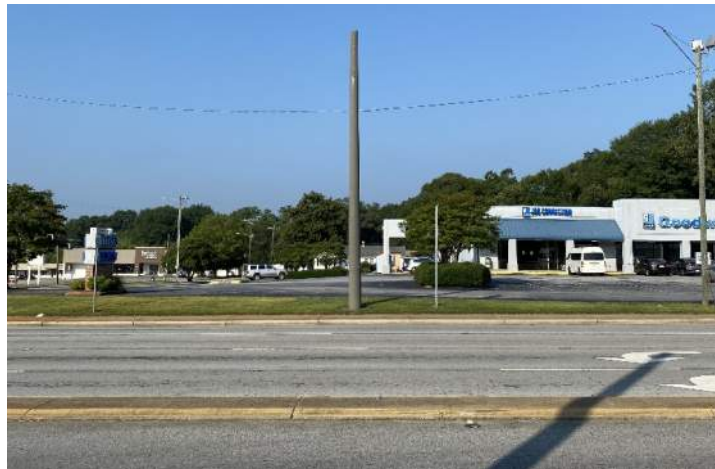
At several locations there are wood or concrete poles erected which may no longer serve a purpose.

Obsolete Concrete Pole

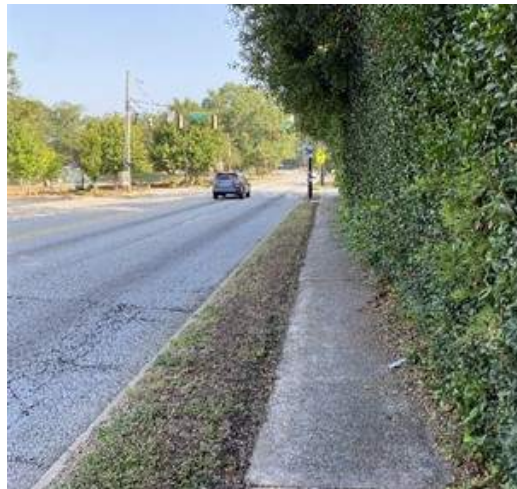
Sections of the sidewalk have sediment buildup and overgrown vegetation.

Overgrown Vegetation near Blythe Drive

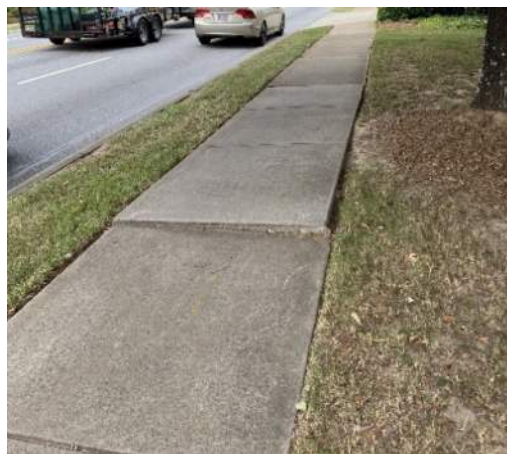
At several locations, sidewalks have experienced heave, either due to the root systems of an adjacent tree, drainage issues, or other environmental causes.

Uneven Concrete Sidewalk

Recommend completing a field review of sidewalks along the Augusta Street corridor to determine portions of sidewalks that may be out of compliance.

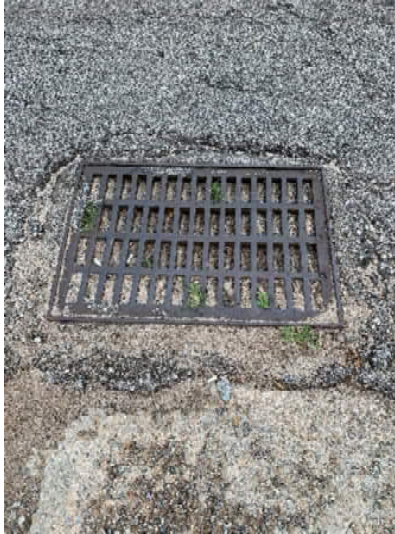
During heavy rains, it was observed that the roadway drainage infrastructure quickly became overwhelmed and standing water was present along much of the corridor.

Catch Basin Blocked with Silt

Recommend all inlets and drainage basins be evaluated to determine existing obstructions and deficiencies with storm sewer system. Vacuuming of silt and removal of blockages should improve conditions in the short term. An increase of water runoff has likely occurred over the past several decades due to commercial growth and increase of impervious surfaces. Consider reviewing existing capacity of storm water infrastructure to determine if additional drainage structures should be placed along the corridor.

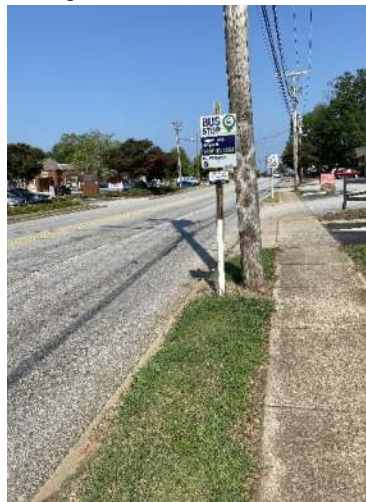
Transit stops are present and used but no pedestrian or bicycle accommodations currently exist. Transit vehicles must stop in traffic to load and unload passengers.

Bus stop without accommodations

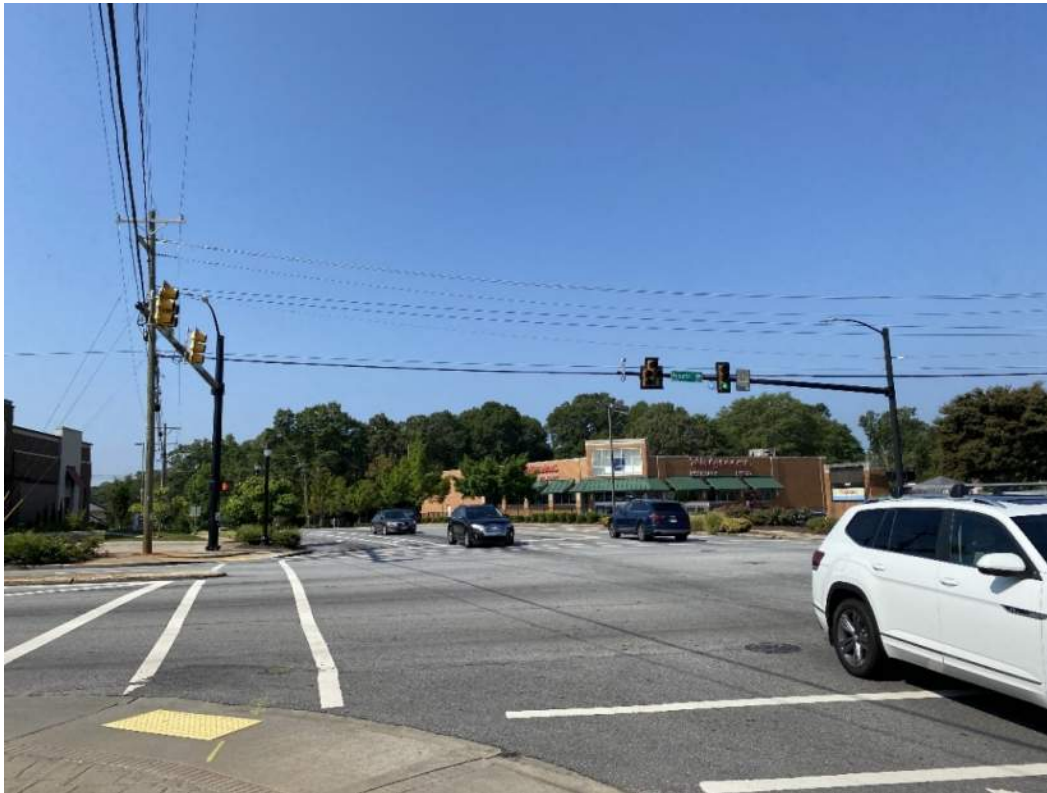
All signalized intersections contain signal heads with backplates, but they have not been outfitted with the reflectorized strips.

Existing Faris Road signal heads without retroreflective backplates.

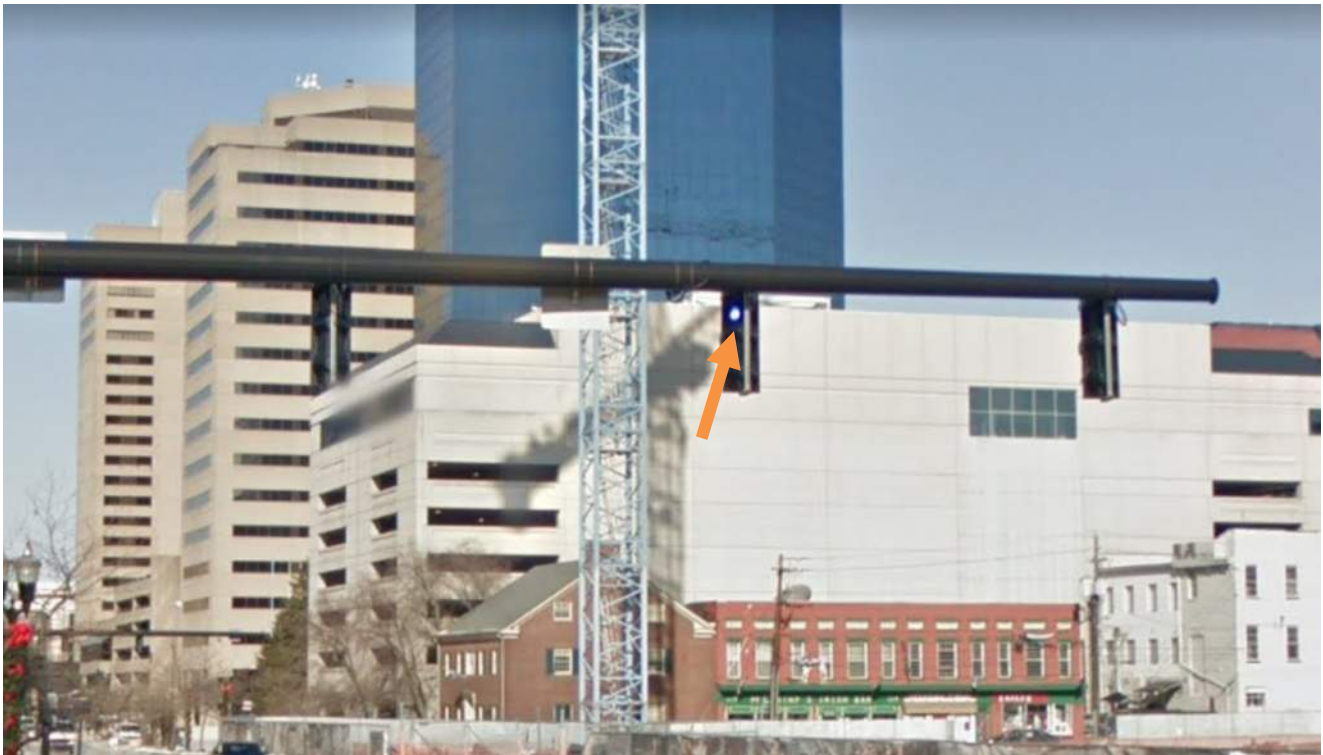
Red light running accounts for roughly 8% of all collisions at signalized intersections on the Augusta Street corridor. Identifying red light running offenders can sometimes be difficult as officers must physically see both the signal indication change to red, and the vehicle disobey the indication.

Red-light Indicator Light (RLIL)

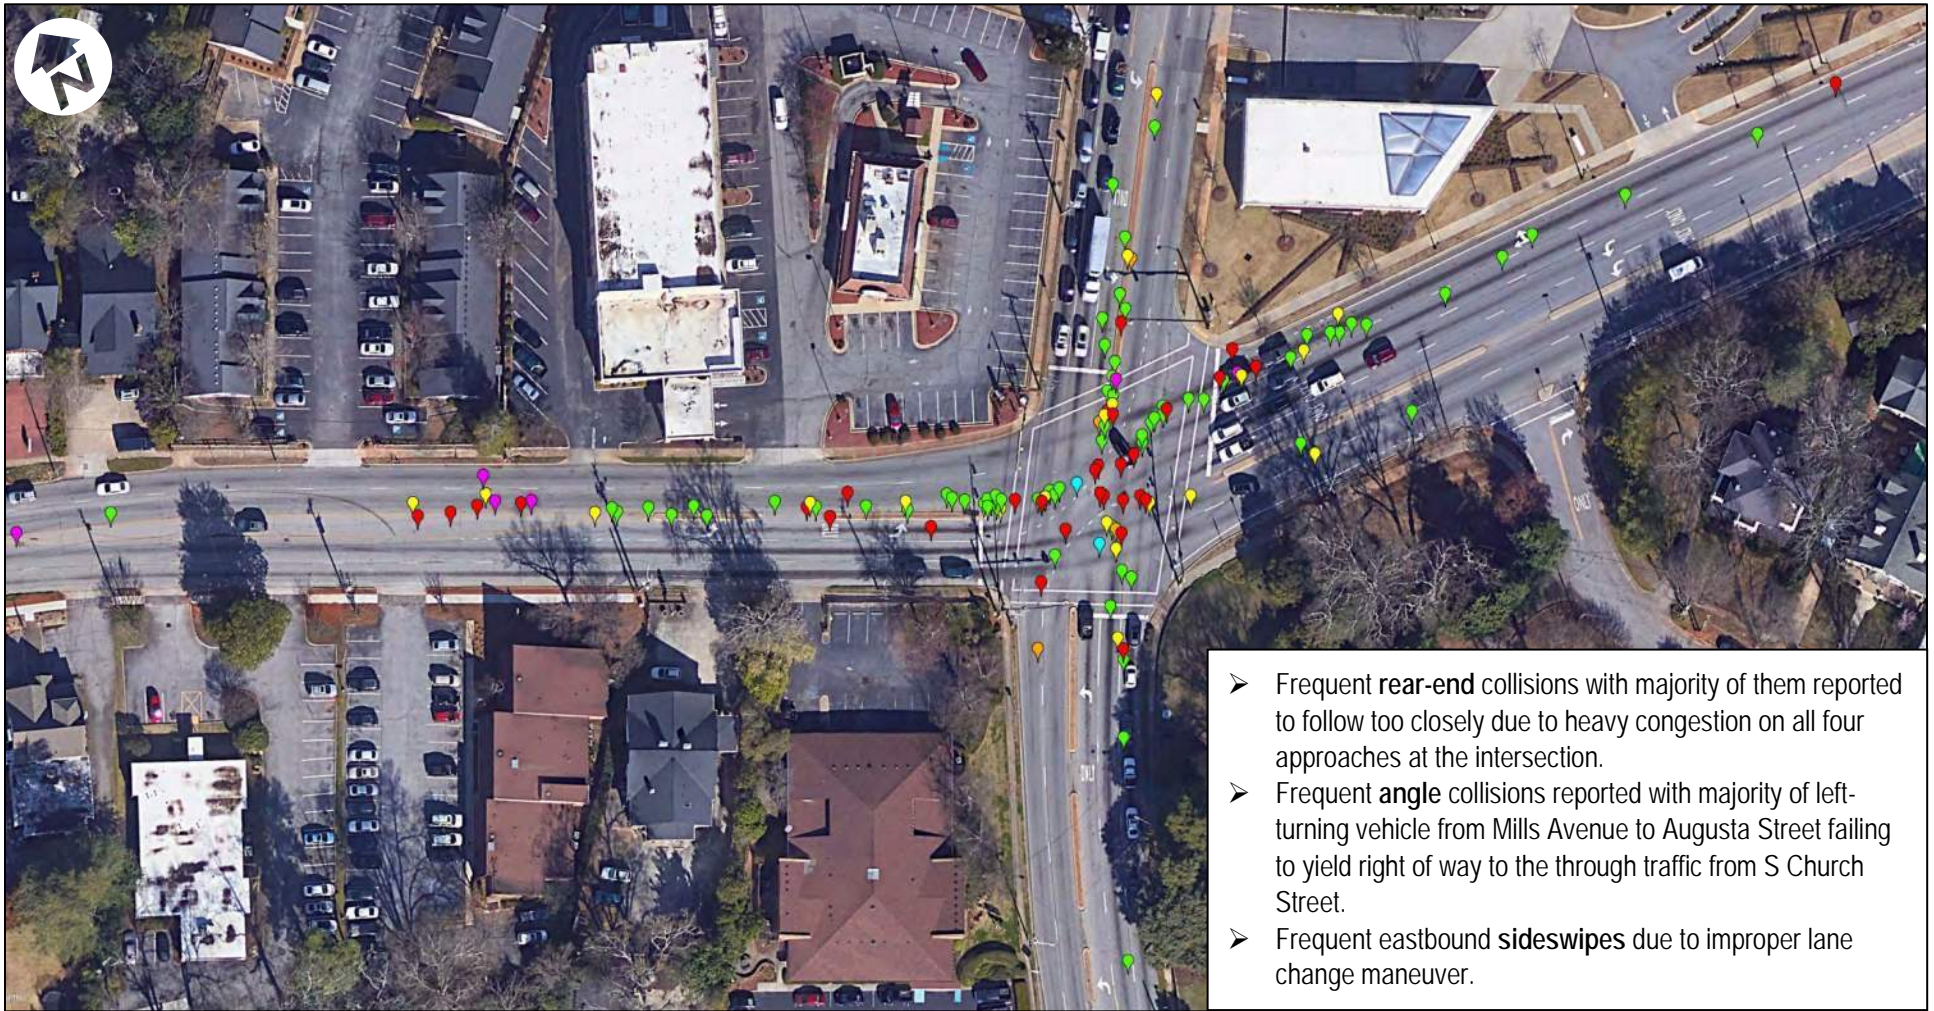
INTERSECTION CRASH EXHIBITS: Mills Avenue/S. Church Street

- Frequent rear-end collisions with majority of them reported to follow too closely due to heavy congestion on all four approaches at the intersection.
- Frequent angle collisions reported with majority of left-turning vehicle from Mills Avenue to Augusta Street failing to yield right of way to the through traffic from S Church Street.
- Frequent eastbound sideswipes due to improper lane change maneuver.

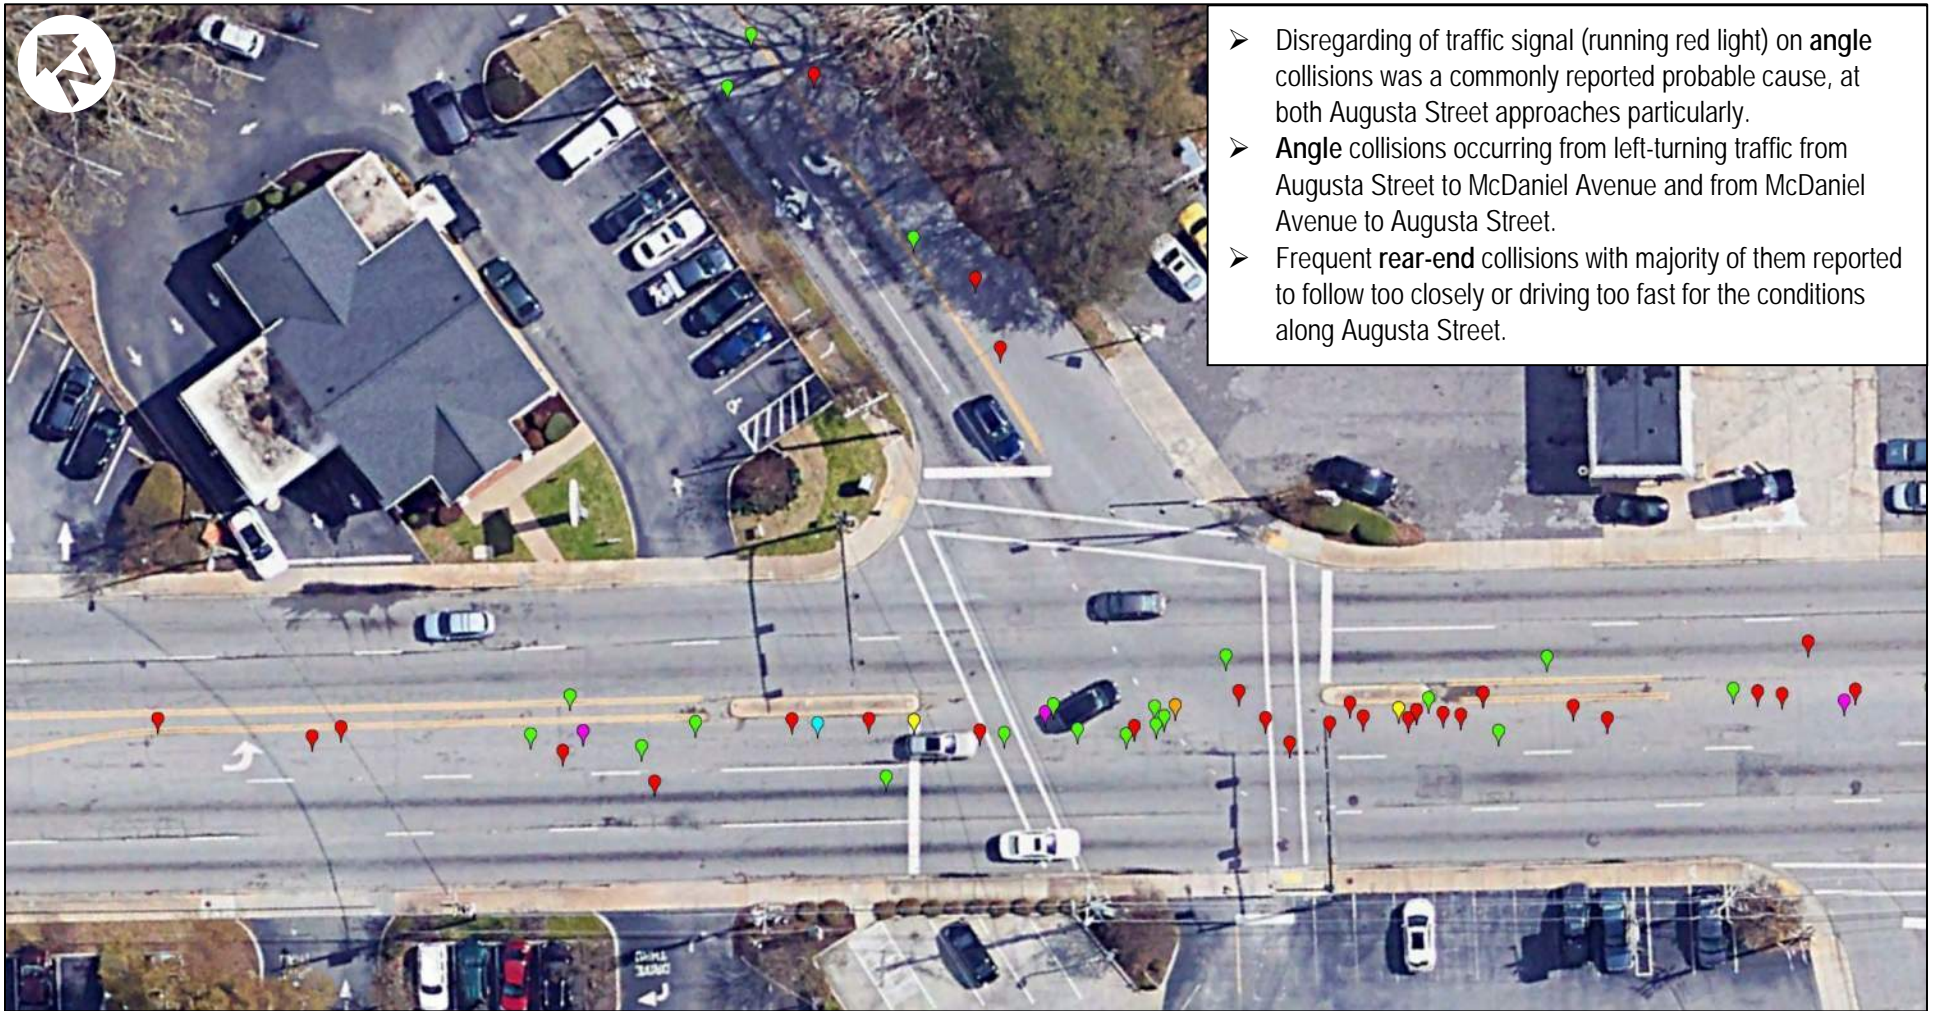
INTERSECTION CRASH EXHIBITS: McDaniel Avenue

- Disregarding of traffic signal (running red light) on **angle** collisions was a commonly reported probable cause, at both Augusta Street approaches particularly.
- **Angle** collisions occurring from left-turning traffic from Augusta Street to McDaniel Avenue and from McDaniel Avenue to Augusta Street.
- Frequent **rear-end** collisions with majority of them reported to follow too closely or driving too fast for the conditions along Augusta Street.

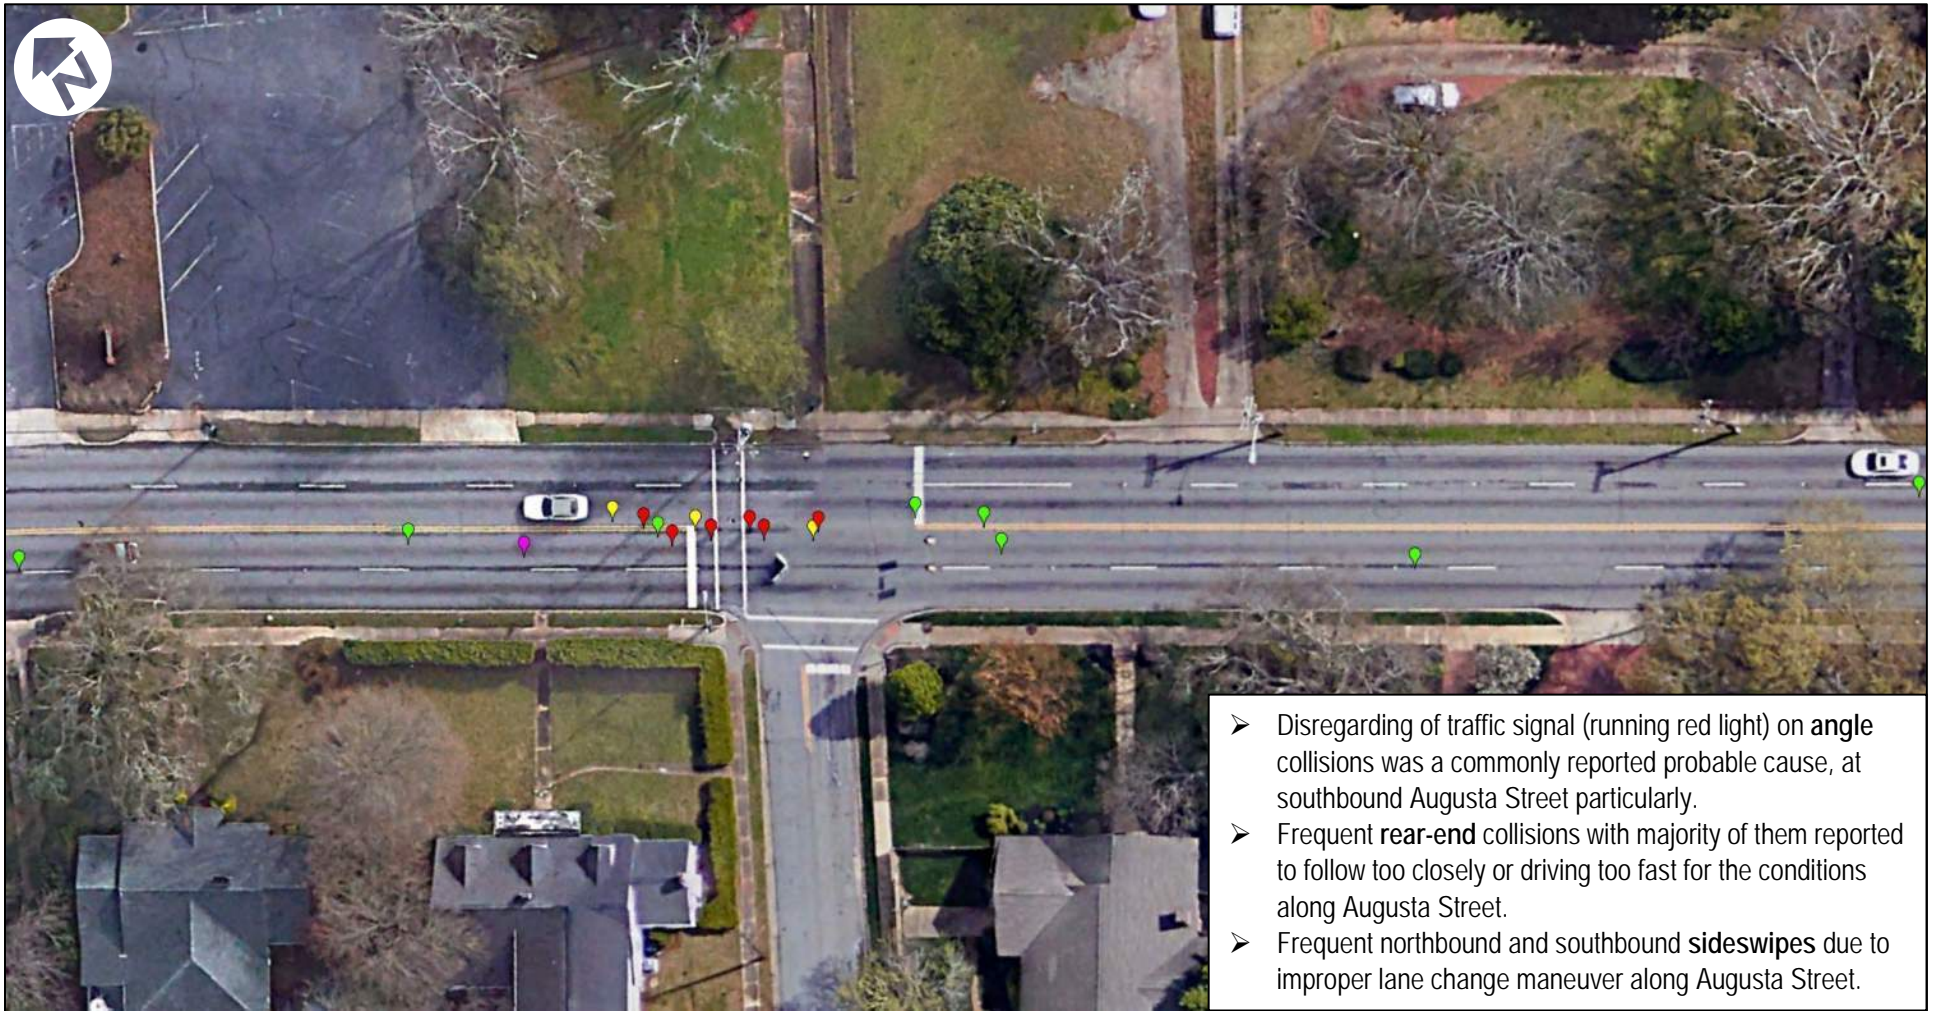
INTERSECTION CRASH EXHIBITS: Rice Street

- Disregarding of traffic signal (running red light) on **angle** collisions was a commonly reported probable cause, at southbound Augusta Street particularly.
- Frequent **rear-end** collisions with majority of them reported to follow too closely or driving too fast for the conditions along Augusta Street.
- Frequent northbound and southbound **sideswipes** due to improper lane change maneuver along Augusta Street.
