Road Safety Assessment Greenville County, South Carolina SC 146 (Woodruff Rd) from MP 1.9 to 5.0

August 2017 AECOM Technical Services, Inc. 10 Patewood Drive, Building VI, Suite 500, Greenville, SC 29615

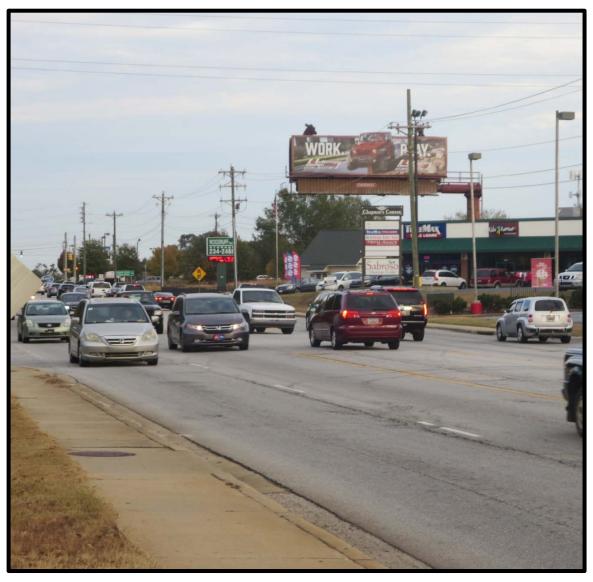
Figure 1 - General Cross Section of SC 146 (Woodruff Rd)

SC 146 (Woodruff Road) is located in Greenville County, South Carolina. It is a 5-lane minor arterial that provides access to many commercial sites, residential developments, and provides access to two major interstates (I-85 and I-385). The portion of SC 146 that is being analyzed runs from mile post (MP) 1.9 to MP 5.0 or from just west of S-183 (Roper Mountain Road) / Verdae Boulevard to Paddock Club Drive. According to data provided by SCDOT, 2,325 crashes have been reported in this section of SC 146 from January 2010 to December 2014.

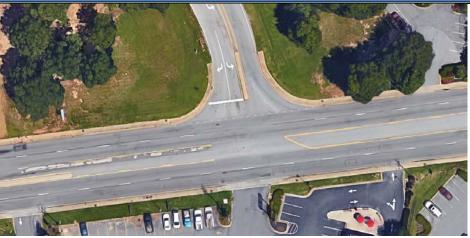
Implement a right-in / right-out turn on the Bagwell Rd approach of the intersection with SC 146 (Woodruff Rd).

Convert 3 access points to right- in/right-out access only.

Anticipated Cost: \$9,150

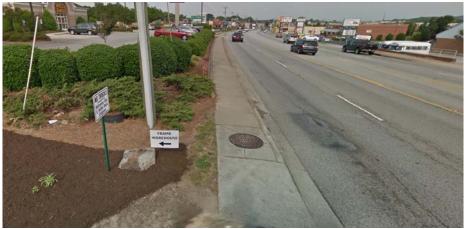
The brick wall along Woodruff Rd at the western driveway of Publix do not provide adequate sight distance for drivers turning onto Woodruff Rd.

- **Short Term** Clear the vegetation from the sidewalk / roadway so that any existing vegetation does not interfere with visibility for vehicles.
 - Anticipated Cost to Implement: \$5,000
- **Short Term** Install a sign prohibiting left-turns from Publix driveway.
 - Anticipated Cost to Implement: \$500
- Mid Term Extend the median 150 feet from the Children's Care Center to Aldi and create a R-cut configuation into the Aldi driveway. This will restrict left turn movements entering and exiting Aldi and Publix.
 - Anticipated Cost to Implement: \$40,000

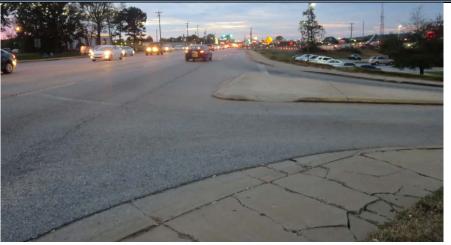
The intersection of SC 146 with the Sam's Entrance does not have ADA compliant ramps. The photograph also shows sidewalk damage.

Upgrade all ramps and pedestrian accommodations to be ADA compliant.

(30 ramps proposed in total, 25 SY per ramp)

Anticipated Cost: \$112,500

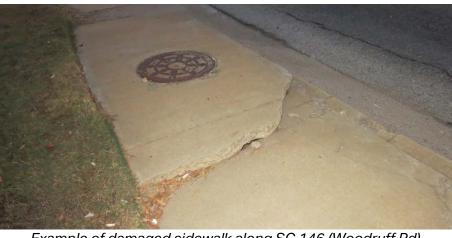
Example of damaged sidewalk along SC 146 (Woodruff Rd).

Additionally, there are some locations with damaged sidewalk that would be problematic for pedestrians. Assuming 400 LF of sidewalk to be replaced:

Anticipated Cost: \$13,000*

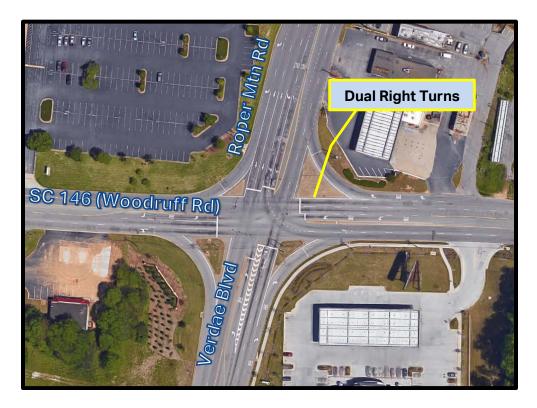
3.2.1 SC 146 & Roper Mountain Rd (S-153) / Verdae Blvd

- There is a high volume of westbound right turns at this intersection.
- Sight distance and rear-end collisions with the channelized right turns.
- ADA and pedestrian accommodations are not present at this intersection.

- Mid Term Remove channelization and Install dual right turn lanes on westbound Woodruff Rd.
 - > Anticipated Cost to Implement: \$100,000
- Mid Term Make intersection ADA compliant with ramps and sidewalks.
 - > Anticipated Cost to Implement: \$48,750
- Mid Term Install pedestrian accommodations (countdown pedestrian heads, crosswalks)
 - Anticipated Cost to Implement: \$10,000
- Long Term Bring all right turn lanes to stop bar and eliminate the yield condition.
 - > Anticipated Cost to Implement: \$150,000 for 3 approaches since WB approach is improved in previous consideration.

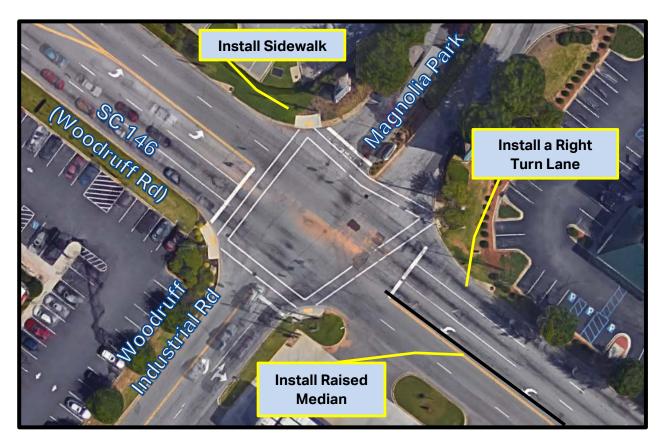
3.2.2 SC 146 & Woodruff Industrial Ln / Magnolia Park

- There is a concentration of full access driveways east and west of the intersection and there were 251 angle crashes in segment 3 during the study period.
- There appears to be a path in the grass indicating pedestrian traffic.
- There is westbound queuing into Magnolia Park with queuing extending back to I-85.

- Mid Term A raised median on SC 146 (Woodruff Rd) from I-85 to Woodruff Industrial being installed as part of a future City of Greenville Project.
 - ➤ Anticipated Cost to Implement: **To be implemented by SCDOT**
- Mid Term Install a sidewalk on north side of road from Verdae Blvd / Roper Mountain Rd (S-153) to I-85.
 - > Anticipated Cost to Implement: To be implemented by City of Greenville
- Long Term Install a right turn lane to accommodate the WB right turns into Magnolia Park.
 - Anticipated Cost to Implement:
 - \$85,000 for construction; \$200,000 cost obtain area required to construct a new lane

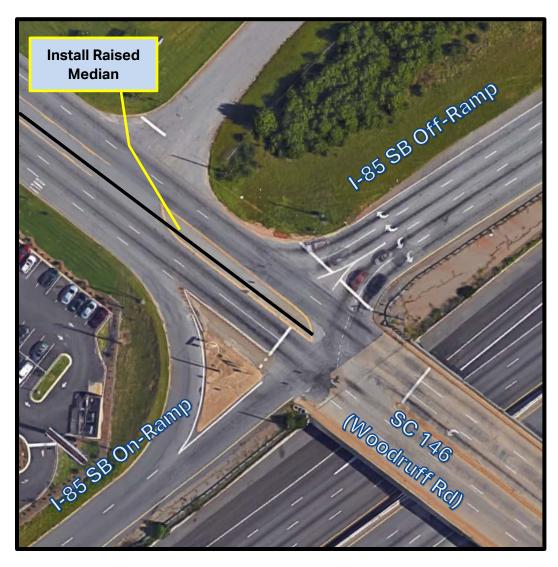
3.2.3 SC 146 & I-85 SB Ramps

- There is a full access side road located less than 150' from the signalized intersection.
- There are no pedestrian accommodations at this intersection.

- Mid Term A raised median from I-85 being installed to Woodruff Industrial as part of a future City of Greenville Project.
 - ➤ Anticipated Cost to Implement: **To be implemented by SCDOT**
- Mid Term Make the location ADA compliant by installing 4 ramps on the northern side of the road (2 at Old Country Rd, 2 at I-85 SB Off-Ramp) as part of sidewalk.
 - ➤ Anticipated Cost to Implement: **To be implemented by City of Greenville**

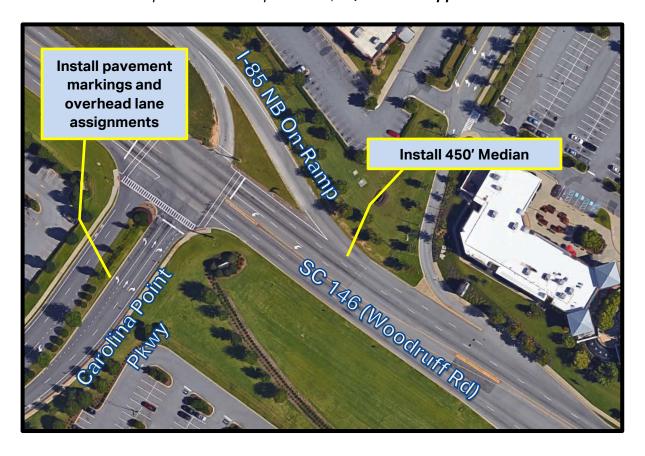
3.2.4 SC 146 & Carolina Point Pkwy

- Weaving between the new driveway from the Shoppes of Greenridge and the new I-85 interchange ramp.
- Poor pavement markings for the turn7ing movements onto Woodruff Road.
- Improved signage may be needed to guide vehicles to left and right turns on to Woodruff Rd and I-85 in advance of intersection.

- **Short Term** Install pavement markings on Carolina Point Pkwy approach.
 - Anticipated Cost to Implement: \$500
- **Short Term** Install overhead lane assignment signs for Carolina Point Pkwy approach.
 - > Anticipated Cost to Implement: \$4,000
- Mid Term Install a 450' foot concrete median starting at the future I-85 on-ramp.
 - Anticipated Cost to Implement: \$12,150 see Appendix E.

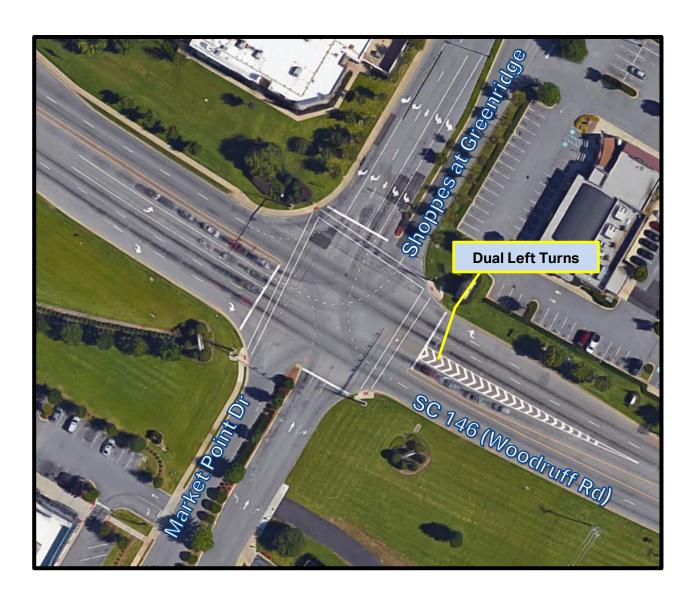
3.2.5 SC 146 & Market Point Dr

Queuing for the westbound left-turn lane on Woodruff Rd.

- **Short Term** Restripe and install dual left turns on WB approach. Review nose of median on Market Point Drive to ensure both turn lanes clear median.
 - > Anticipated Cost to Implement: \$3,000

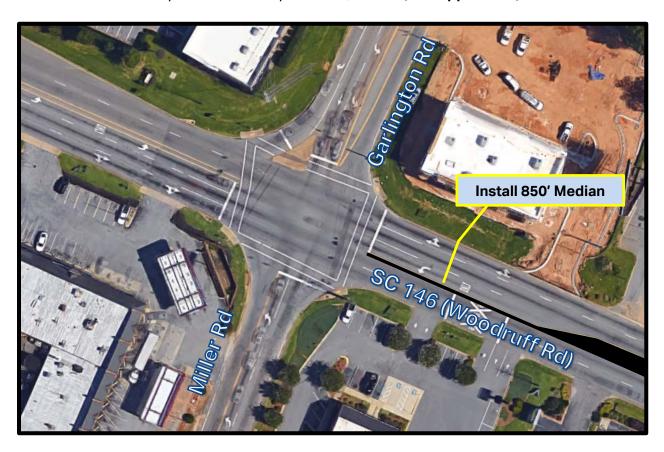
3.2.6 SC 146 & Miller Rd (S-564) / Garlington Rd (S-564)

- There are full access driveways close to the intersection.
- Review storage for left turn lane on Woodruff Rd WB.

- Mid Term Install an 850 foot concrete median from Miller Rd /Garlington Rd to the
 I-385 Ramp intersection.
 - > Anticipated Cost to Implement: \$63,200 (See Appendix E)

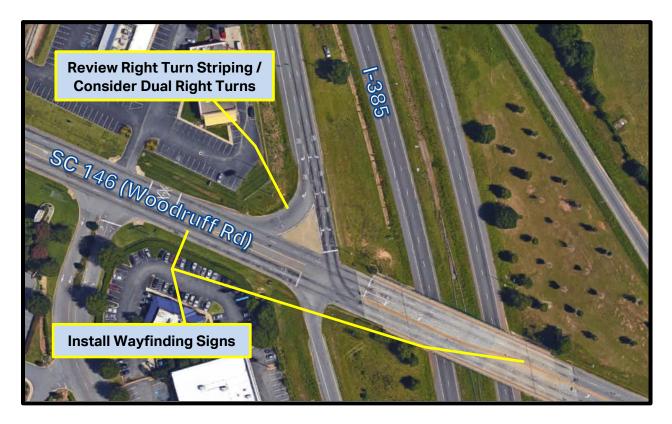
3.2.7 SC 146 & I-385 Ramps

- I-385 SB off-ramp is very wide and causes some confusion for drivers.
- Long queues on Woodruff Road in advance of I-385
- Pavement striping is worn.

- **Short Term** Improve striping.
 - ➤ Anticipated Cost to Implement: To be implemented by SCDOT as part of I-85 / I-385 project
- **Short Term** Review right turn lane from I-385 onto Woodruff Road. Install additional striping to indicate to drivers that it is not a dual right turn.
 - Anticipated Cost to Implement: \$500
- Mid Term Install overhead lane use (wayfinding signs) in both direction along Woodruff Road prior to I-385.
 - > Anticipated Cost to Implement: \$15,000
- Mid Term Consider dual right turn lanes off of I-385 SB off-ramp.
 - > Anticipated Cost to Implement: \$75,000

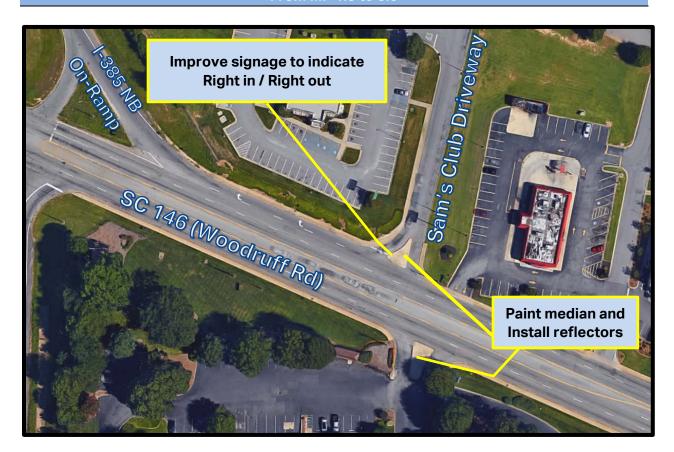
3.2.8 SC 146 & Sam's Club Driveway

- The median in the northern approach is unclear as to whether the driveway should be right in / right out only.
- No pedestrian accommodations to make the location ADA compliant.
- The radius on the right turns on the EB and WB approaches are small and requires drivers to reduce speed to enter safely.
- The raised medians on the NB and SB approaches have poor visibility.
- There is a WB weaving movement between Sam's Club Driveway and I-385 NB On -Ramp

- **Short Term** Improve signage at the Sam's driveway to indicate a right in / right out driveway only.
 - Anticipated Cost to Implement: \$1,250
- Short Term Install "No Left Turn" signs on the NB and SB approaches.
 - Anticipated Cost to Implement: \$500
- Short Term Install reflectors and paint the base of the medians located on the NB and SB approaches.
 - > Anticipated Cost to Implement: **\$500**
- Mid Term Make the location ADA compliant.
 - Anticipated Cost to Implement: \$30,000
- Mid Term Provide larger radius for right turns from Woodruff into development.
 - > Anticipated Cost to Implement: \$2,750
- Long Term As traffic volumes increase, consider closing Sam's Club Driveway to remove weaving movement.
 - Anticipated Cost to Implement: \$50,000

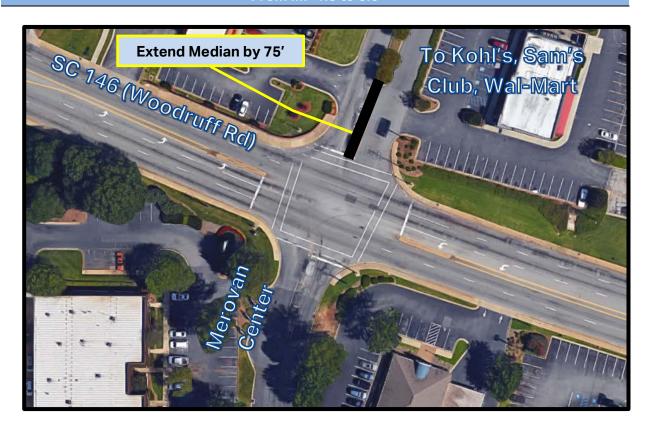
3.2.9 SC 146 & Merovan Center / Applebee's

- There are no pedestrian signals present at this intersection but existing crosswalks are present.
- The ramps at this intersection are not ADA compliant.
- Signal heads do not have backplates (8).
- It would be beneficial to implement flashing yellow arrows signals at this intersection.
- Crosswalks need to be repainted.
- The base of the existing median needs to be repainted to increase visibility.
- The median in the driveway on the northern leg should be extended closer to the intersection in order to block the left turns into the businesses located close to the intersection.

- Short Term Install countdown pedestrian signals (8).
 - > Anticipated Cost to Implement: \$8,000
- Short Term Implement Flashing Yellow Arrow signals on all approaches.
 - > Anticipated Cost to Implement: Installed by SCDOT District 3
- Short Term Install 8 backplates on existing signal heads.
 - > Anticipated Cost to Implement: \$2,600
- Short Term Restripe all crosswalks.
 - > Anticipated Cost to Implement: \$1,900
- Short Term Restripe the base of the existing median.
 - > Anticipated Cost to Implement: \$250
- Mid Term Make intersection ADA compliant. Install 4 ramps with detectable warning surface.
 - Anticipated Cost to Implement: \$15,000
- Mid Term Extend the median by 75 feet on the northern leg to the stop of the intersection.
 - Anticipated Cost to Implement: \$6,500

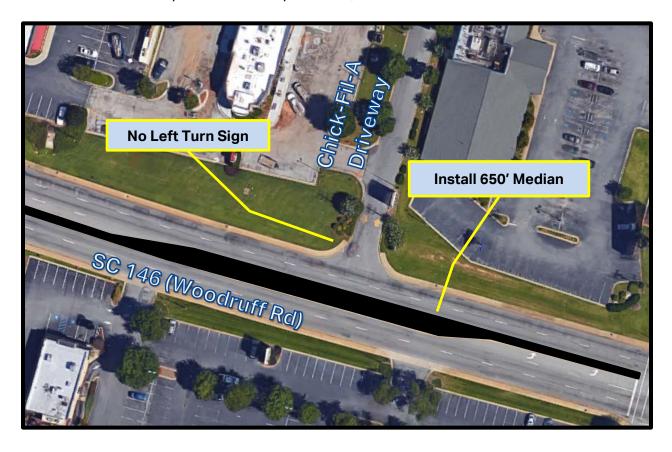
3.2.10 SC 146 & Chick-Fil-A Driveway

- Left turns out of the Chick-Fil-A Driveway cause delays for those leaving the development and may contribute to the angle crashes.
- There are many angle crashes coming from the side road accessing Chick-Fil-A.

- Short Term Install no left turn sign on road coming from Chick-Fil-A.
 - Anticipated Cost to Implement: \$150
- Mid Term Install 650-foot median on Woodruff road extending from the Merovan Center intersection to Smith Hines Rd to restrict left turns entering and exiting the Chick-Fil-A driveway.
 - > Anticipated Cost to Implement: \$57,000

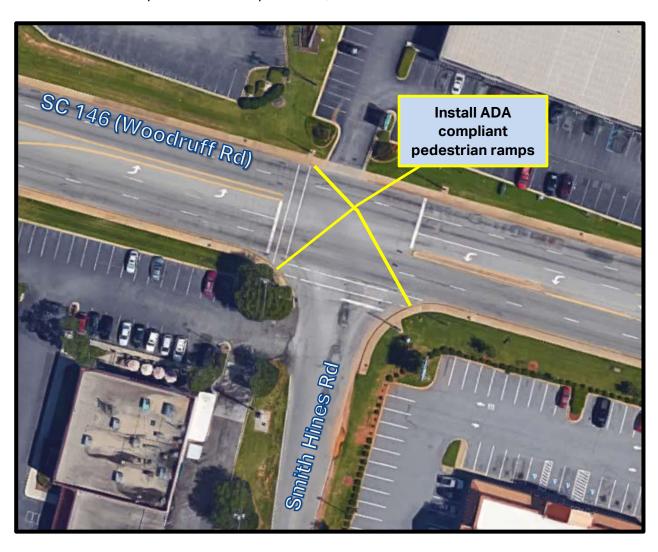
3.2.11 SC 146 & Smith Hines Rd

- No backplates present on signal heads (6).
- No pedestrian signals present.
- The intersection is not ADA compliant.

- Short Term Install backplates on signal heads (6).
 - Anticipated Cost to Implement: \$1,950
- **Short Term** Install countdown pedestrian signals.
 - > Anticipated Cost to Implement: \$4,000
- Mid Term Make intersection ADA compliant.
 - Anticipated Cost to Implement: \$11,250

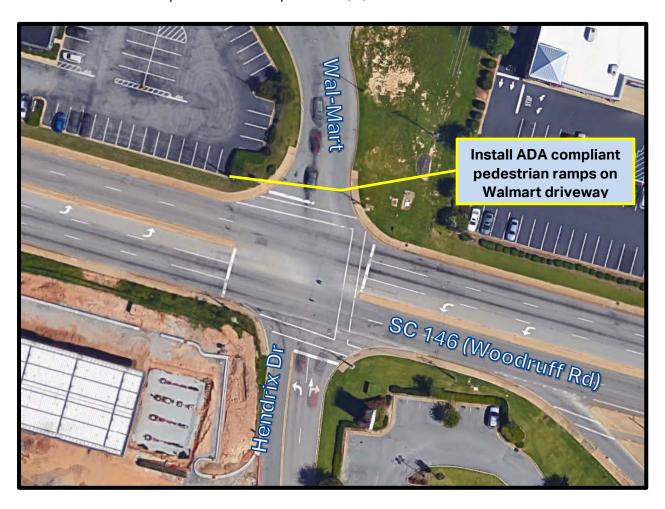
3.2.12 SC 146 & Hendrix Dr / Wal-Mart

- No backplates are present on signal heads (8).
- Ramps on northern side of roadway are not ADA compliant.

- Short Term Install backplates on signal heads (8).
 - Anticipated Cost to Implement: \$2,600
- Short Term Install countdown pedestrian signals (6).
 - Anticipated Cost to Implement: \$6,000
- Mid Term Make intersection ADA compliant.
 - > Anticipated Cost to Implement: \$7,500

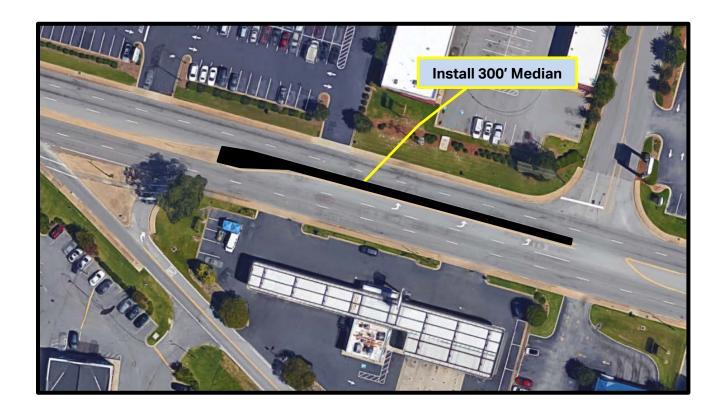
3.2.13 SC 146 & Spinx Gas Station near Tanner Rd (S-655)

• The Spinx has two full access driveways on SC 146 (Woodruff Rd).

- Mid Term Extend the existing median that begins at Hendrix Dr by 300 feet to block the left turns in and out of the Spinx Gas station.
 - > Anticipated Cost to Implement: \$18,650

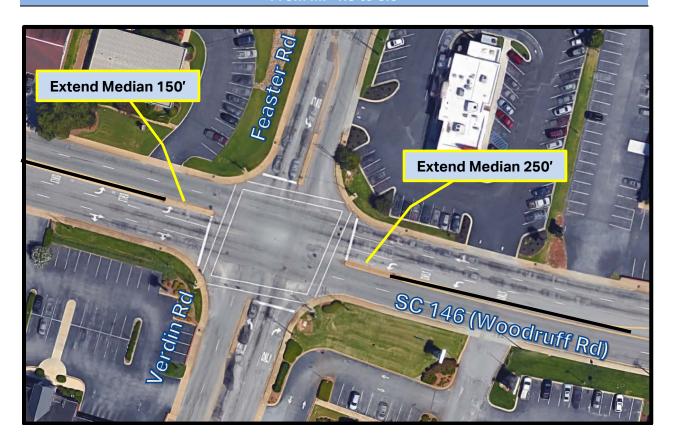
3.2.14 SC 146 & Verdin Rd (S-333) / Feaster Rd (S-333)

- Signal sight distance is poor for the westbound Woodruff Rd approach.
- Crosswalks are faded.
- The visibility of the left turning vehicles onto SC 146 (Woodruff Rd) is limited due to the slight negative offset of the left turn lanes.
- There are unsignalized driveways before the signalized intersection for which the left turn lanes are used.

- Short Term Install a nearside signal head on the WB approach of SC 146 (Woodruff Rd).
 - > Anticipated Cost to Implement: \$1,000
- **Short Term** Implement Flashing Yellow Arrows on all approaches at this intersection.
 - > Anticipated Cost to Implement: Installed by SCDOT District 3
- **Short Term** Restripe all crosswalks.
 - > Anticipated Cost to Implement: \$600
- Mid Term Extend the concrete medians on SC 146 (Woodruff Rd) through the storage in the left turn lanes to make the vehicles turning left into the surrounding businesses utilize Verdin Rd and Feaster Rd. Extend the EB leg by 150 feet and extend the WB leg by 250 feet.
 - > Anticipated Cost to Implement: \$20,250
- Mid Term Realign left-turn lanes on the minor street approach by restriping shifting medians to create a positive offset.
 - Anticipated Cost to Implement: \$7,500

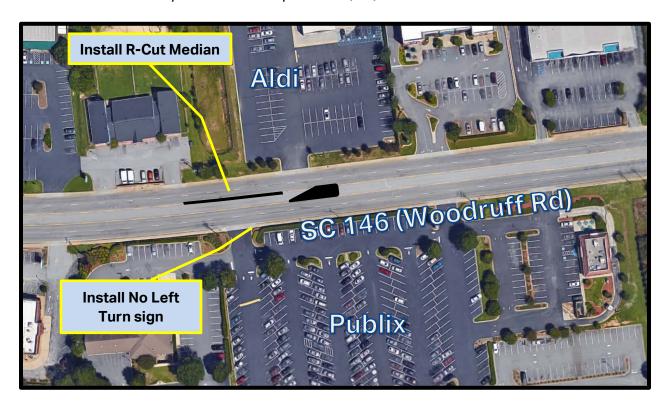
3.2.15 SC 146 & Publix Driveway

- There are many points of conflict for vehicles utilizing the TWLTL along this segment of roadway in front of the Publix.
- Sight distance is poor from Publix driveway.

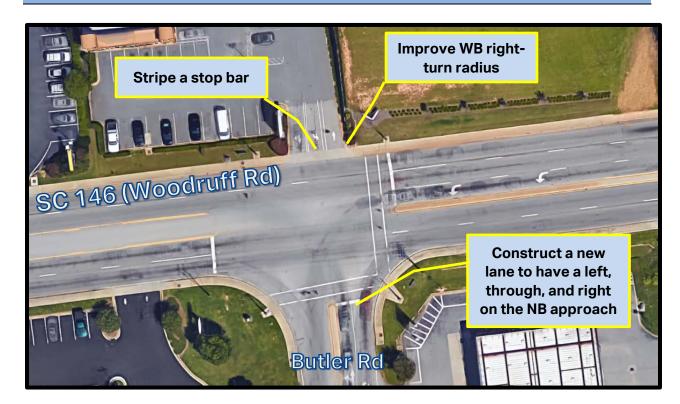
3.2.16 SC 146 & E Butler Rd (S-107)

- There are no pedestrian signals present at this intersection.
- There are no pedestrian ramps on the northern side of SC 146 (Woodruff Rd).
- There are no object markers on the median on the NB (Butler Rd) approach.
- There are no backplates on the existing signals.
- There is no stop bar on the SB approach.
- The intersection would benefit from implementation of flashing yellow arrow signals.
- Review the left turn lengths for the intersection clearance timings.
- Consider split phasing for the NB and SB approaches.
- The radius for the WB right turn into the development is very tight and requires vehicles to slow down before making a right turn.

- **Short Term** Install countdown pedestrian signals (4).
 - > Anticipated Cost to Implement: \$4,000
- Short Term Install object markers on the median of the Butler Rd approach.

- Anticipated Cost to Implement: \$75,000

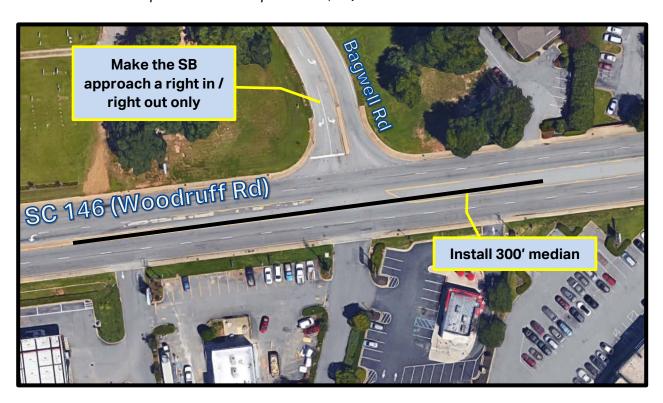
- Update all pavement markings at this intersection.
- Queuing from adjacent signal blocking intersection.
- There is significant sediment build up and debris in the gutters.

- **Short Term** Update pavement markings (left turn arrows & right turn arrows)
 - > Anticipated Cost to Implement: \$500
- Short Term Limit Bagwell Rd to right turns out only using a concrete median channelization.
 - Anticipated Cost to Implement: \$8,500
- Short Term Clean sediment and debris from sidewalk, gutters, and roadway.
 - Anticipated Cost to Implement: \$5,000
- Mid Term Install a 300 foot concrete median extending in front of Bagwell Rd.
 - > Anticipated Cost to Implement: \$15,000
