Road Safety Assessment Greenville County, South Carolina US 25 (White Horse Rd) from MP 23.5 to 30.0

May 2017

AECOM Technical Services, Inc.

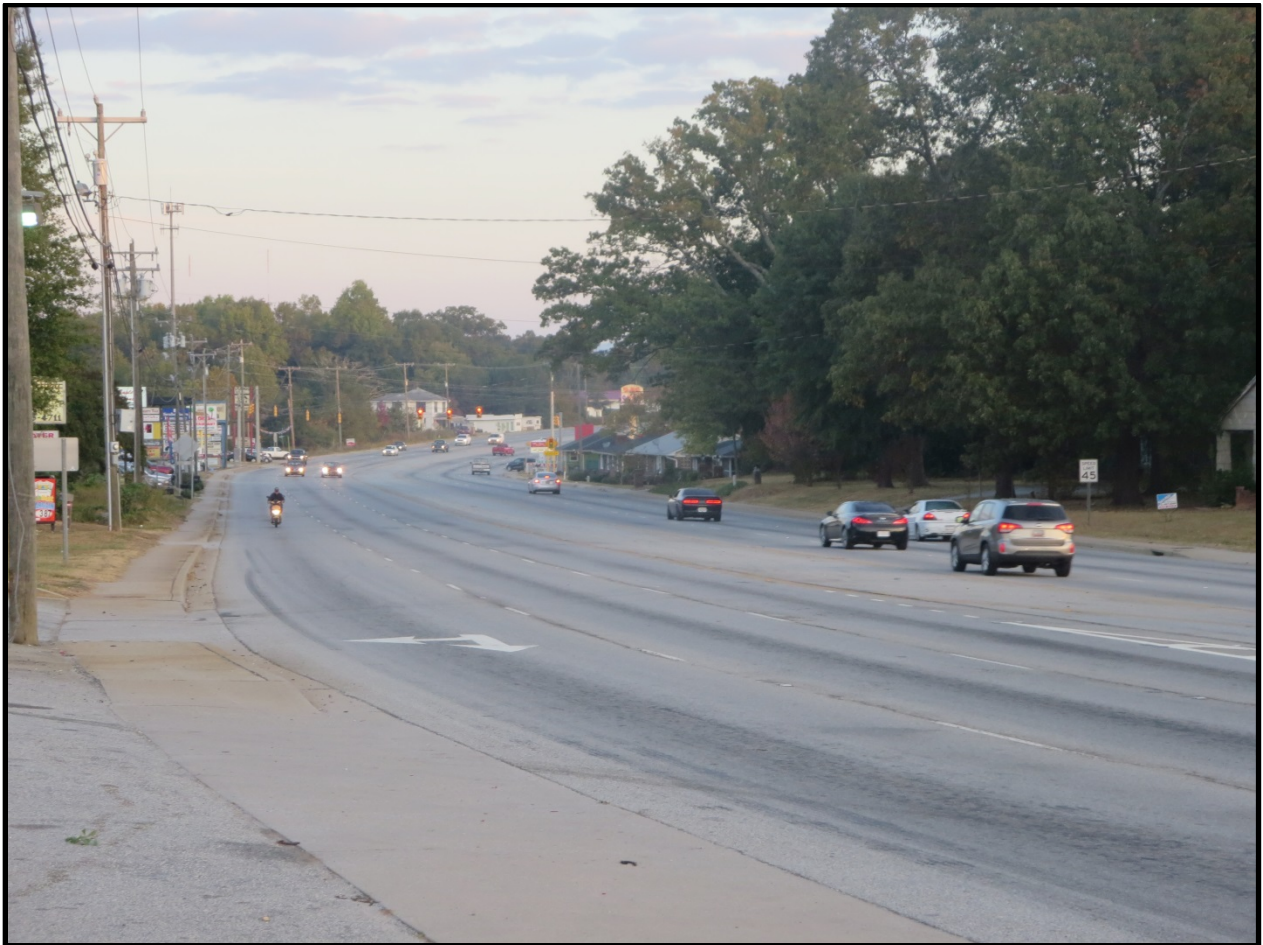
Figure 1 – Typical Section of US 25 (White Horse Rd)

US 25 (White Horse Rd) is found in Greenville County, South Carolina. It is a 7-lane principal arterial that provides access to many commercial sites and residential developments. In addition, it serves as a major truck corridor that connects I-26 from the Asheville Area to I-85. Significant highway intersections along this section of US 25 are grade separated and include Interstate 85, Interstate 185, US 123 (New Easley Hwy), and SC 124 (Old Easley Hwy). The corridor also provides bus service via Greenlink Transit, Route 6, with multiple stops along the study area. The portion of US 25 that is being assessed runs from mile post (MP) 23.5 - 30.0 or just south of I-85 to S-782 (Lily St). According to data provided by SCDOT, there have been 1,971 reported crashes within this section of US 25 from January 2010 to December 2014.

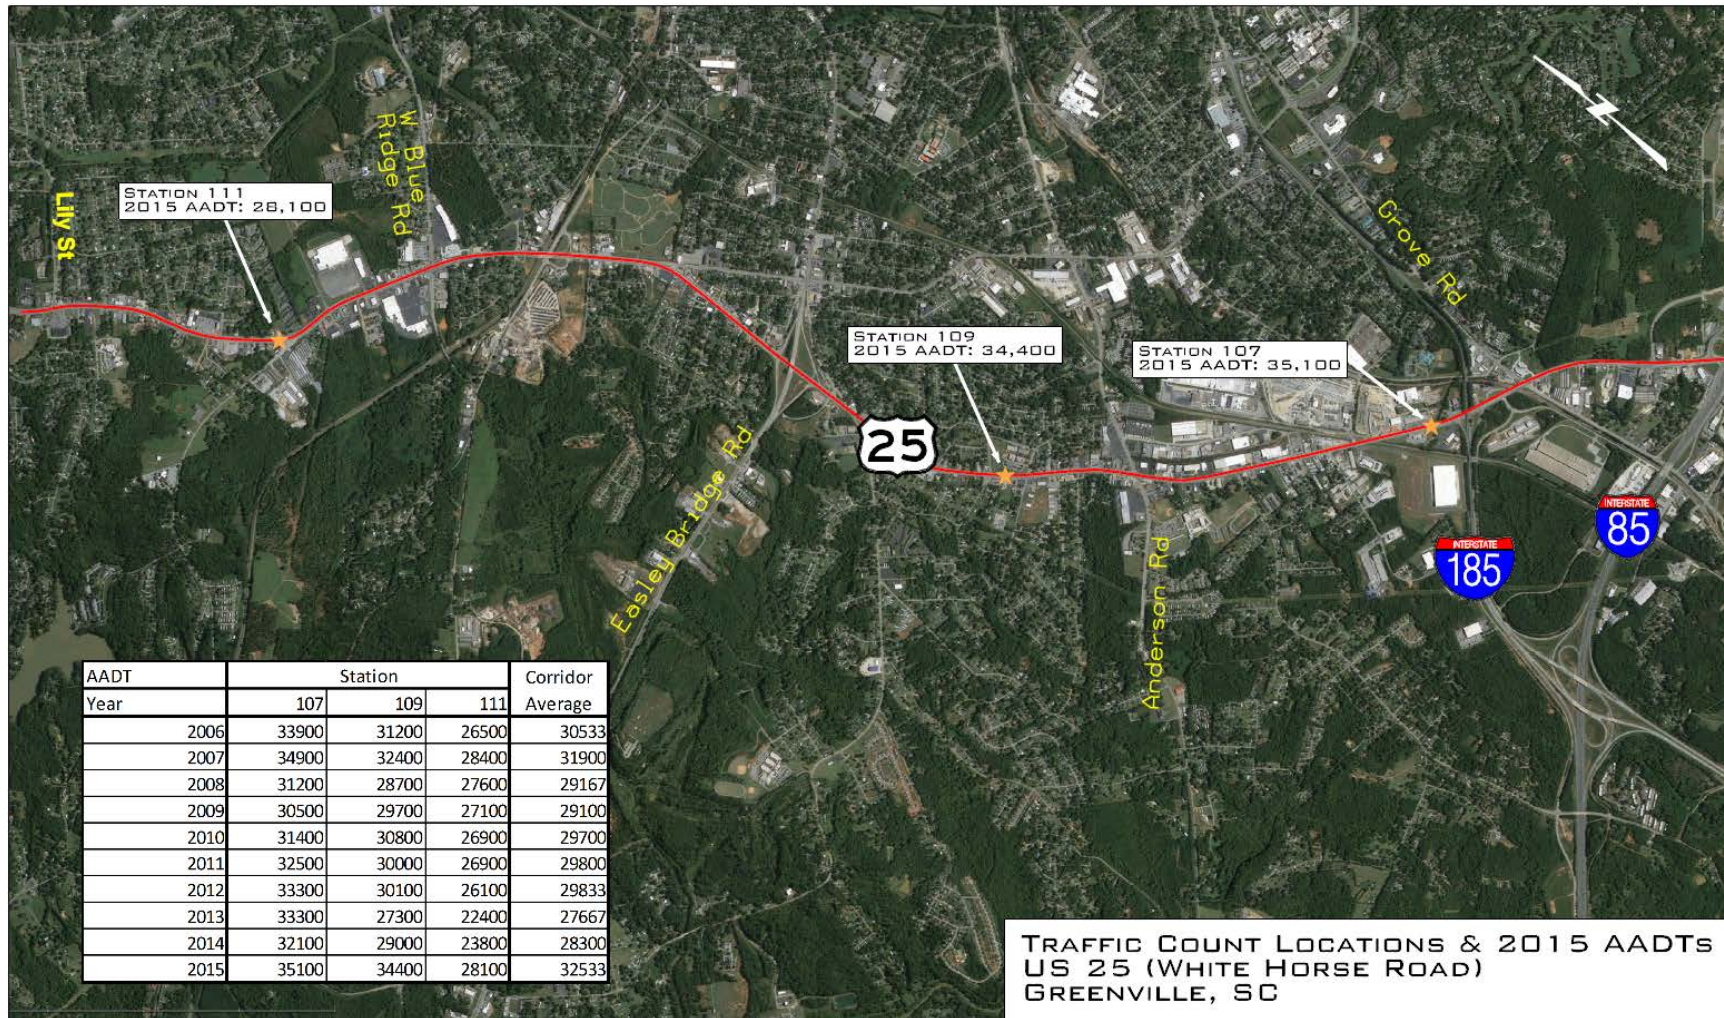
Figure 5 – SCDOT Traffic Count Locations

Figure 5 shows the locations at which counts were recorded, along with average AADT and growth rate.

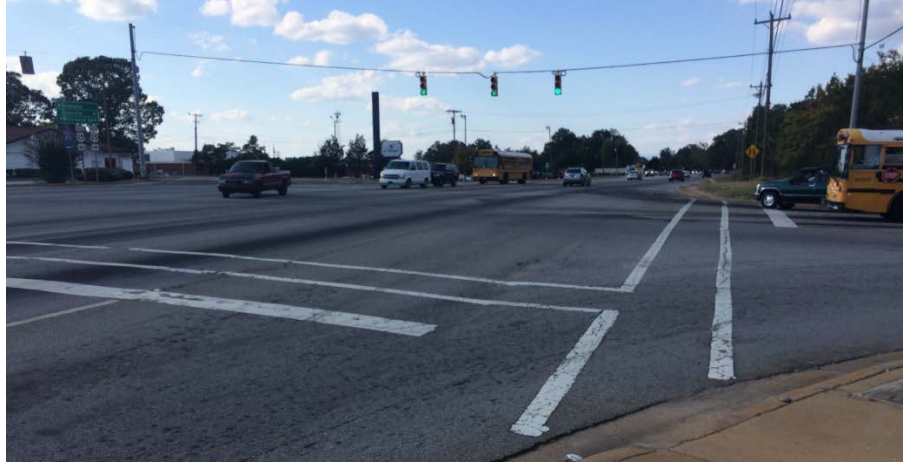
<i>Findings</i>	<i>Examples</i>	<i>Improvements and Considerations</i>
<p><u>Traffic Signals</u></p> <p>Not all intersections are fully equipped with backplates on each signal head. These include (# of backplates needed):</p> <ul style="list-style-type: none"> • US 25 @ I-85 SB Ramps (9) • US 25 @ Frontage Rd (11) • US 25 @ Two Notch Rd (12) • US 25 @ Old Easley Bridge Rd (12) • US 25 @ Wal-Mart Entrance (10) • US 25 @ Lily St (11) <p>Some locations would benefit from the installation of a nearside signal head that is more visible to drivers:</p> <ul style="list-style-type: none"> • US 25 @ Anderson Rd • US 25 @ Blue Ridge Dr • US 25 @ Grove Rd <p>Install flashing yellow arrow signal heads :</p> <ul style="list-style-type: none"> • US 25 @ Anderson Rd • Consider at all intersections as it has been proven to improve safety.

<p style="text-align: center;"><i>Some signals are not equipped with backplates.</i></p>

<p style="text-align: center;"><i>Install flashing yellow arrow signals where necessary.</i></p>	<p>Install backplates on signal heads. Anticipated cost: \$20,550</p> <p>Install nearside signal heads. Anticipated Cost: \$3,000</p> <p>Make use of flashing yellow arrow signals. Anticipated Cost: \$4,000</p> <p>Cost would be \$15,000 if FYAs implemented at all intersections along corridor.</p>

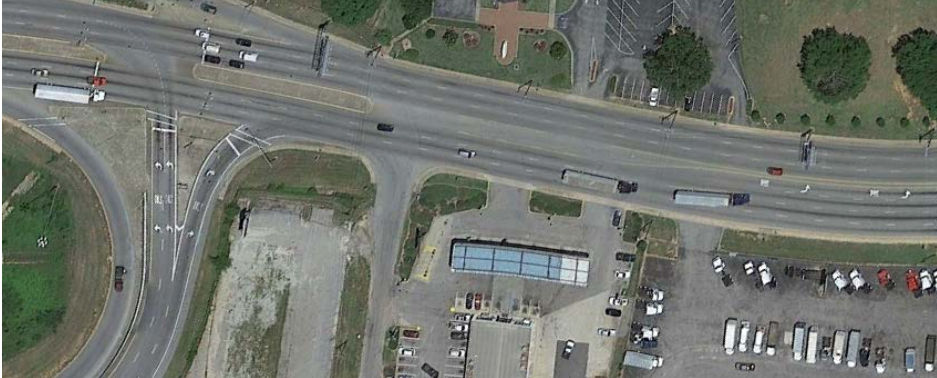
Findings	Examples	Improvements and Considerations
<p><u>Access Management, Driveway Geometry, & Sight Distance</u></p> <p>Some locations have multiple full access driveways along US 25 (White Horse Rd).</p> <p>Medians would prevent left turns from some unsignalized side streets and driveways, thus minimizing conflicts and lessen the severity of crashes.</p> <p>Existing structures impede sight distance at some locations.</p>

<p><i>Install right-in / right-out turns at driveways near some intersections along US 25 (White Horse Road)</i></p>

<p><i>The existing brick wall and fence on Staunton Bridge Rd does not allow drivers to adequately see north to make a safe right turn on red.</i></p>	<p>Construct new or extend existing concrete medians to restrict access to driveways especially near signals. (3,850 feet total) Anticipated Cost: \$225,650</p> <p>There would be approximately 50 total driveways affected by the addition of the proposed concrete medians along US 25 (White Horse Rd).</p> <p>Convert 3 driveways to right-in/right-out access only. Anticipated Cost: \$7,900</p>

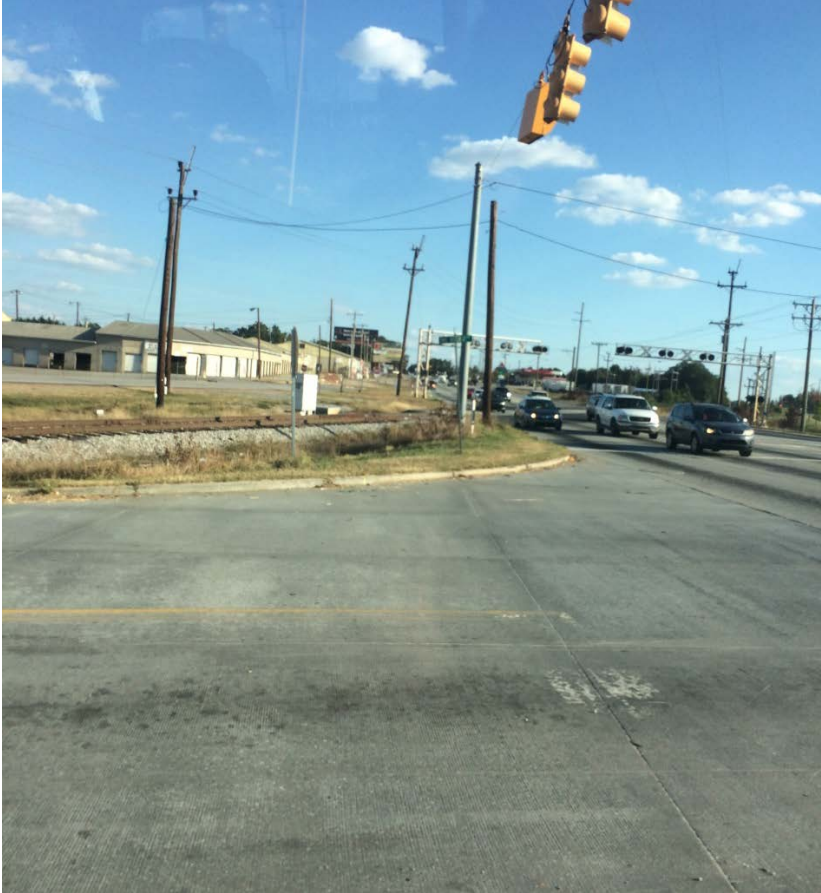
Table 4 – Signs & Pavements Markings Findings and Considerations

<p><i>Stop bars and lane designations are faded as shown in this image of the westbound approach at US 25 and Two Notch Rd.</i></p>	<p>Install overhead street signs at all signalized intersections along US 25 (White Horse Rd) Anticipated Cost: \$15,960*</p> <p>Restripe stop bars, skip lines, and approaches to intersections where necessary. Anticipated Cost: \$100,700*</p> <p>Restripe solid yellow lines and white dashed lines throughout corridor. Anticipated Cost: \$300,000*</p> <p>Replace all raised pavement markers along corridor. Anticipated Cost: \$50,000*</p> <p>Ensure sign visibility. Anticipated Cost: \$5,000*</p> <p>(*) – These costs were incorporated in the Long Term improvements table located on Page 60. The total is reflected in the row called "Corridor Wide Improvements."</p>

Findings	Examples	Improvements and Considerations
<p><u>Signs & Pavement Markings</u></p> <p>Lanes and pavement markings are not clearly defined at all intersections. Install skip lines to guide cars making left turns at signalized intersections where necessary.</p> <p>Install overhead street name signs at all intersections.</p> <p>Ensure visibility of all signs along the corridor by clearing vegetation where necessary,</p>

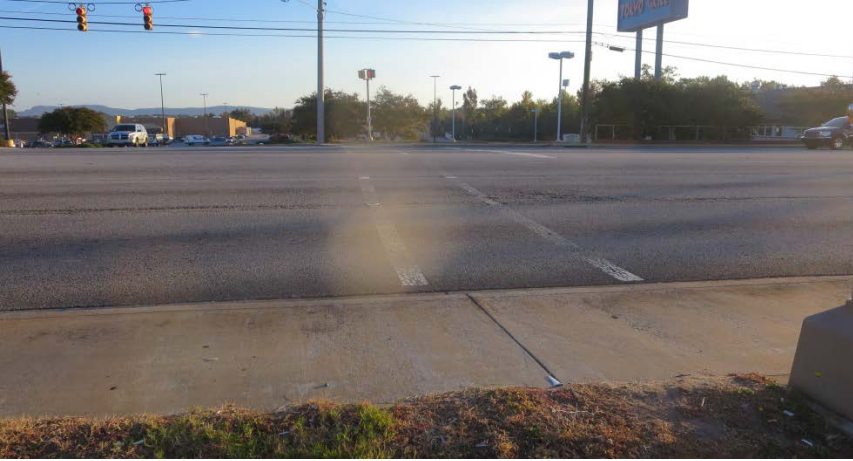
Findings	Examples	Improvements and Considerations
<p><u>Pedestrian Accommodation</u></p> <p>Countdown pedestrian signals are not present at all signalized intersections with crosswalks.</p> <ul style="list-style-type: none"> • US 25 at Grove Rd • US 25 at Two Notch Rd • US 25 at Page Dr (Future Signal) • US 25 at Saluda Dam Rd <p>Crosswalks are not present in all locations where pedestrian signals are installed:</p> <ul style="list-style-type: none"> • US 25 at Rangeview Cir <p>Not ADA compliant:</p> <ul style="list-style-type: none"> • US 25 at I-85 SB Ramps • US 25 at Frontage Rd • US 25 at Grove Rd • US 25 at Two Notch Rd • US 25 at Staunton Bridge • US 25 at Anderson Rd • US 25 at Page Dr • US 25 at US 123 Ramps • US 25 at Walmart Entrance • US 25 at W Marion Rd • US 25 at Saluda Dam Rd • US 25 at Rangeview Cir <p>Lighting would be beneficial in certain locations to alleviate pedestrian related crashes. Segments that would benefit from lighting are: 6, 7, 10, 11, 12, 20, 21</p>

<p><i>Some intersections need upgrades to ramps, crosswalks, and pedestrian signals to be ADA compliant. Shown here is a crosswalk that leads to a sidewalk with no ramp access.</i></p>

<p><i>This median has a walkway through it that would be challenging for a wheelchair to navigate.</i></p>	<p>Install / Upgrade existing pedestrian signal heads to countdown pedestrian signals at the following intersections:</p> <ul style="list-style-type: none"> • US 25 at Grove Rd (8) • US 25 at Two Notch Rd (8) • US 25 at Page Dr (8) • US 25 at Saluda Dam Rd (6) <p>Anticipated Cost: \$30,000</p> <p>Install new and restripe existing crosswalks with 12" lines.</p> <p>Upgrade all ramps and pedestrian accommodations to be ADA compliant. (71 ramps proposed in total)</p> <p>Anticipated Cost: \$219,625</p> <p>Clear sediment from gutters and remove trip hazards from the sidewalk.</p> <p>Anticipated Cost: \$5,000*</p> <p>Provide lighting in select segments on US 25.</p> <p>Anticipated Cost: \$505,000*</p> <p>(*) - See note on Page 16 under "Improvements and Considerations" for cost information.</p>

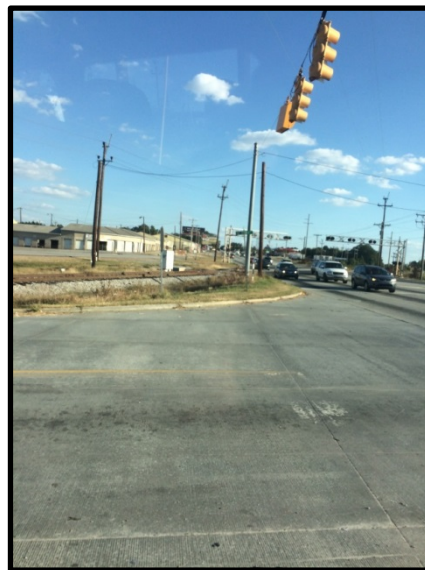
- ADA accommodations are not present at the intersection of US 25 at Two Notch Rd. No sidewalk is present on the east side of the road across railroad, which could make pedestrians have to cross US 25. Review pedestrian routes / access.
- Backplates are not present on signal heads at intersection of US 25 at Two Notch Rd.
- Delineating lane assignments on the WB approach of Two Notch Road are faded.
- The stop bar on the WB approach of Two Notch Road is worn.
- NB vehicles on US 25 turning left into exit only driveway prior to Two Notch Rd signal

- **Short Term** – Install backplates on signal heads at US 25 at Two Notch Road intersection.
 - *Anticipated Cost to Implement: \$3,800*
- **Short Term** – Restripe the WB approach of Two Notch Rd and indicate lane assignments with pavement markings along with a new stop bar.
 - *Anticipated Cost to Implement: \$2,560*
- **Short Term** – Install crosswalks and pedestrian signals (8) at US 25 at Two Notch Rd.
 - *Anticipated Cost to Implement: \$9,000*
- **Mid Term** – Upgrade (8) ramps and add 300 feet of sidewalks to be ADA compliant at the US 25 at Two Notch Rd intersection.
 - *Anticipated Cost to Implement: \$100,000*
- **Mid Term** – Extend the concrete median on the US 25 NB approach to Two Notch Rd intersection approximately 100 feet (4 foot wide) to the limits of the railroad right of way.
 - *Anticipated Cost to Implement: \$4,050*

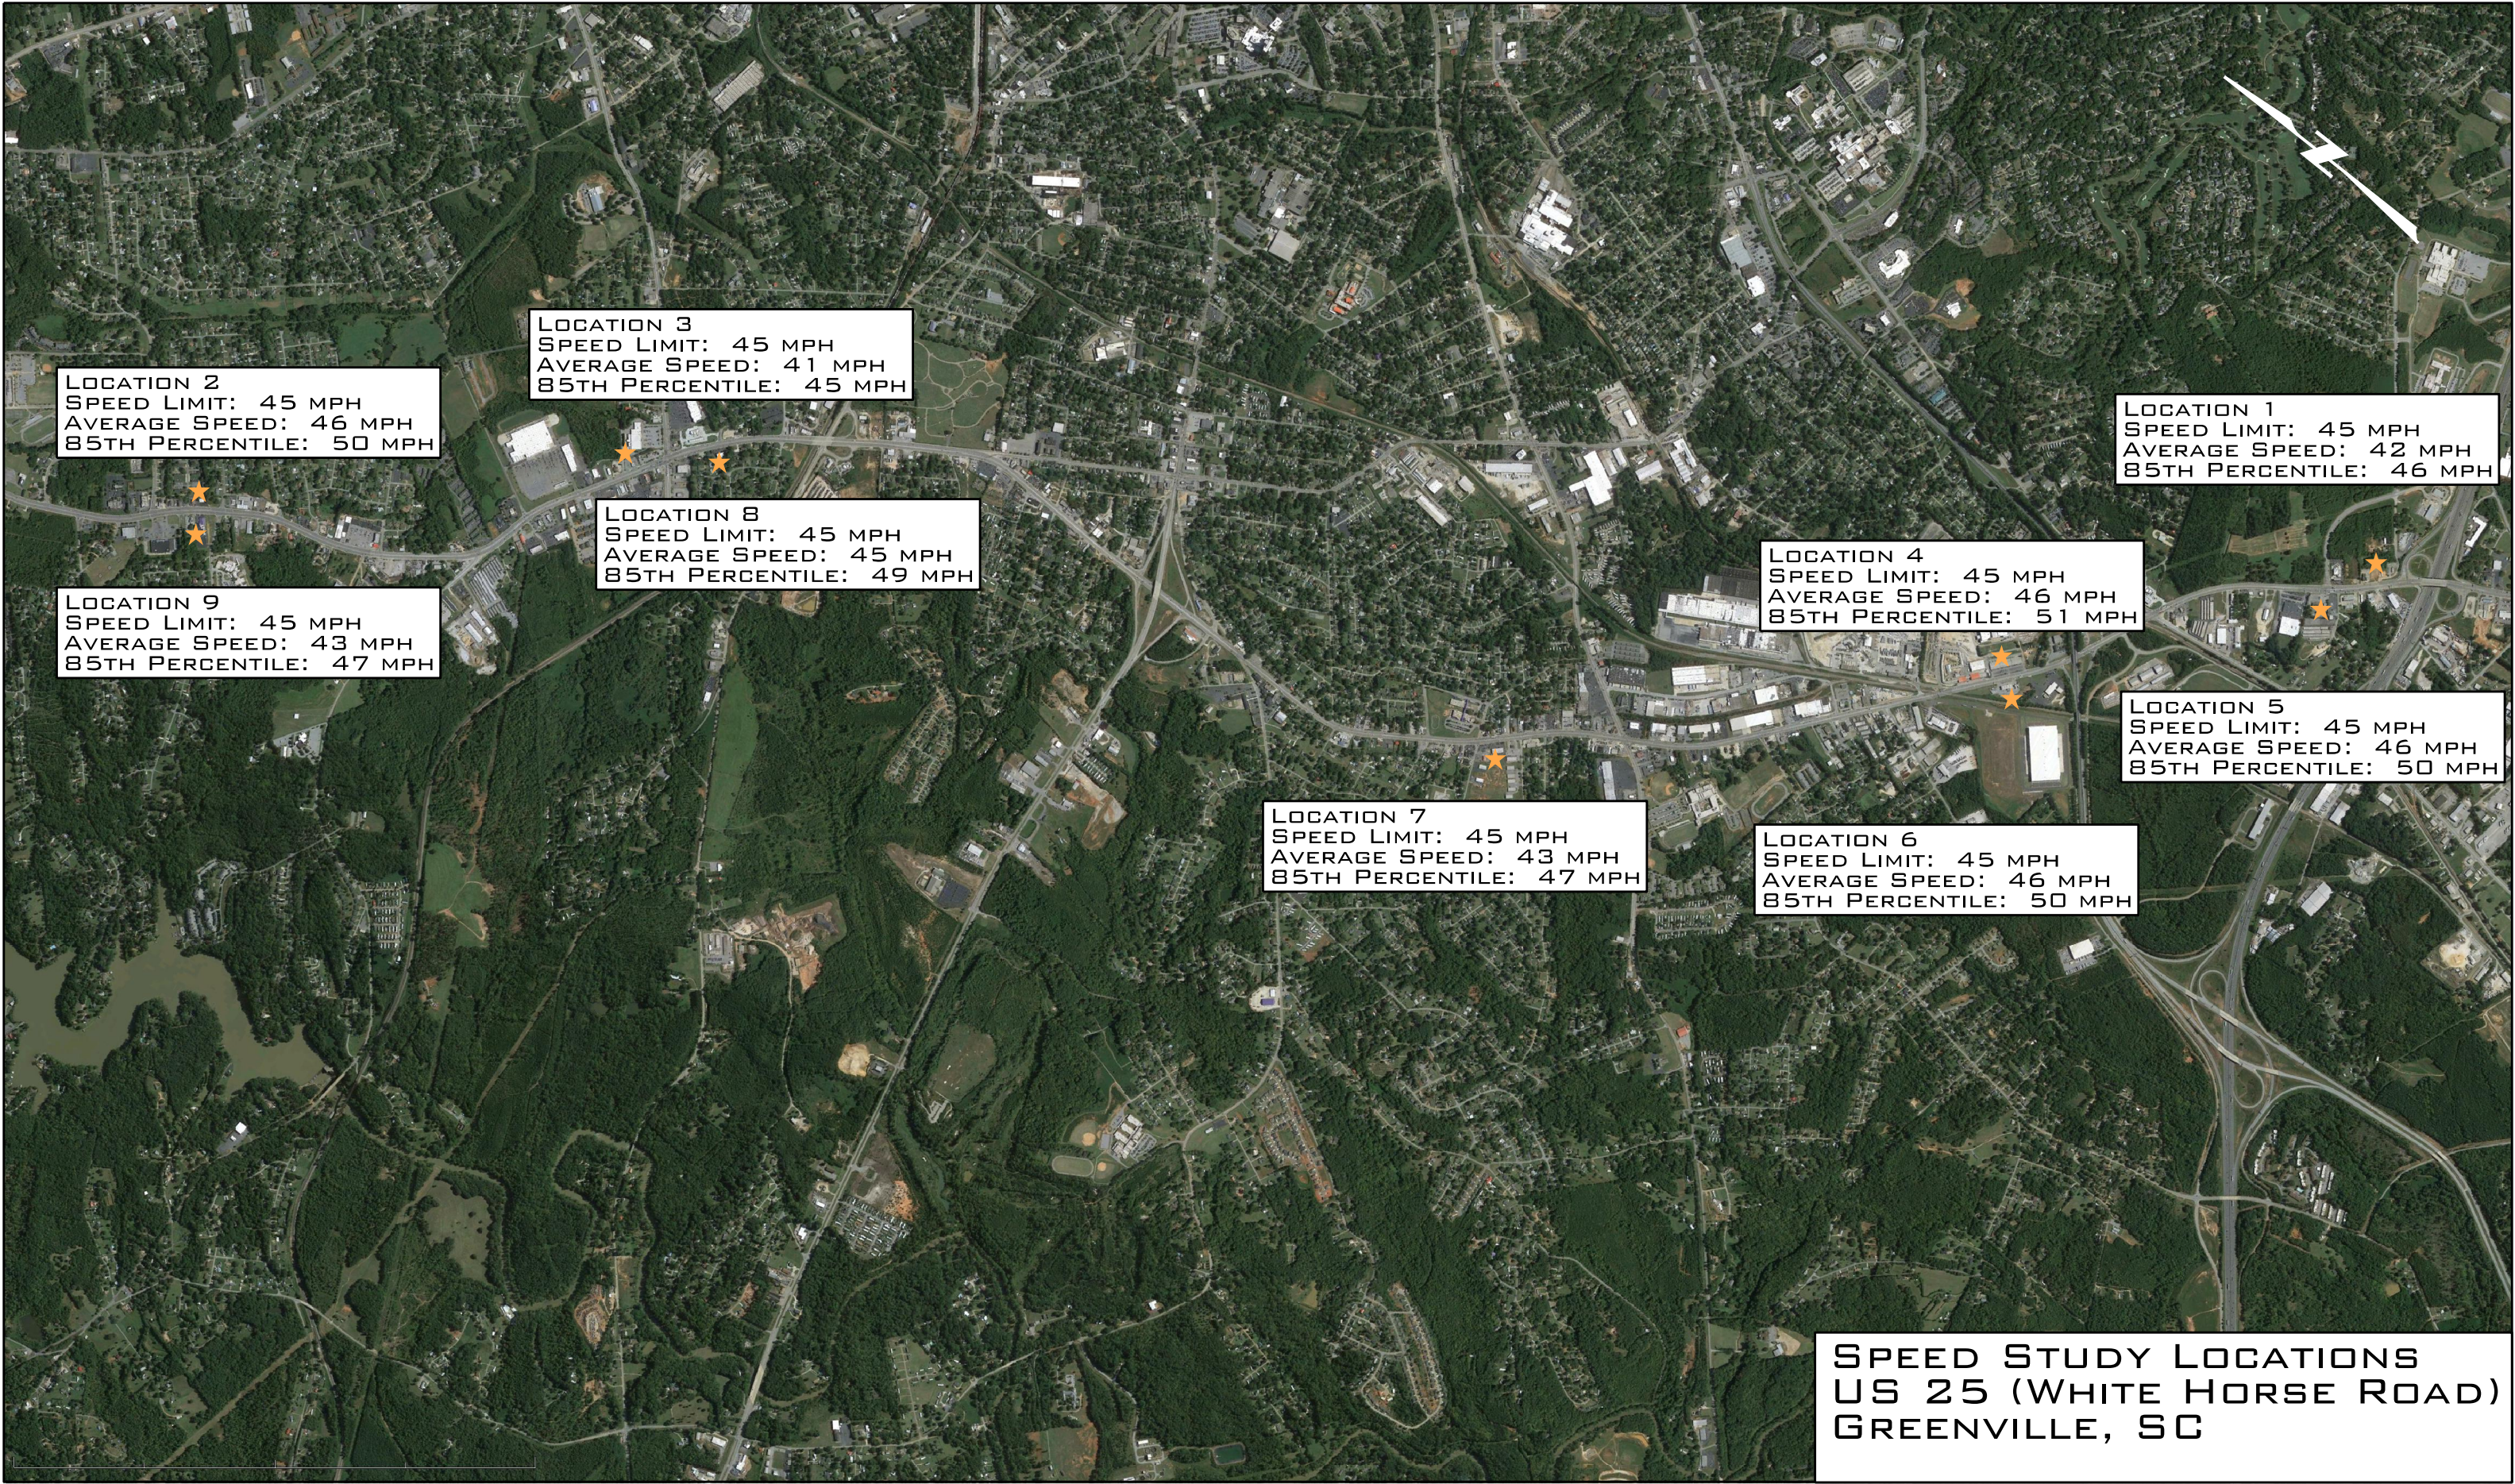
SPEED STUDY LOCATIONS
US 25 (WHITE HORSE ROAD)
GREENVILLE, SC

LOCATION 2
SPEED LIMIT: 45 MPH
AVERAGE SPEED: 46 MPH
85TH PERCENTILE: 50 MPH

LOCATION 3
SPEED LIMIT: 45 MPH
AVERAGE SPEED: 41 MPH
85TH PERCENTILE: 45 MPH

LOCATION 6
SPEED LIMIT: 45 MPH
AVERAGE SPEED: 46 MPH
85TH PERCENTILE: 50 MPH

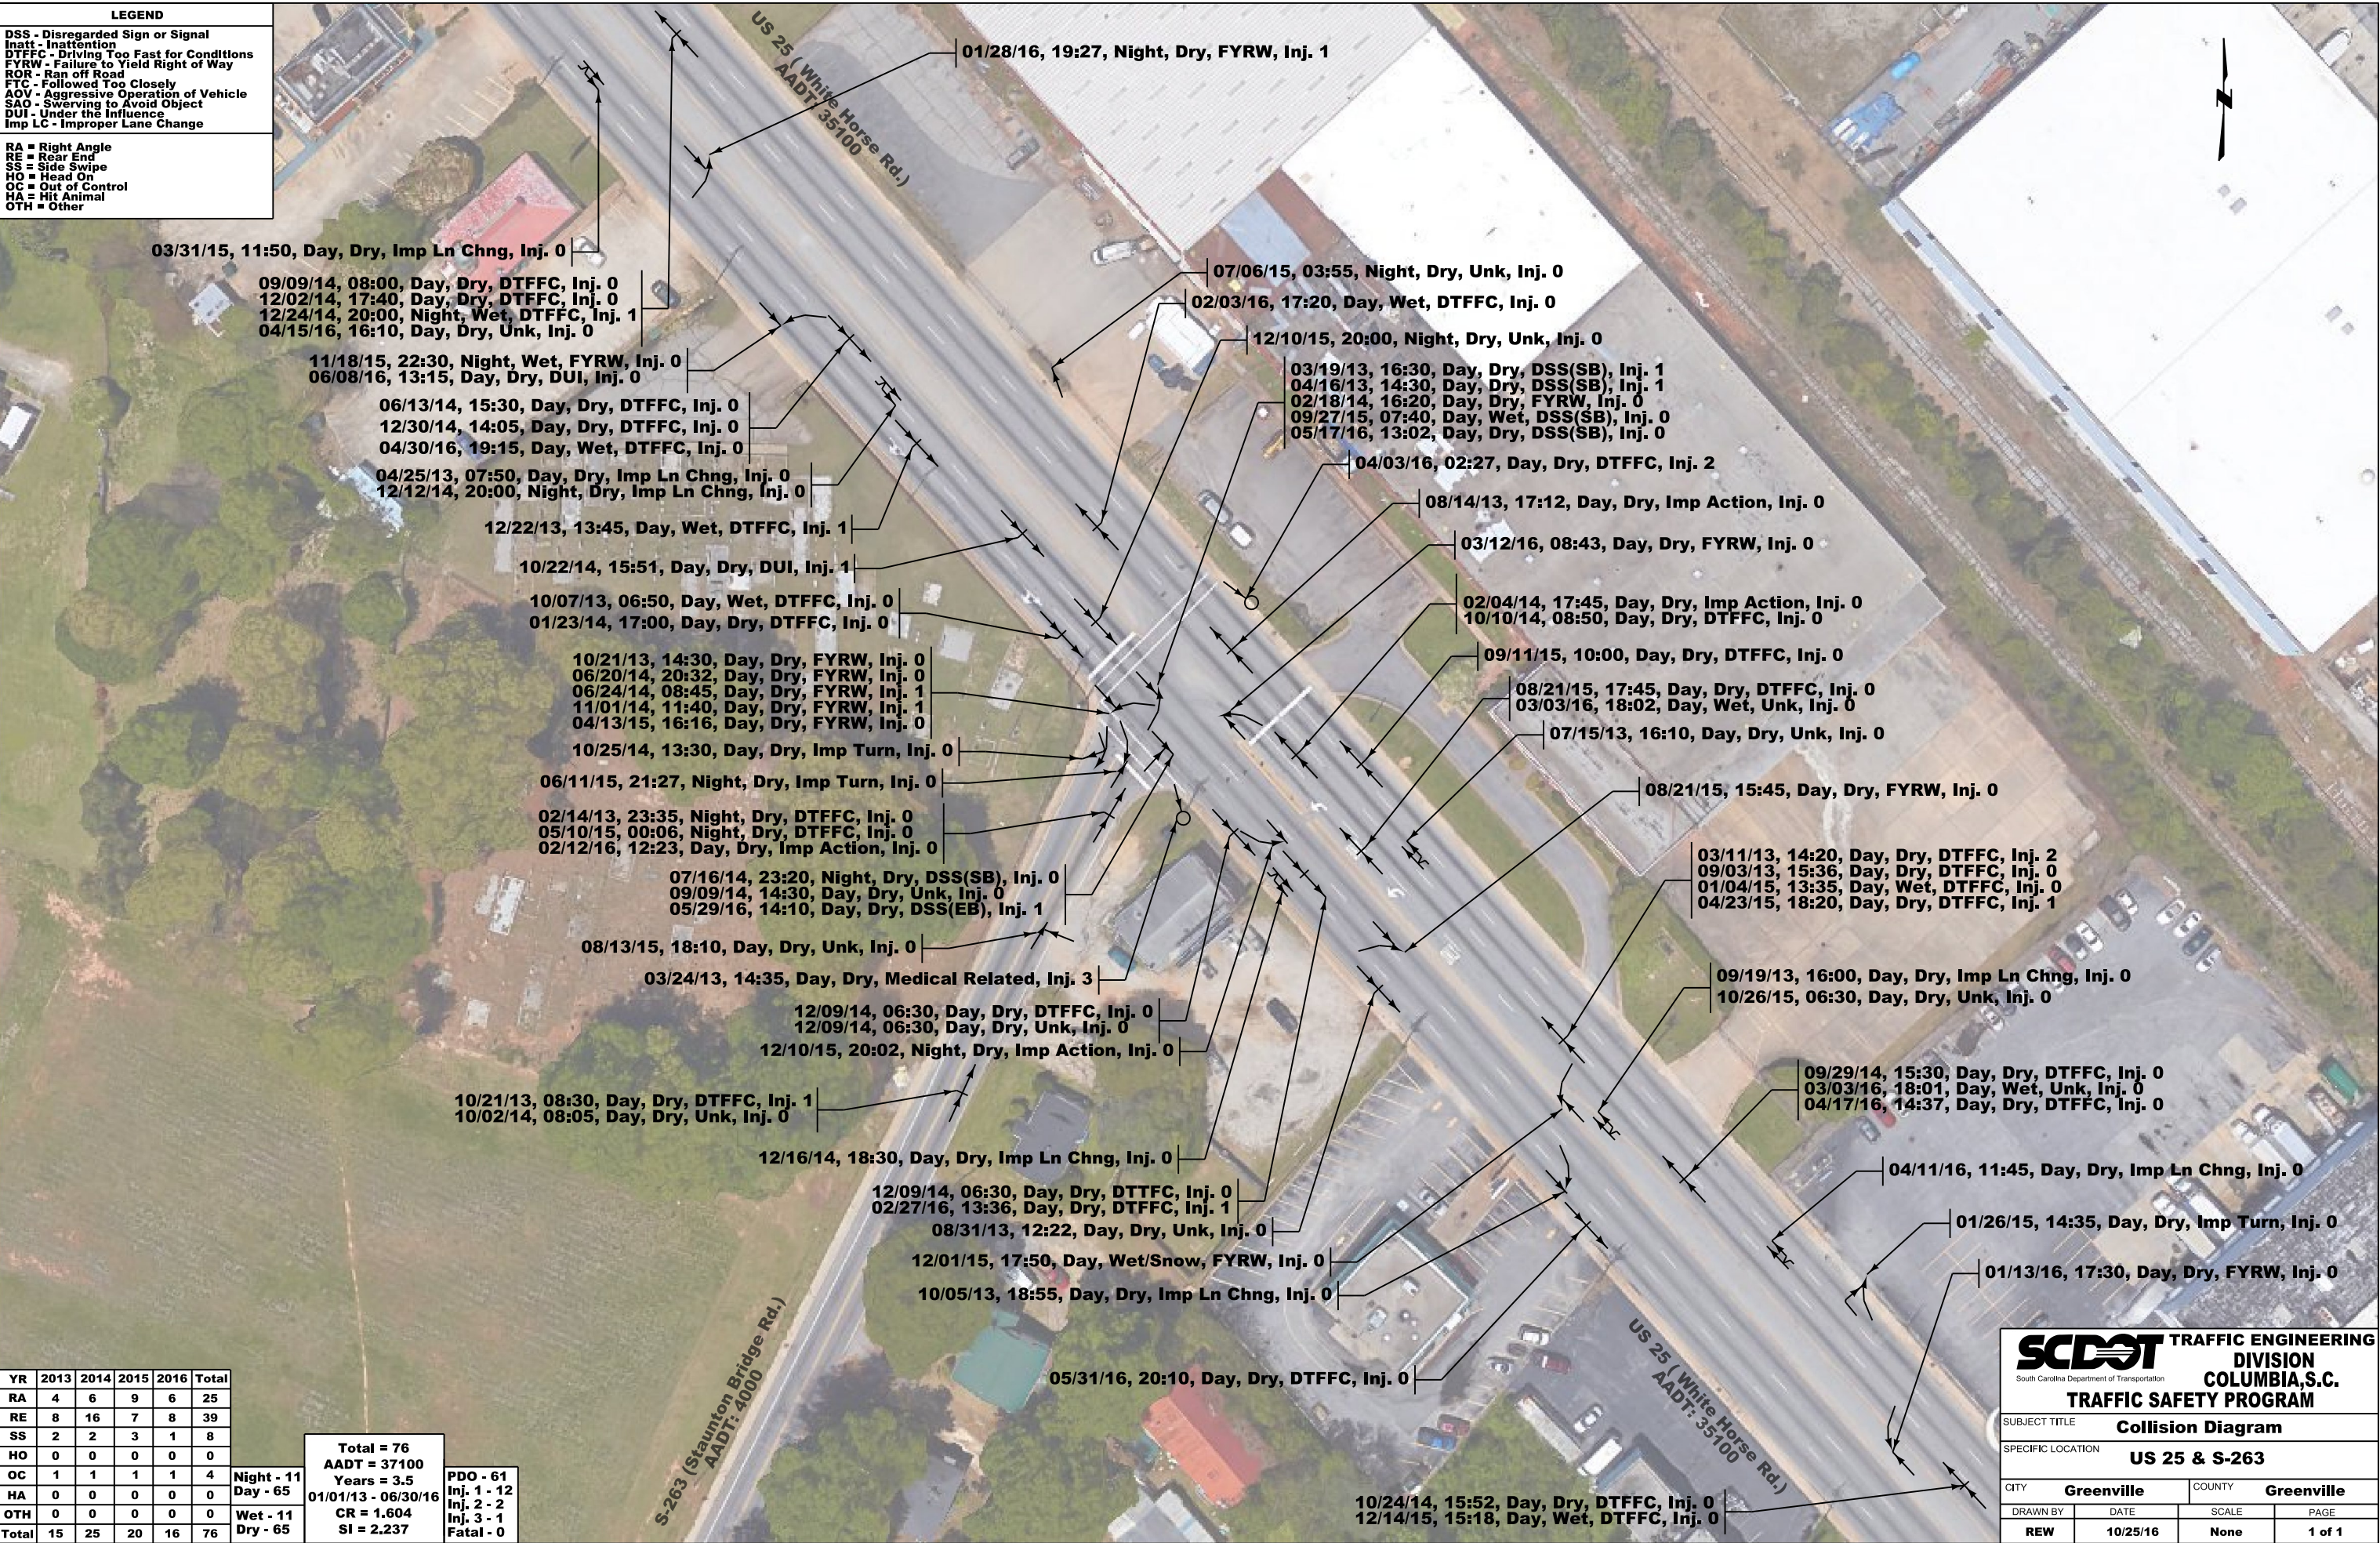
YR	2013	2014	2015	2016	Total
RA	4	6	9	6	25
RE	8	16	7	8	39
SS	2	2	3	1	8
HO	0	0	0	0	0
OC	1	1	1	1	4
HA	0	0	0	0	0
OTH	0	0	0	0	0
Total	15	25	20	16	76

Total = 76
AADT = 37100
Years = 3.5
01/01/13 - 06/30/16
CR = 1.604
SI = 2.237

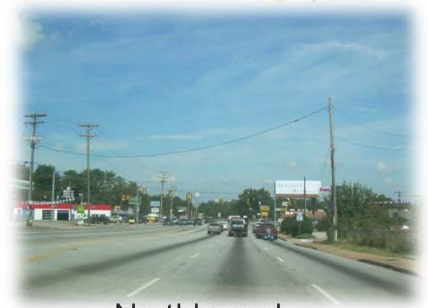
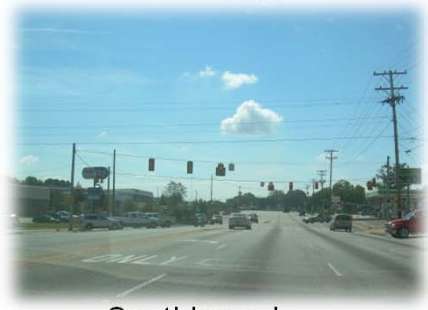
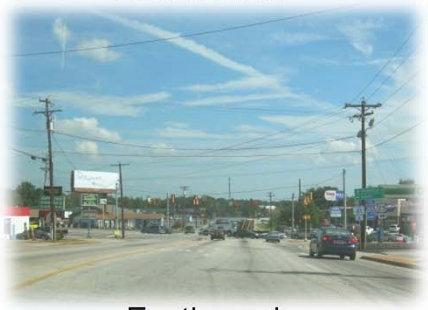
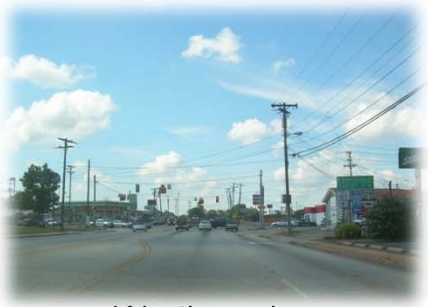
AECOM			
SUBJECT TITLE Figure 2 Existing Conditions			
SPECIFIC LOCATION US 25 (White Horse Rd.) & SC 81 (Anderson Rd.)			
CITY	Greenville	COUNTY	Greenville
DRAWN BY	DATE	SCALE	
SWC	10/23/2012	None

SC 81 (Anderson Road) is a four-lane east-west roadway at the intersection with White Horse Road. The eastbound approach has an AADT of 9500. The roadway geometry of the eastbound approach consists of four lanes with a two-way left-turn lane. The truck and bus percent ranges from 1 to 2 percent for the AM and PM peak periods. The westbound approach has an AADT of 14,300. The roadway geometry of the westbound approach consists of four lanes with a two-way left-turn lane. The posted speed limit is 40 mph.

Figure 1 depicts the location map and study area and **Figure 2** depicts the existing geometry, existing signal phasing, signs, traffic control, layout and configuration of the intersection.

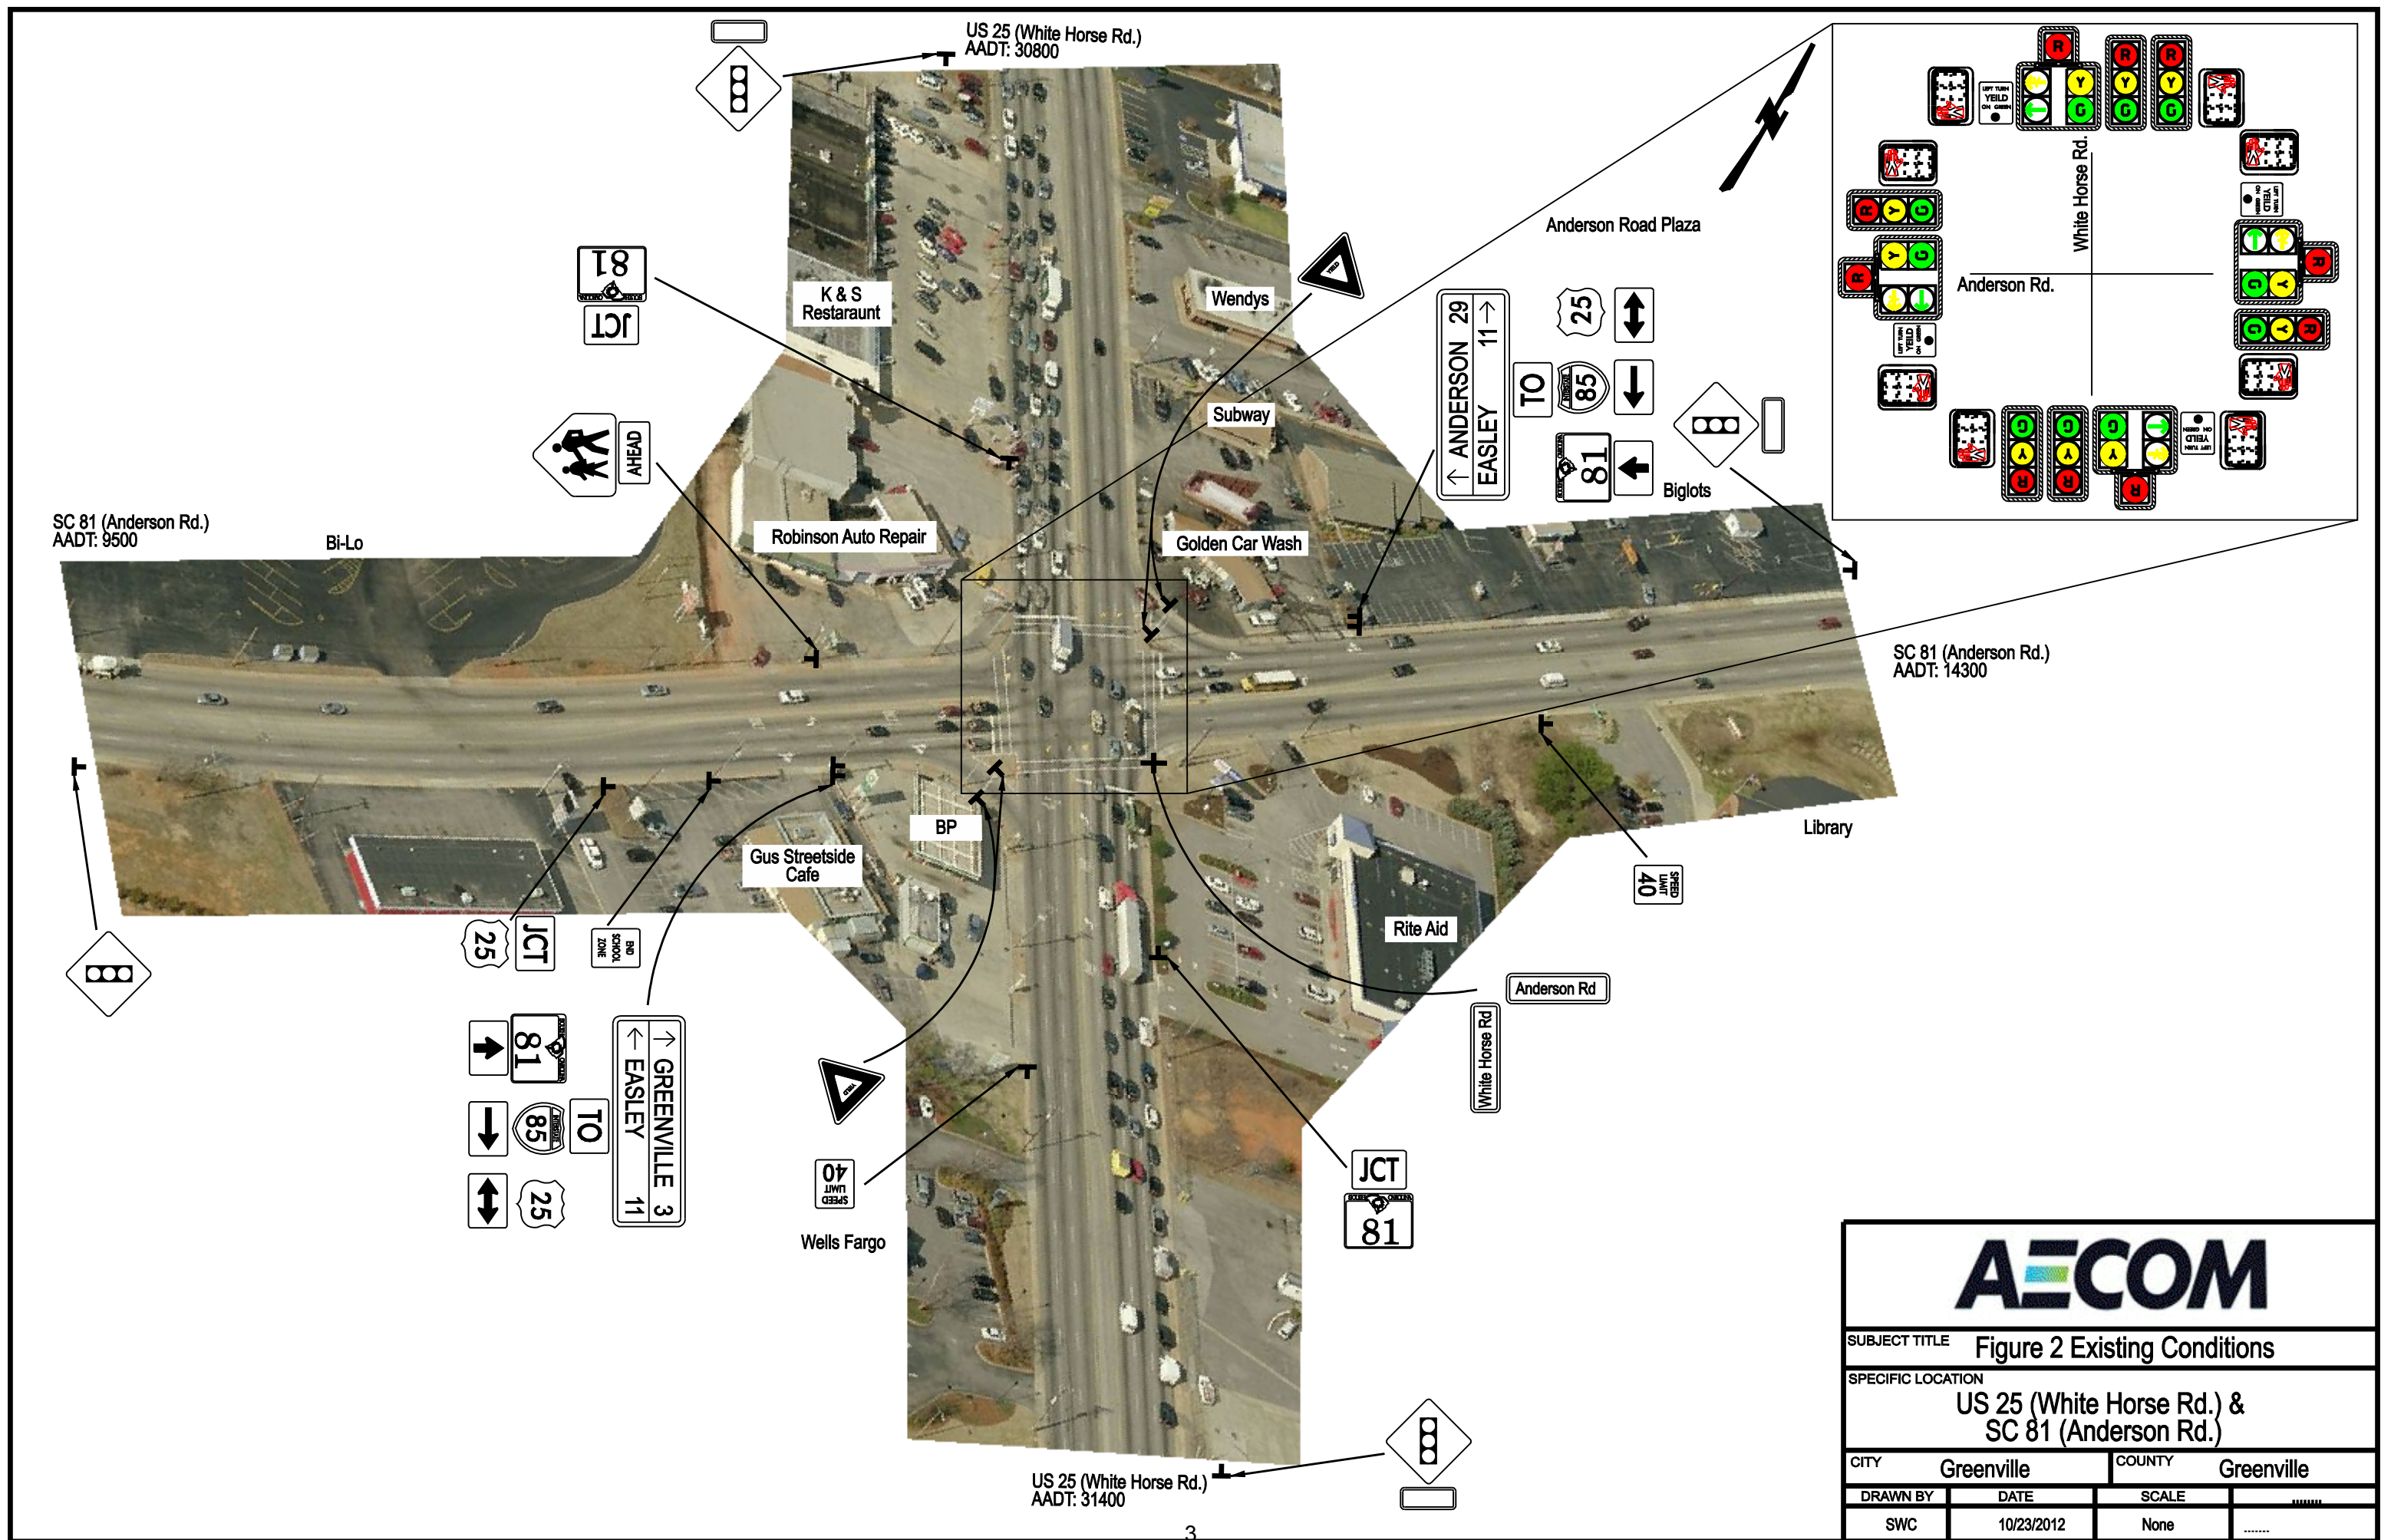
The signalized intersection is maintained by the SCDOT and controlled by a 170 controller. The signal is running uncoordinated (free or isolated condition). Multiple business driveways are close to the intersection. The two major roadways, White Horse Road and Anderson Road are described below.
