Road Safety Assessment Greenville County, South Carolina US 25 (White Horse Rd) from MP 23.5 to 30.0

May 2017

AECOM Technical Services, Inc.

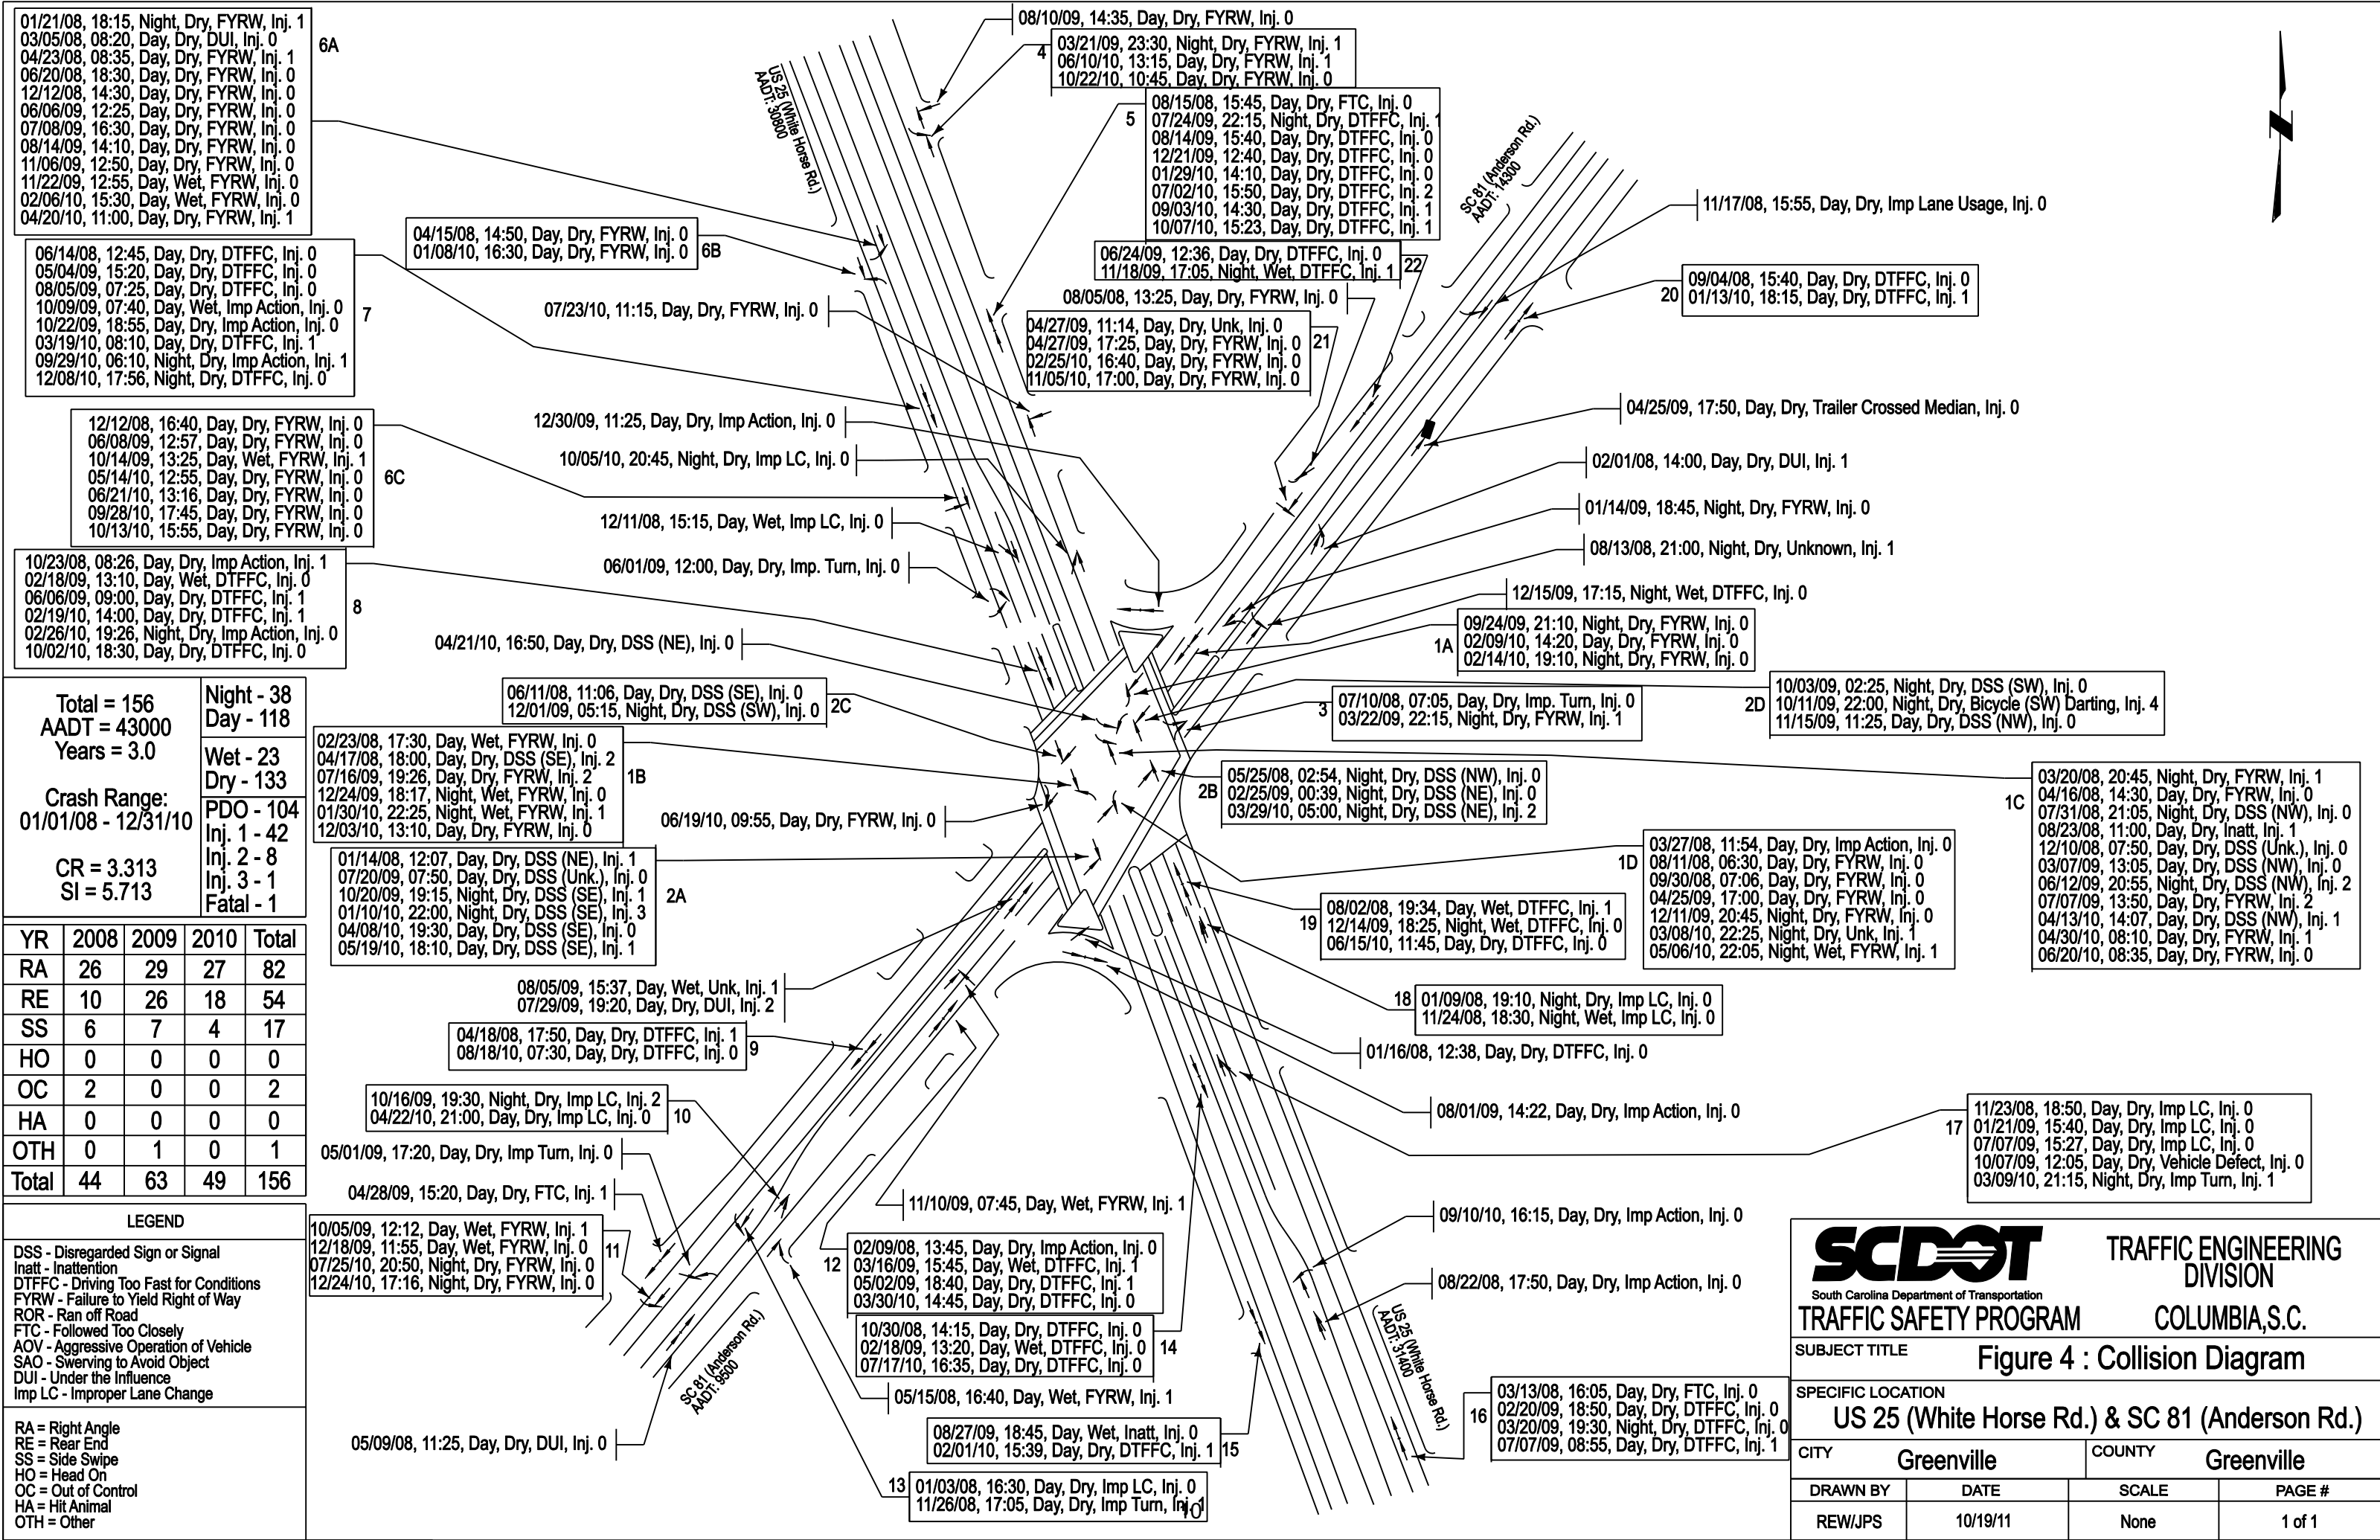
In the crash diagram analysis, a thorough look at each type and location of crash was analyzed. The analysis describes in detail by the location of crash, number and type of crash, and potential casual factors and considerations. The considerations are categorized into near-term and long-term recommendations and are shown in more detail in **Figures 5 and 6**.

Table 3: Crash Diagram Analysis for US 25 (White Horse Road) at SC 81 (Anderson Road)					
Location of crash	Location # (See Figure 4)	Type of Crash	Potential Causal Factor	Considerations	
				Near-Term	Long- Term
In the Intersection	1A	(3) EB left-turns opposing WB through traffic (FTRW)	Vehicles making left-turn on red, sight distance, no lighting	Adjust yellow, red clearance interval, or Flashing Yellow Arrow (FYA),	Add protected left-turns, install street light
	1B	(6) NB left-turns opposing SB through traffic (FTRW,DSS)	Vehicles making left-turn on red, sight distance	Adjust yellow, red clearance interval, or Flashing Yellow Arrow (FYA)	Widen intersection for better left-turn offset, Add protected left-turns, lighting
	1C	(11) SB left-turns opposing NB through traffic (FTRW,DSS, Inatt)	Vehicles making left-turn on red, sight distance	Adjust yellow, red clearance interval, or Flashing Yellow Arrow (FYA), add protected only left turn, add nearside head NB through	Widen intersection for better left-turn offset, install street light

1D	(7) WB left-turns opposing EB through traffic (FTRW, Imp Action, Unk)	Vehicles making left-turn on red, sight distance, no lighting	Adjust yellow, red clearance interval, or Flashing Yellow Arrow (FYA)	Add protected left-turns, install street light
	2A	(6) Right Angle EB and SB throughs (DSS)	too many distractions, intersection not coordinated	Adjust red clearance	Install street light
	2B	(3) Right Angle EB and NB throughs (DSS)	too many distractions, intersection not coordinated	Adjust red clearance	Install street light
	2C	(2) Right Angle SB and WB throughs (DSS)	too many distractions, speed	Adjust red clearance	Install street light
	2D	(3) Right Angle NB and WB throughs (DSS)	too many distractions, speed, no lighting	Adjust red clearance	Install street light
	3	(2) Side swipe SB left-turn and NB right-turn (Imp Turn, FYRW)	Vehicles making left-turn on red, sight distance	Adjust yellow, red clearance interval, or Flashing Yellow Arrow (FYA)

Southbound (White Horse Rd)	4	(4)Right Angle into/out of shopping center (FYRW)	speed, fail to yield right of way	Install right-in/right-out only at Plaza shopping center driveway	Install median on North leg of intersection from signal to just past shopping center driveway
	5	(8) Rear End NB (FTC, DTFFC)	speed	Install sign for Big Lots Shopping Center just before intersection to have motorists turn right at intersection and left into shopping center driveway	Install right turn storage bay for Big Lots shopping center
	6A	(12) Right Angle out of K & S Shopping Center Entrance 2(FYRW, DUI)	speed, sight distance curve	Install right-in/right-out only at shopping center driveway	Install median on North leg of intersection from signal to just past shopping center driveway
	6B	(2) Right Angle into K & S Shopping Center Entrance 2 (FYRW)	speed, crossing too many lanes	Install right-in/right-out only at shopping center driveway	Install left-over for left-turns into the shopping center driveway

12	(4) Rear End EB (DTFFC, Imp Action)	speed, signal not coordinated	Adjust red clearnace, add name plate to exisitng "Signal Ahead" warning sign	
	13	(2) Right Angle in TWLTL (Imp Turn, Imp LC)	too many distraction, inattention, worn pavement markings	Re-paint lane lines to make them more visible	Install median on West leg of intersection from signal to just past shopping center driveway
Northbound (White Horse Rd)	14	(3) Rear End SB (DTFFC)	speed, too many distractions		
	15	(2) Rear End SB (DTFFC, Inatt)	speed, too many distractions		
	16	(4) Rear End NB (FTC, DTFFC)	speed, too many distractions	Install nearside signal head	
	17	(5) Side Swipe (Imp LC, Imp Turn)	worn pavement lane markings	Re-paint lane lines to make them more visible	Overhead lane marking signs
	18	(2) Side Swipe (Imp LC)	worn pavement lane markings	Re-paint lane lines to make them more visible	Overhead lane marking signs
	19	(3) Rear End NB (DTFFC)	speed, signal not coordinated	Adjust red clearnace

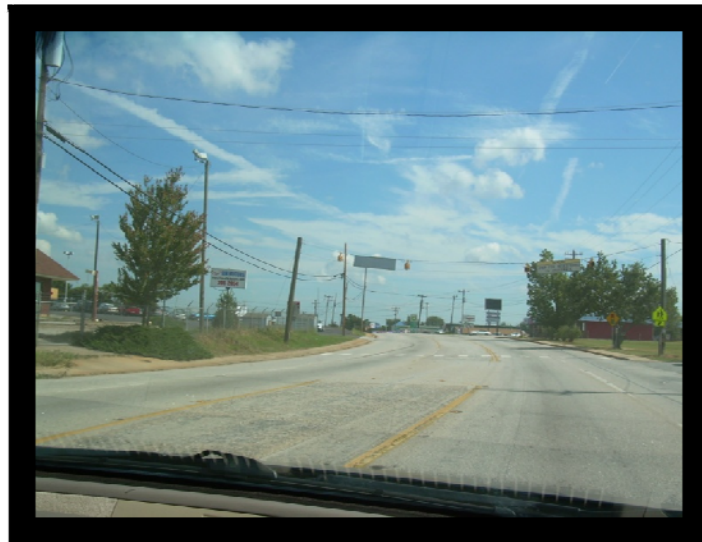
- **9, 12** - Install a larger advanced signal ahead warning sign W3-3 with name plate 'White Horse Road' to give motorists advance warning of the approaching intersection. There are 6 rear end crashes approaching the intersection. Picture 1 shows the eastbound view approaching this intersection; the small advance signal sign is just pasted the crosswalk sign.

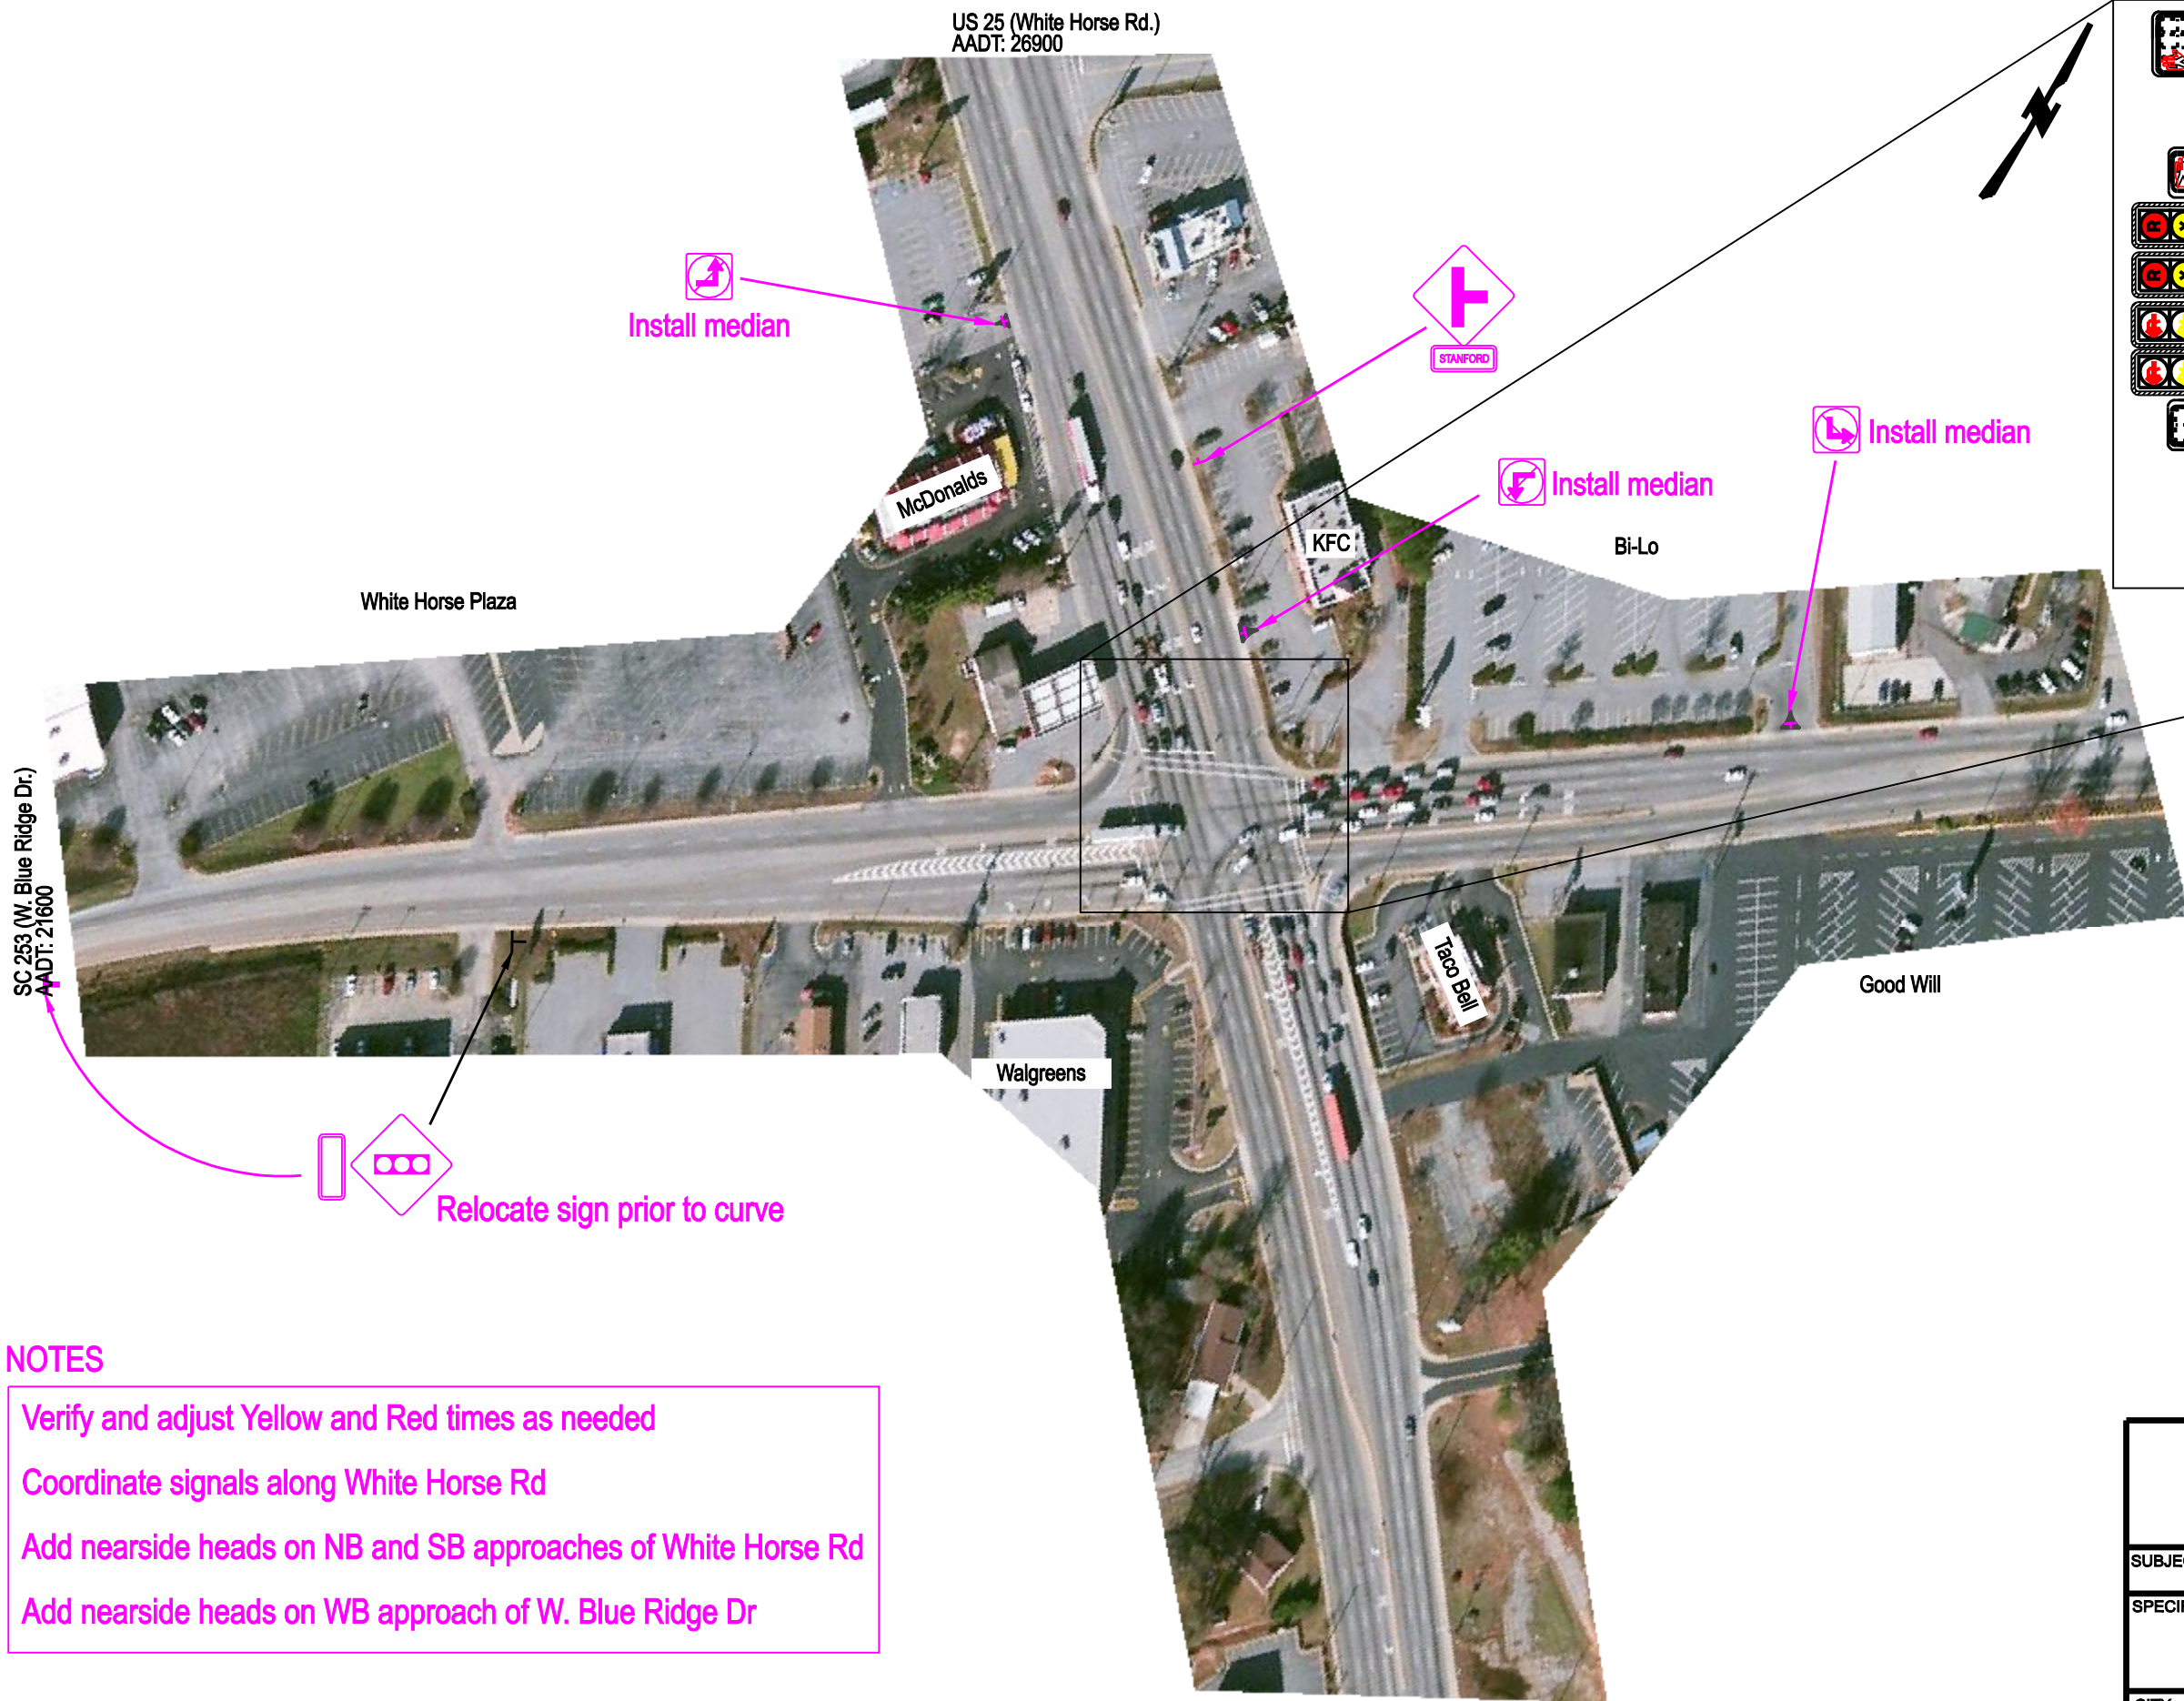
Install nearside thru and left-turn signal heads. Sight distance is restricted when truck traffic approaches the +6% grade intersection.

US 25 (White Horse Rd.)
AADT: 26900

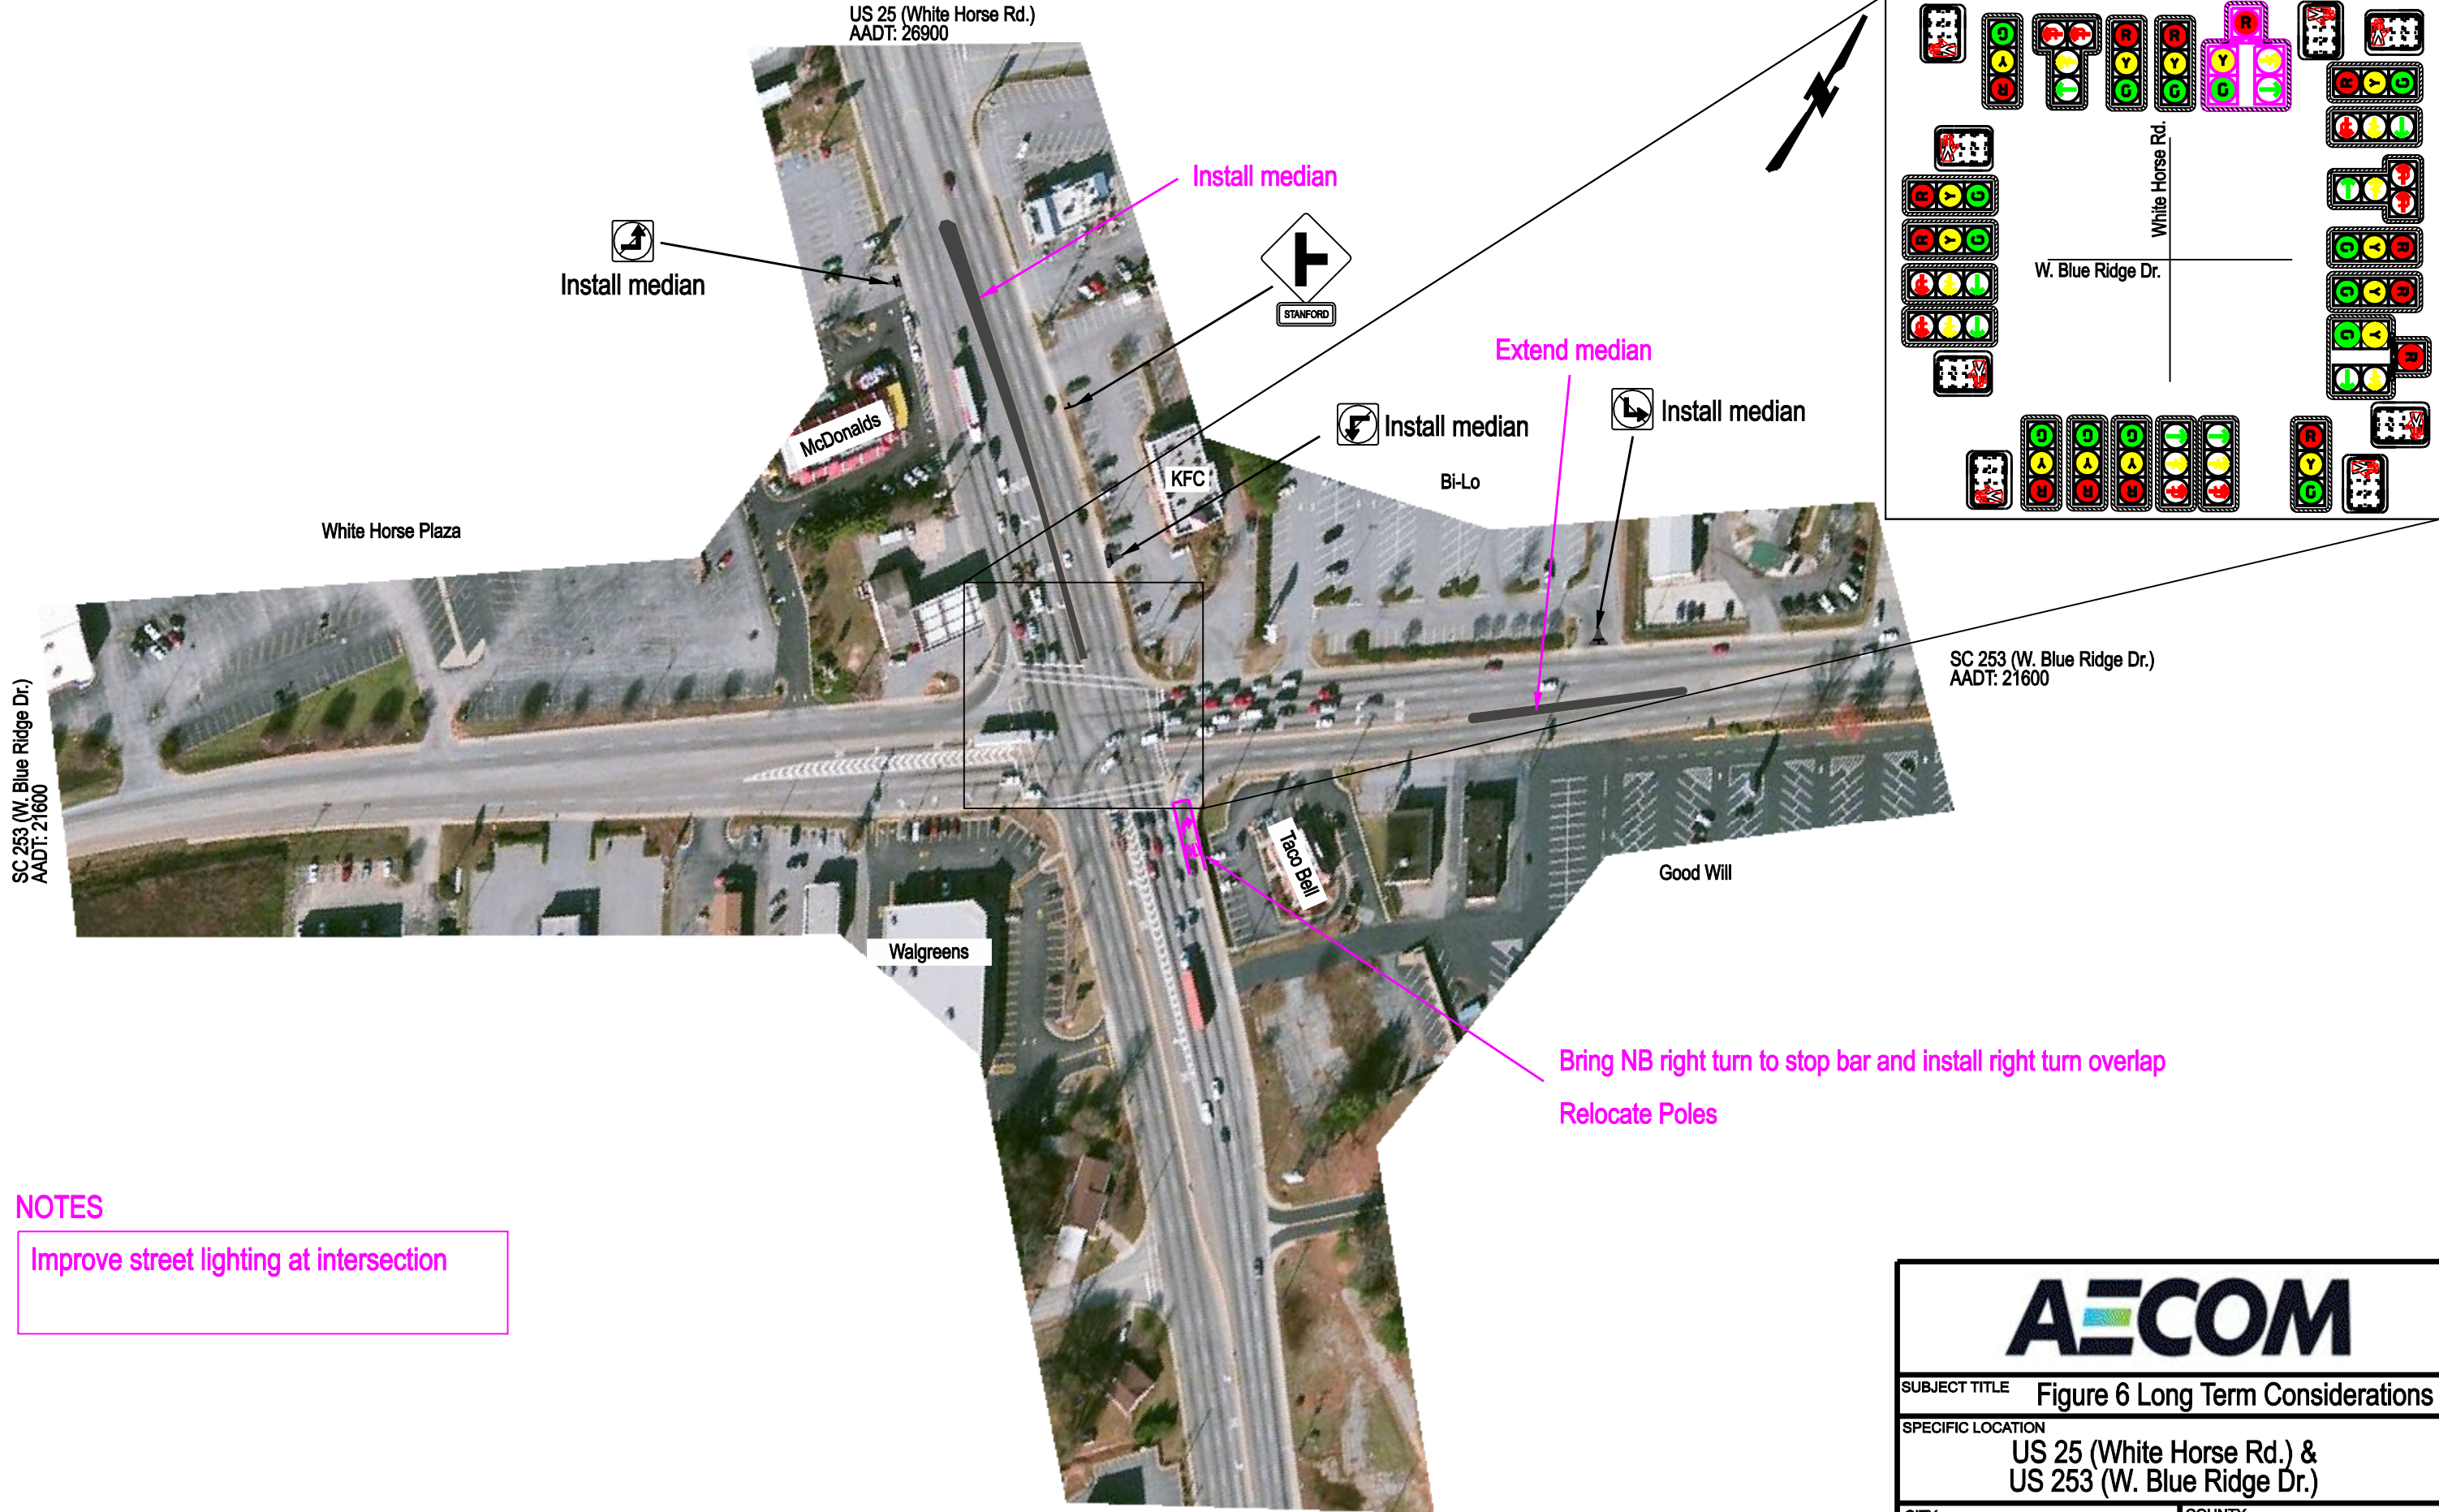
- **21** – A recommendation to extend the concrete median on the westbound of White Horse Road will prohibit left-turns into and out of the second Bi-Lo shopping center and other driveways to / from Blue Ridge Drive. By installing a concrete median, these conflict points are reduced removing seven right-angle crashes.

Improve street lighting at intersection
